**MP 28.0 40' Deck Plate Girder Timber Deck**

**Mile 26.9 Trail MP 25.9 Over Papp Road**

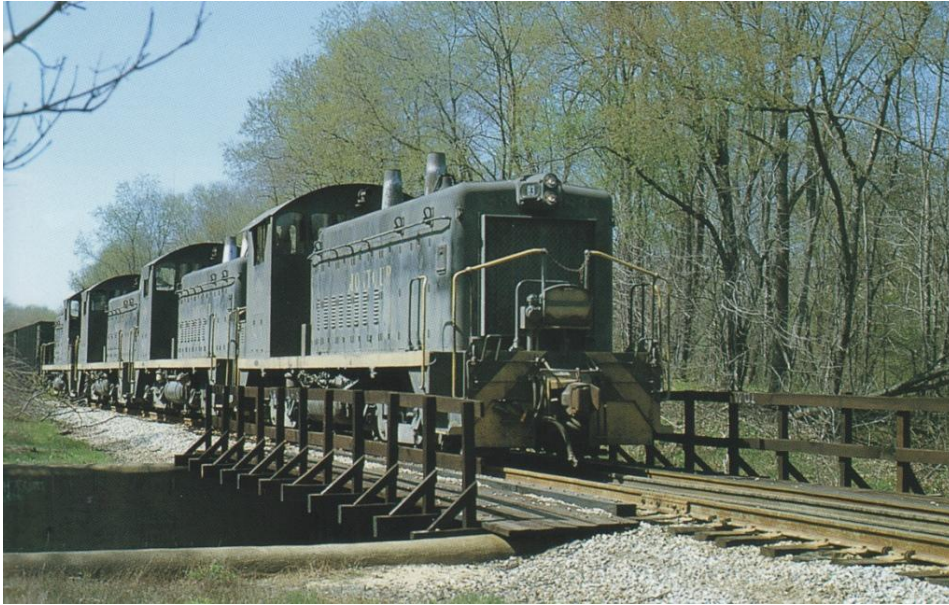
An eastbound Montour train crosses Papp Road bridge on May 1, 1979

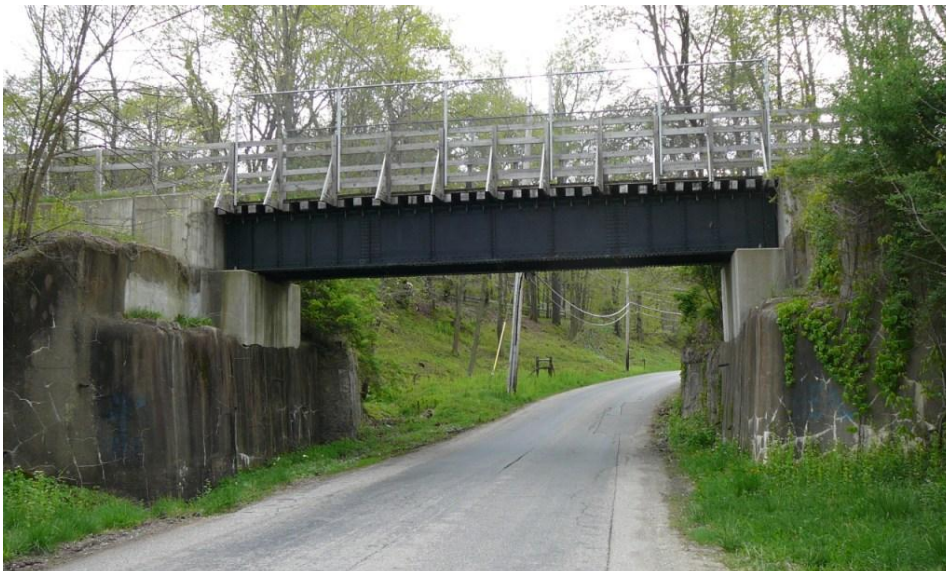
Looking south – uphill on Papp Road. Added abutments can be seen under bridge.

Additional abutments installed by Montour Trail Council raised bridge approx. 5 feet

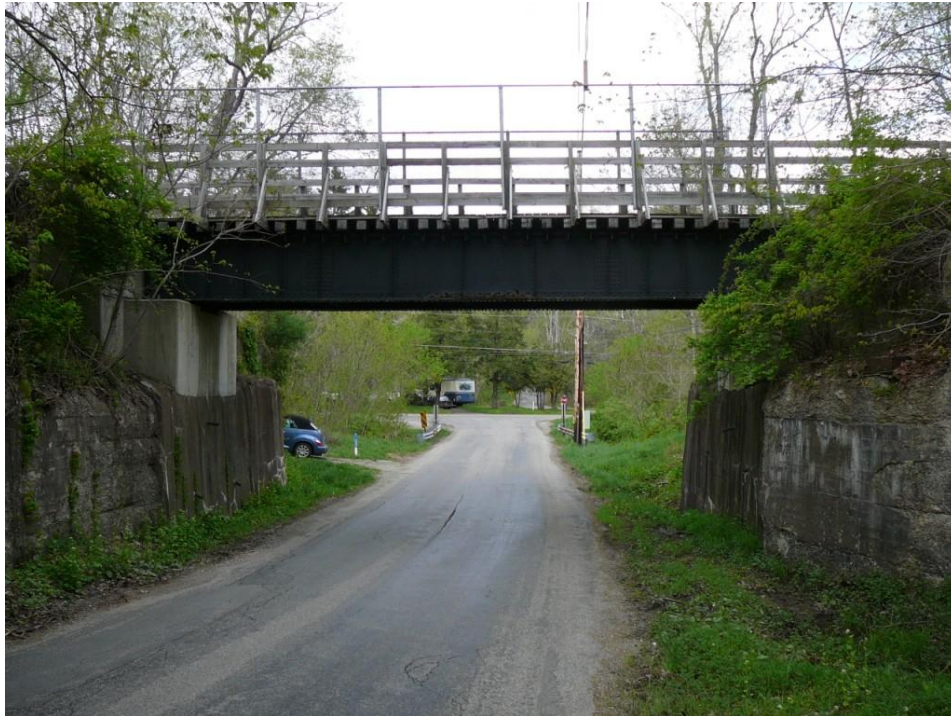
Looking north – downhill – towards Cecil-Henderson Road intersection.

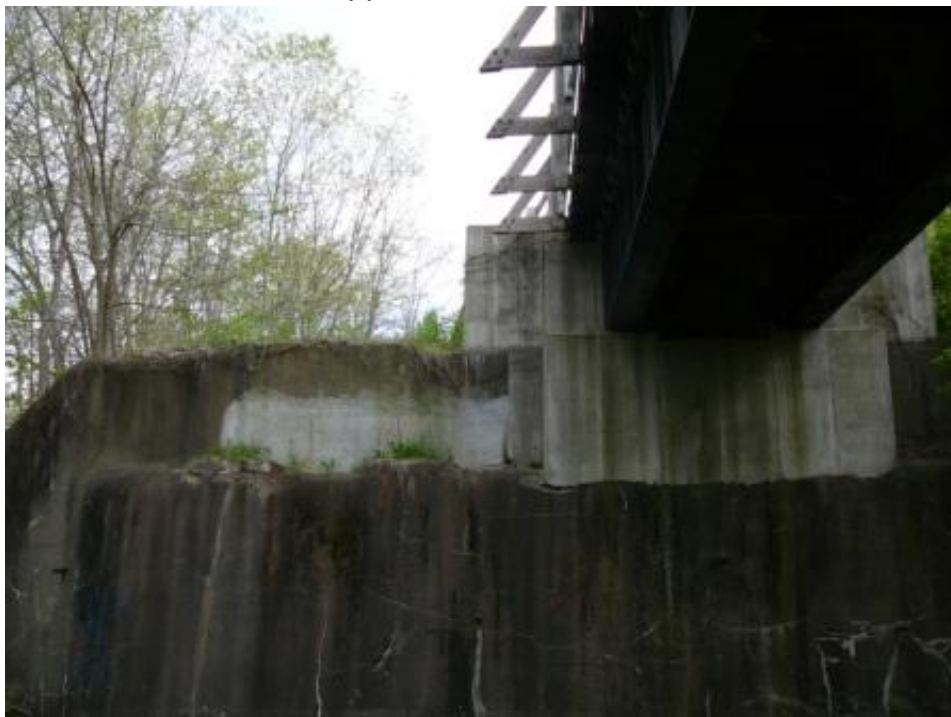
Bridge originally was located on pads to left (north) of its current location. The bridge was moved and raised approx. 5 feet for additional clearance.

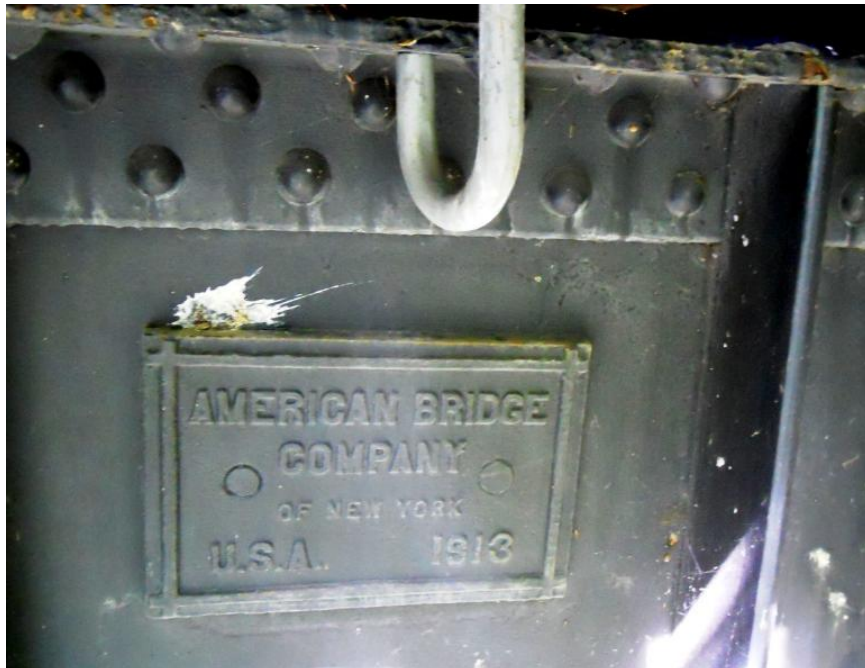
Builder's Plate – American Bridge Co. - dated 1913

Builder's Plate – American Bridge Company of New York U.S.A. 1913

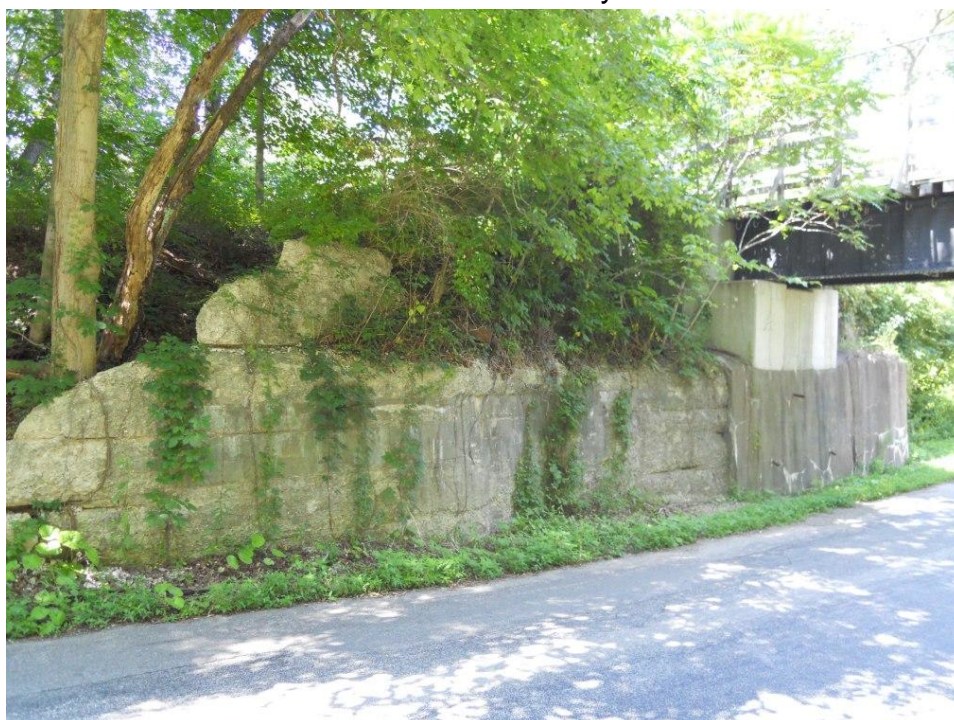
Additional concrete abutments on the south side indicate where a second span was located that led into the National # 2 Mine yard tracks.

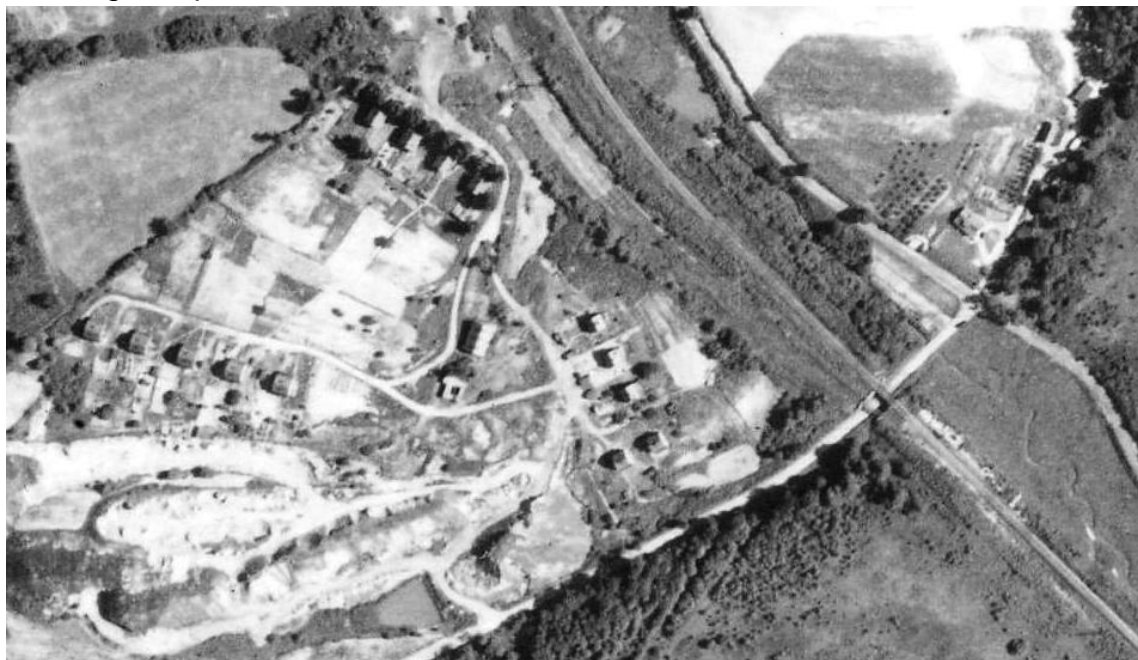
Aerial view from 1939 shows bridge at right center. Note second span to left that carried tracks into National #2 Mine complex. The mine was closed in 1927 and tracks and loading facilities were dismantled by 1939. Mine buildings and houses in this picture have now also been removed. Cecil-Henderson Road runs from top center to lower right of picture.

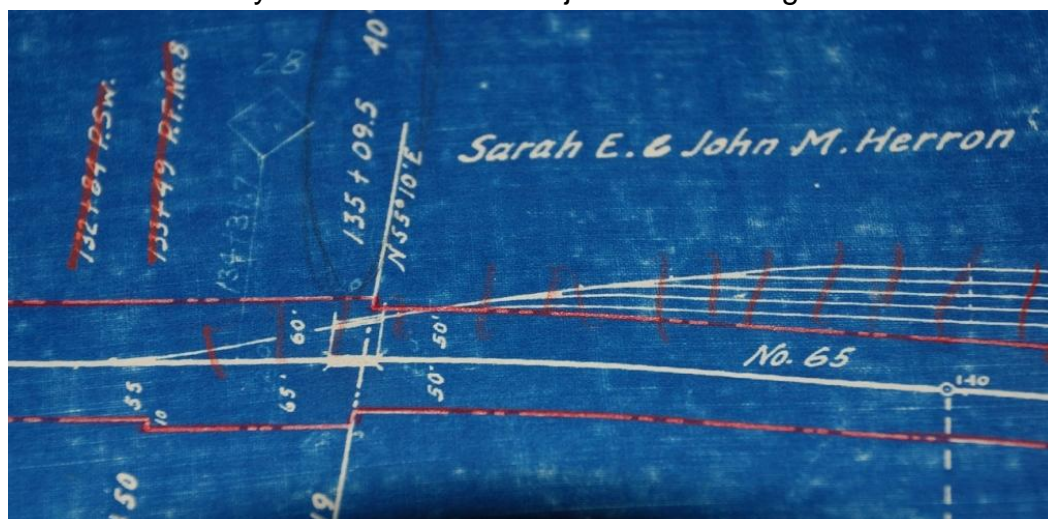
1915 Track Map shows bridge on the main line, with secondary span leading into the National Mine #2 yard. MP 28 is noted just east of bridge.

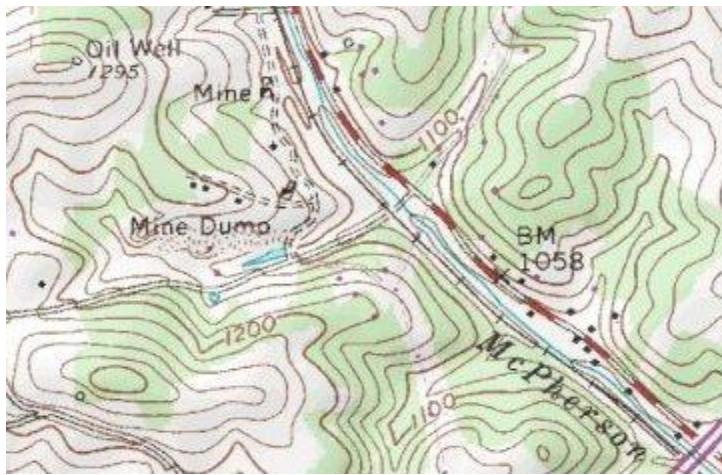
Topo map shows bridge at center. Mine noted at upper center is National #2. McPherson Creek runs parallel to railroad. Cecil-Henderson Road is in dashed red, with I-79 bridge at bottom right corner.
