MP 31.5 8' Concrete Slab

Mile 30.4 Trail MP 29.4 Over Drainage Ditch

Probably Built 1913 No markings on concrete

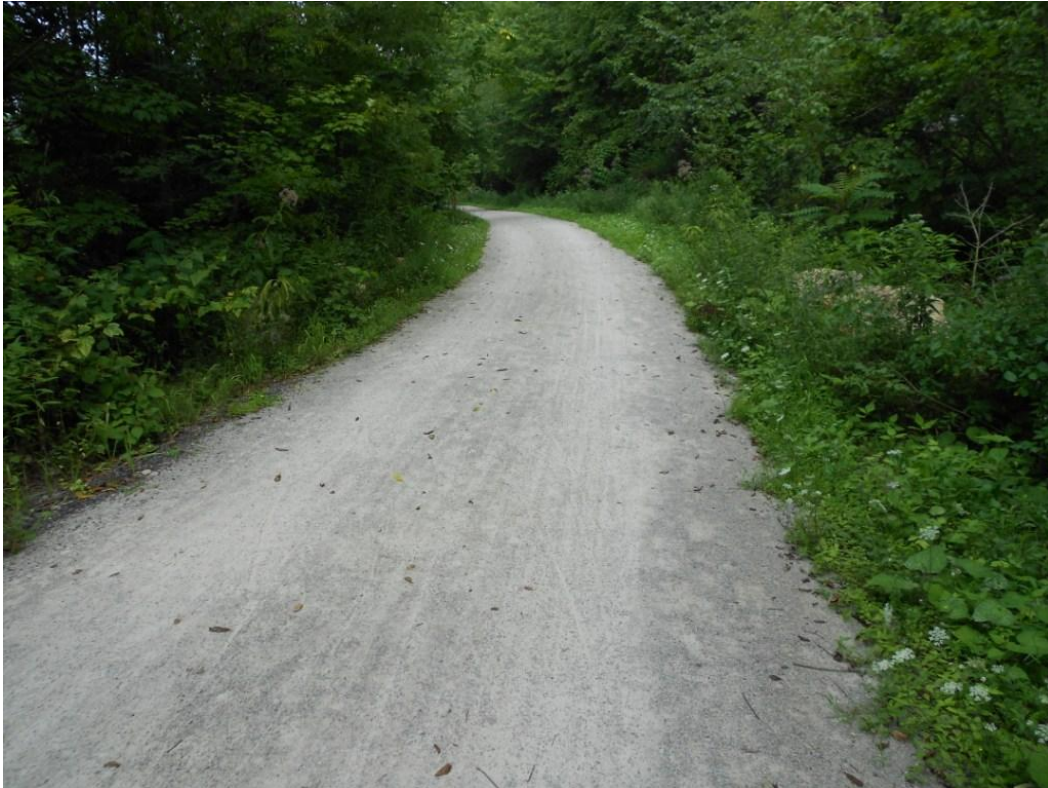
The abutments cannot be seen from the Trail surface, so you have to hunt down over the hillside and in the ditch to see the concrete facing. There are some large rocks on either side of the Trail, piled on top of the edges of the bridge to hold back erosion.

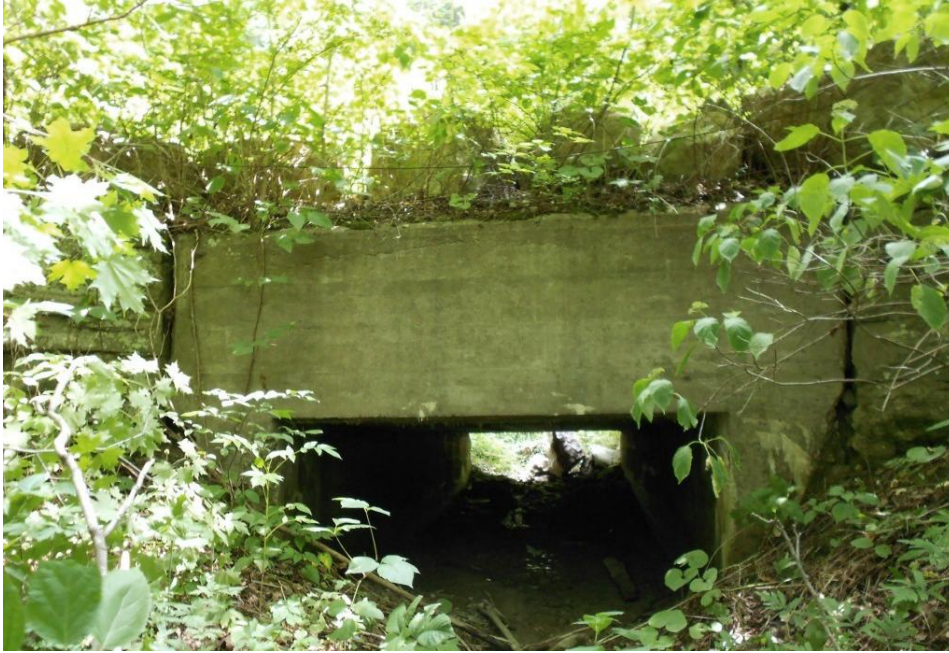
This is a view from the west side of the bridge, above Chartiers Creek & Buckeye Street, with no dates evident in the concrete. Stone retaining walls are on either side of bridge. Above bridge on either side are stanchions made from lengths of rail, with guard cables strung between them. The large rocks seen above the concrete are along the edge of the Trail surface.

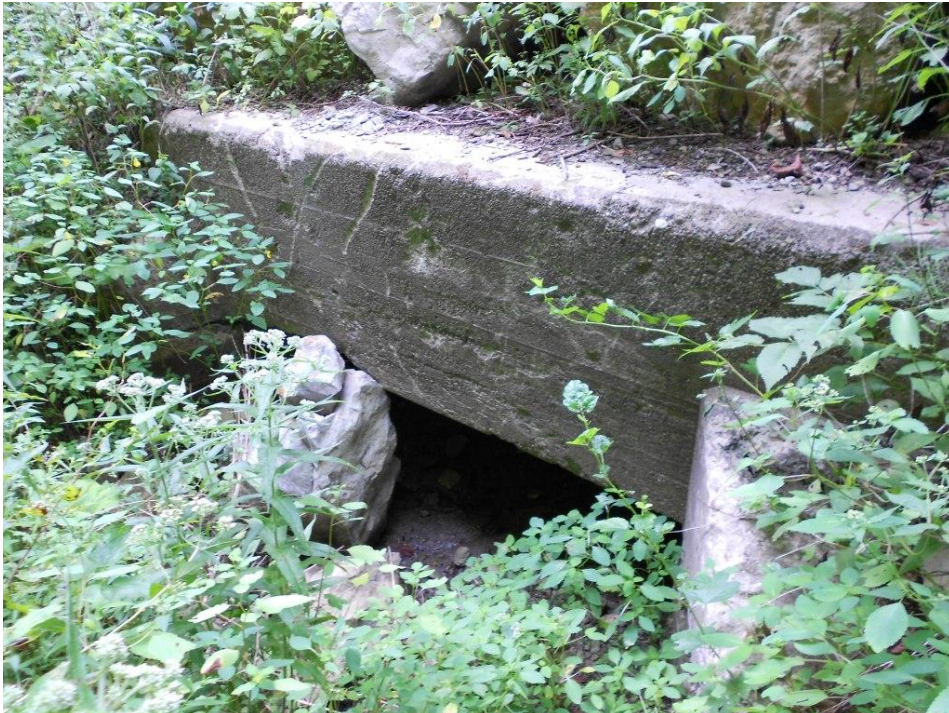
This view is from the hillside ditch edge of the bridge.

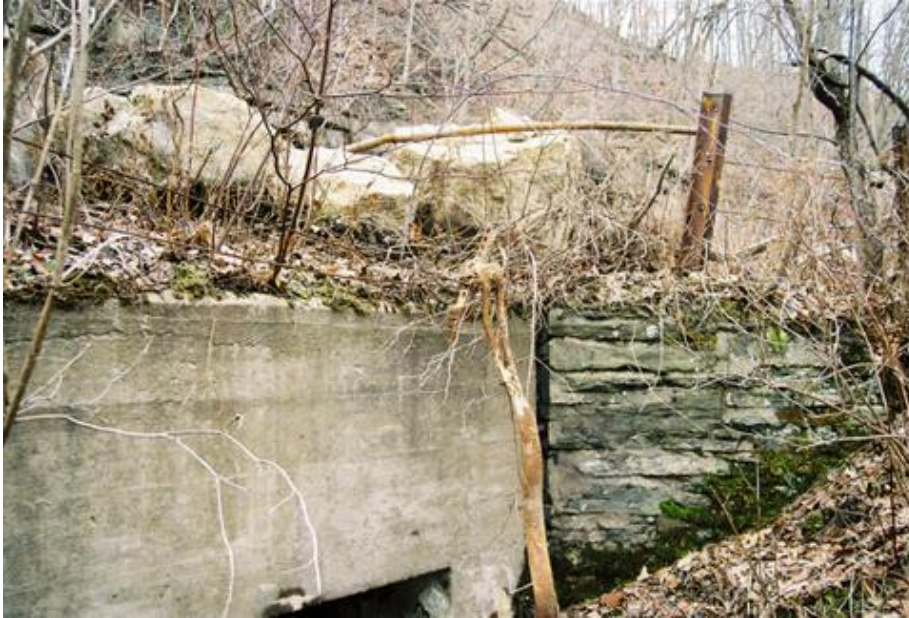
This view shows the stone retaining wall on right side, with rail stanchions above and guard cables strung through stanchions.
