MP 34.8 24' Concrete Arch

Mile 33.7 Trail MP 32.8 Over Bebout Road

Builder's date of 1913 in concrete

Removed October, 2011 and replaced by 144' steel beam span in 2012

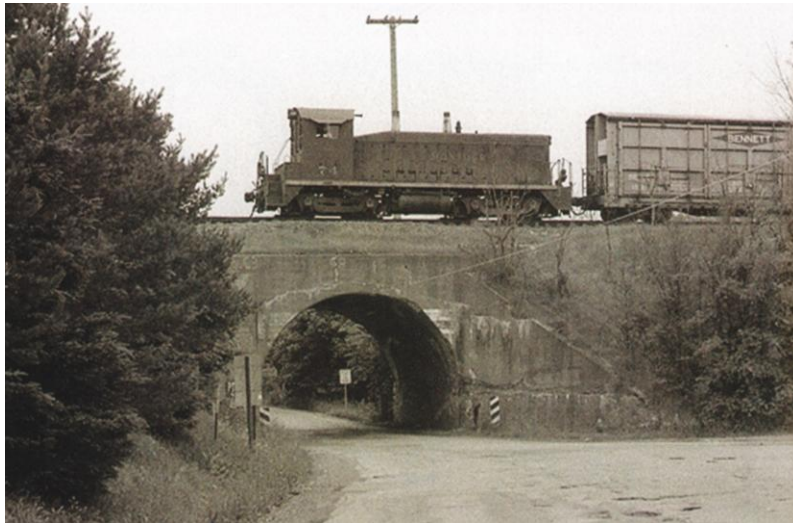
View looking south from Valley Brook Road intersection in 1979. 12' 0" clearance presents problems for large trucks and sight lines from Valley Brook intersection limit view of traffic approaching on Bebout Road. These conditions caused PennDOT to place the arch on their list for removal and replacement.

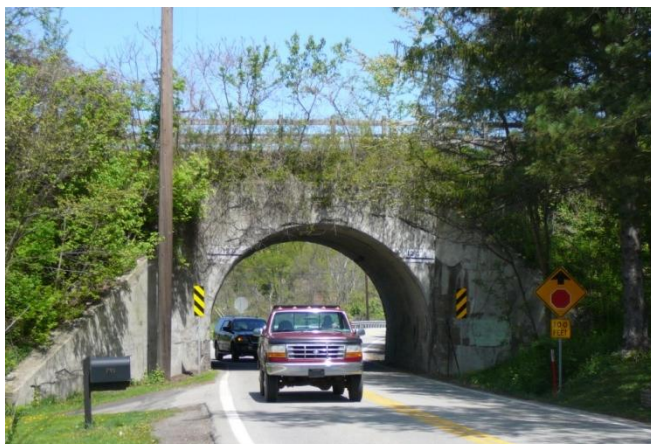
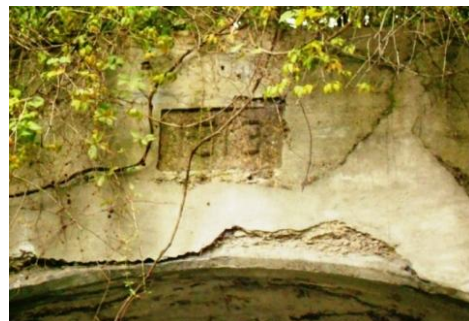
View looking north. Valley Brook Road intersection is beyond bridge. 1913 builder's date is over arch.

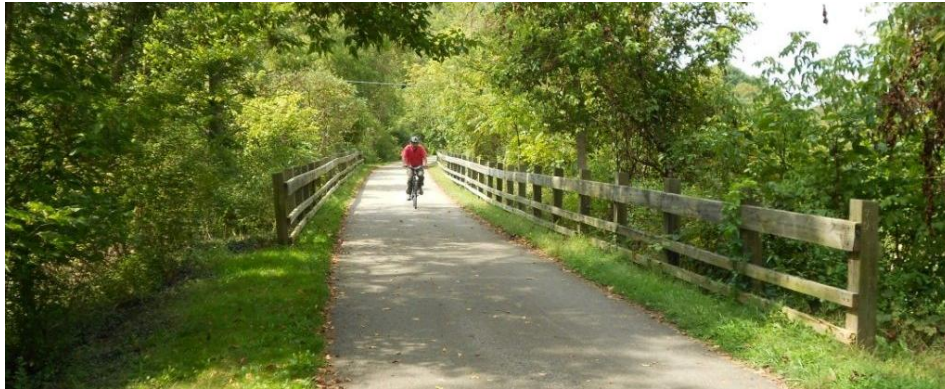
Looking west across the bridge in September, 2011.

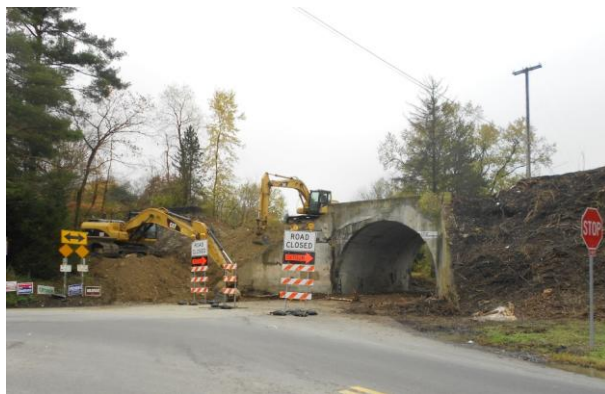
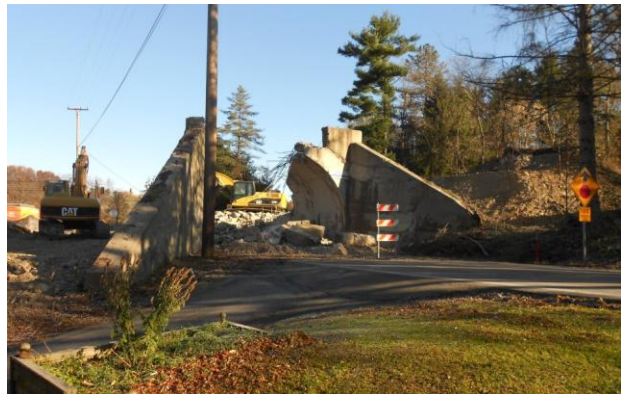
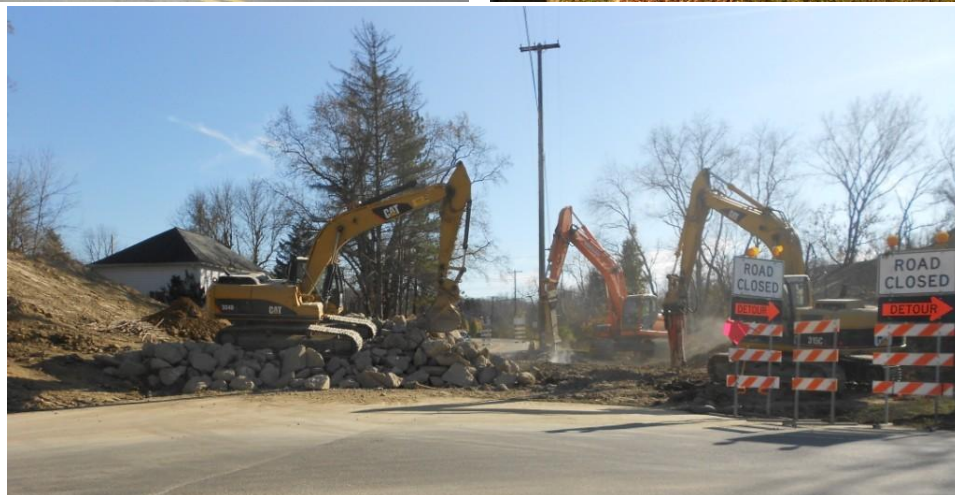
In October 2011, demolition begins and just over a week later the old arch is gone.

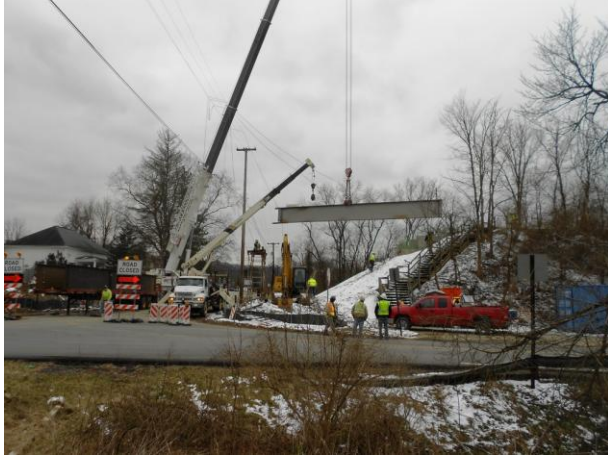
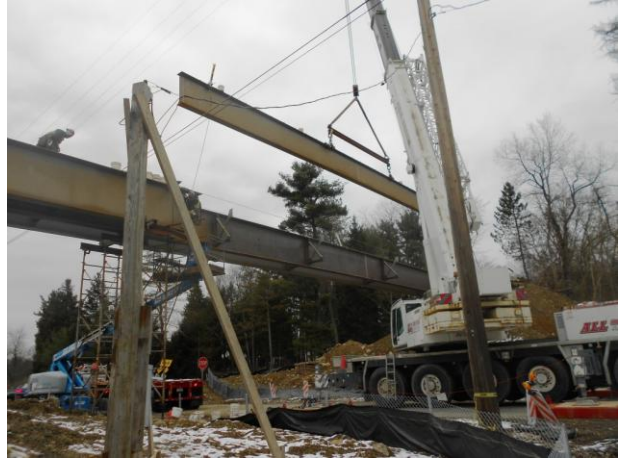
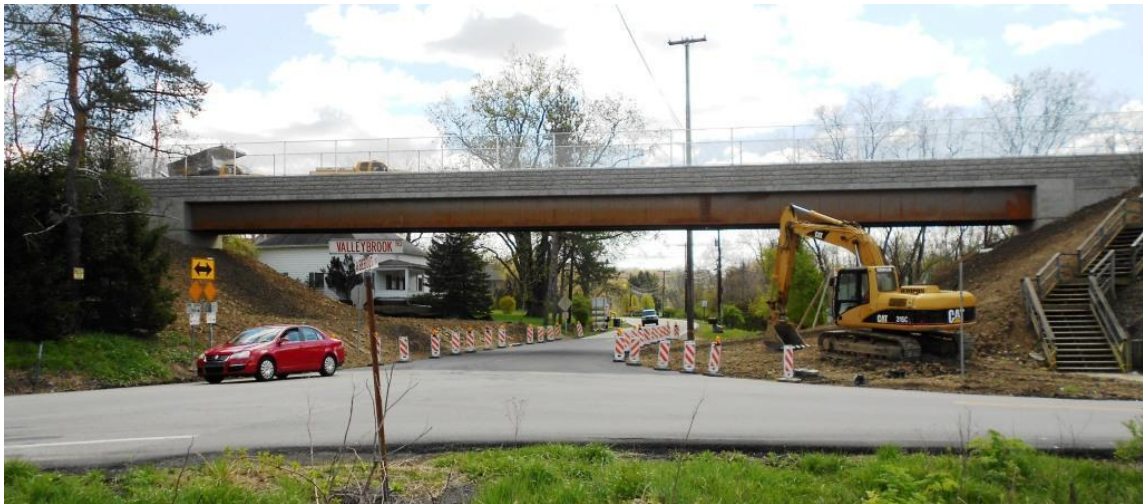
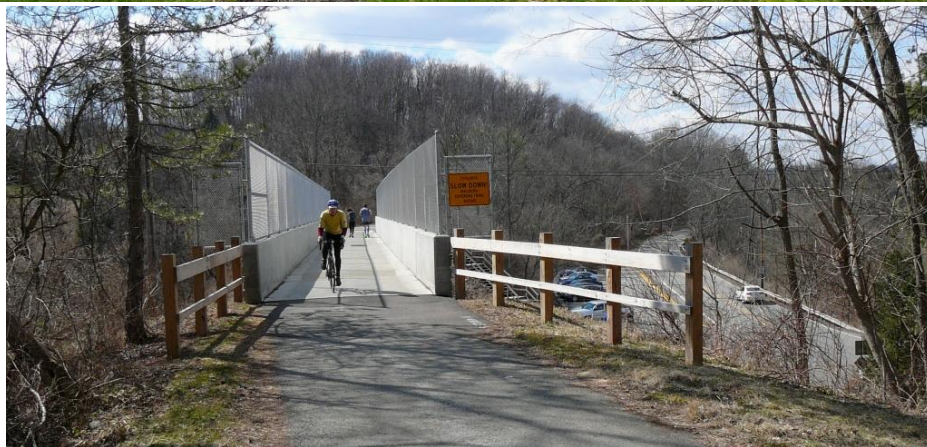
Winter of 2012 sees the new steel beams being set into place and by April the new bridge is completed and the trail reopened. The new span is composed of 2 steel beams for each girder, a 52 and a 92 foot section, making the new bridge 144 feet. A concrete deck was poured on top of the girders and steel decking.

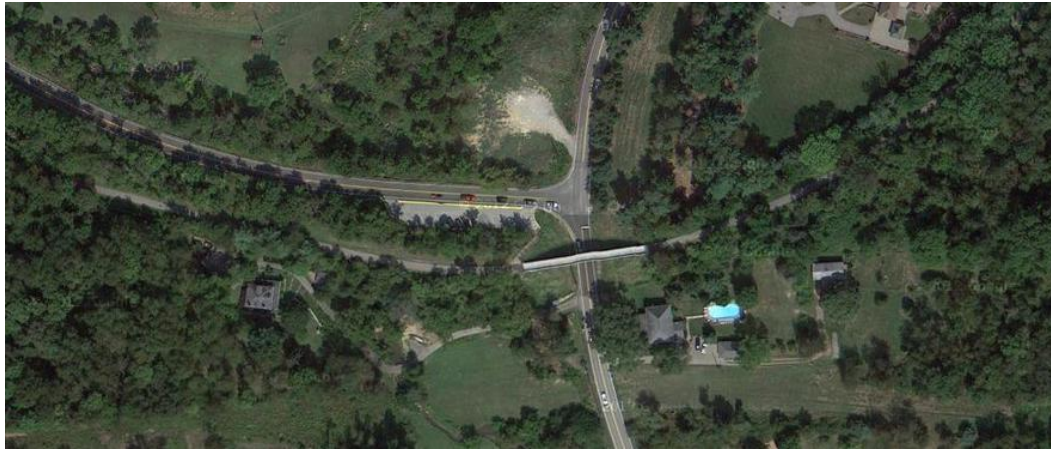
Satellite view shows bridge at center. Bebout Road runs top to bottom, with Valley Brook Road running from upper left to intersection at center.

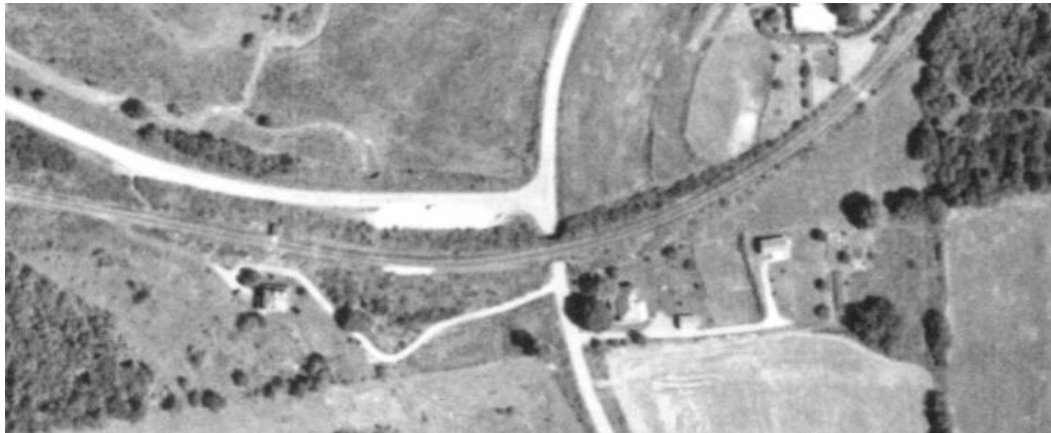
Similar aerial view from 1958. Driveway below railroad goes to house at left center, owned by the Montour Railroad and used by the Section Gang Foreman. Opposite the house, beside the tracks, is the McMurray Tool House.

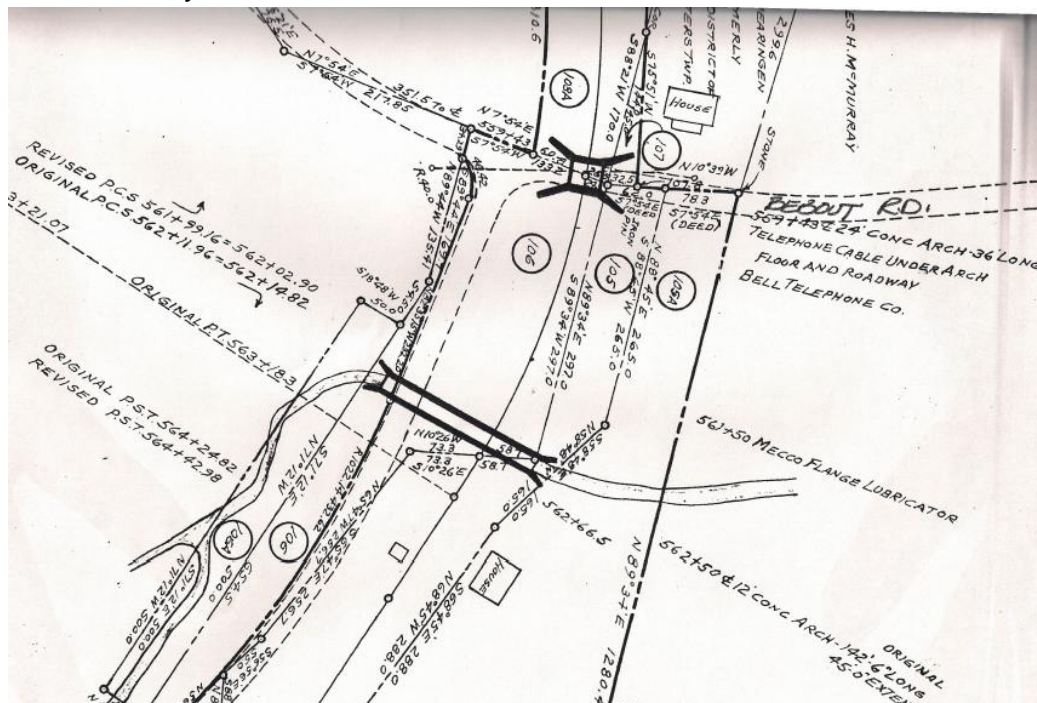
Valuation plan shows bridge at upper center over Bebout Road. Valley Brook Road runs from lower left to upper center at intersection. Brush Run flows under railroad in concrete culvert at center of frame. House at lower center was owned by the Montour Railroad and used by the Section Gang Foreman. The square to left of this house was the McMurray tool house. North is at left of frame.

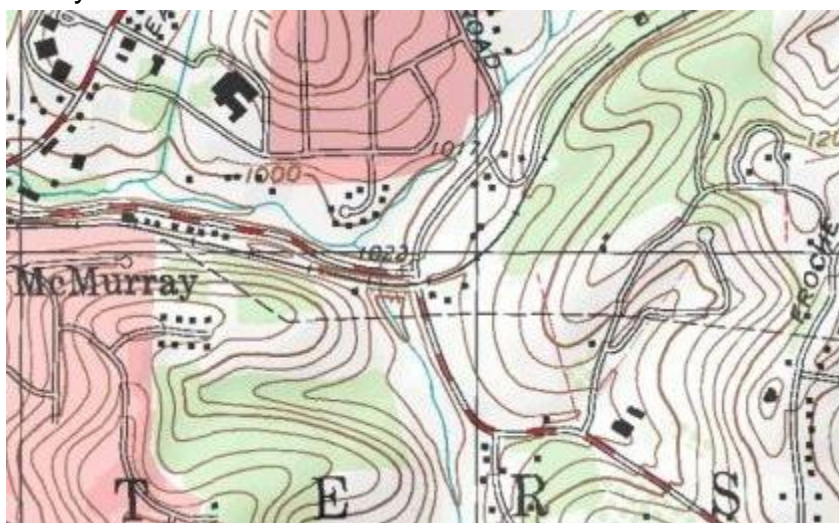
Topo map shows bridge at center. Bebout Road runs top center to bottom right and Valley Brook Road center left to intersection at center at bridge location.
