Montour No. 9 Mine (Bob Ciminel ©2012)

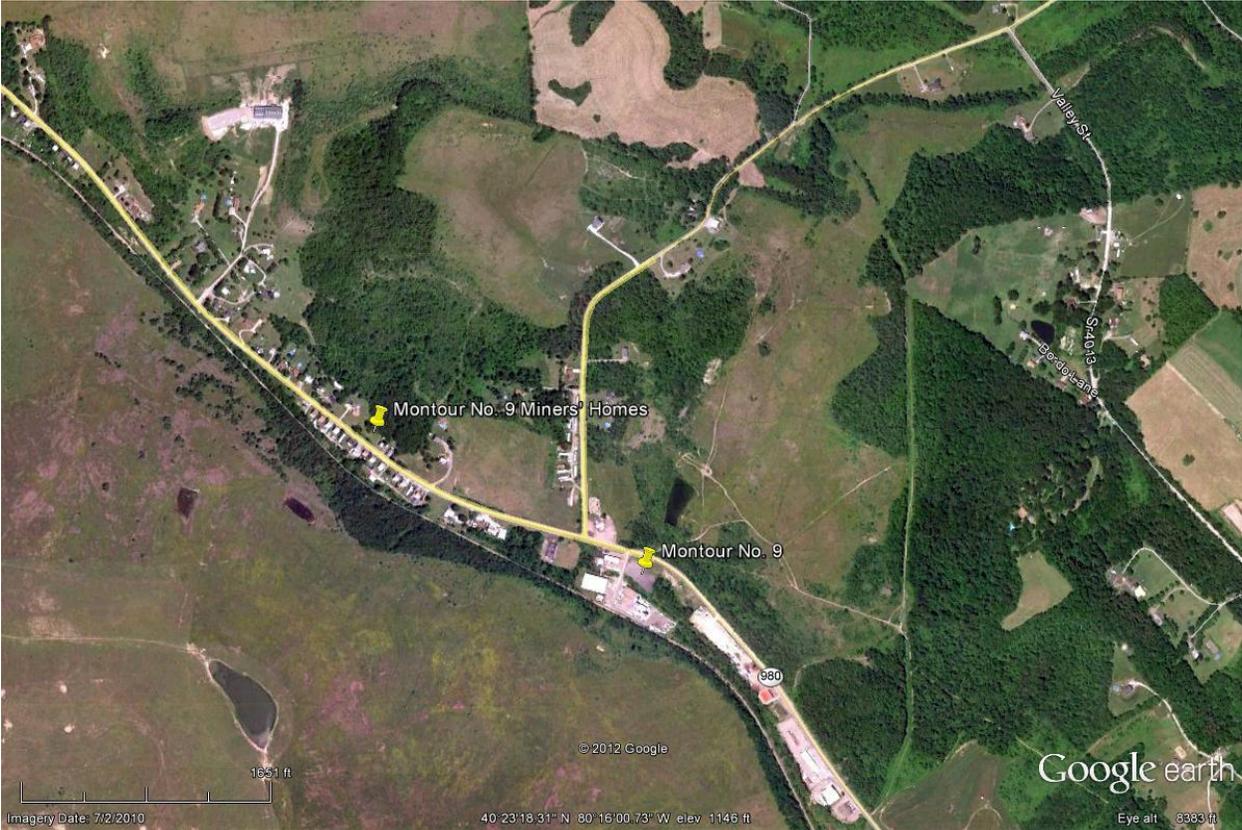
This 2010 Google Earth image shows the former site of Montour No. 9 and the miners' village at McAdams. The pushpin shows the location of the main entries that passed beneath Route 980. The level area between the highway and the Montour Trail was the location of the tippie and yard.

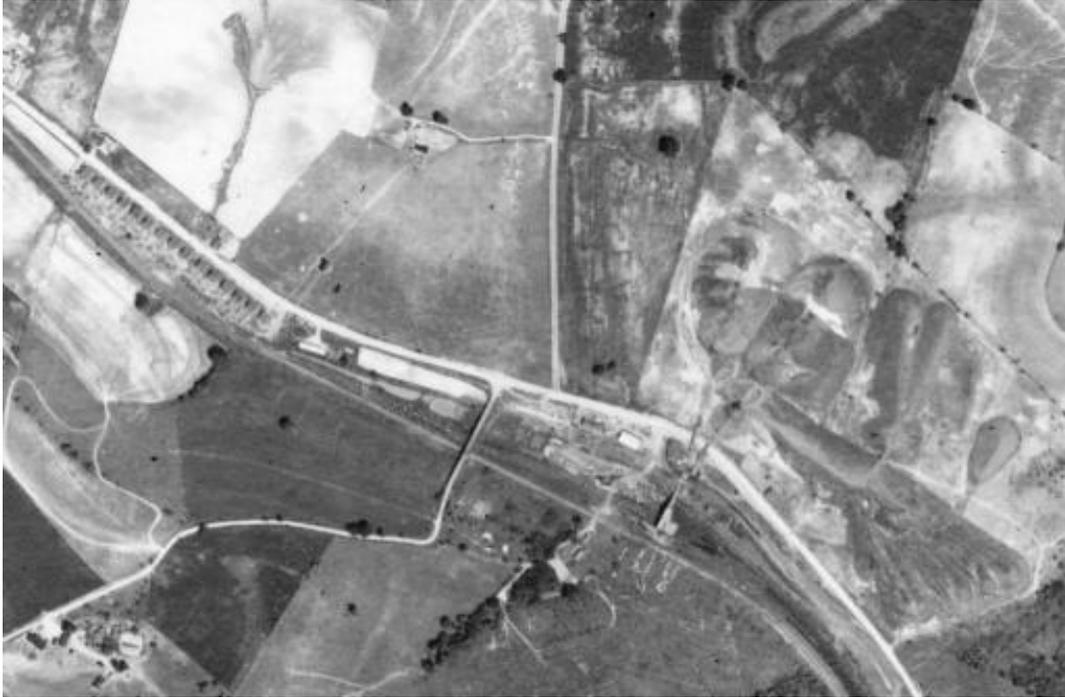
This 1939 aerial photo show the tipple and waste dump for Montour No. 9 and the village to the west on Route 980. Note the bridge across the Montour Railroad northwest of the tipple.

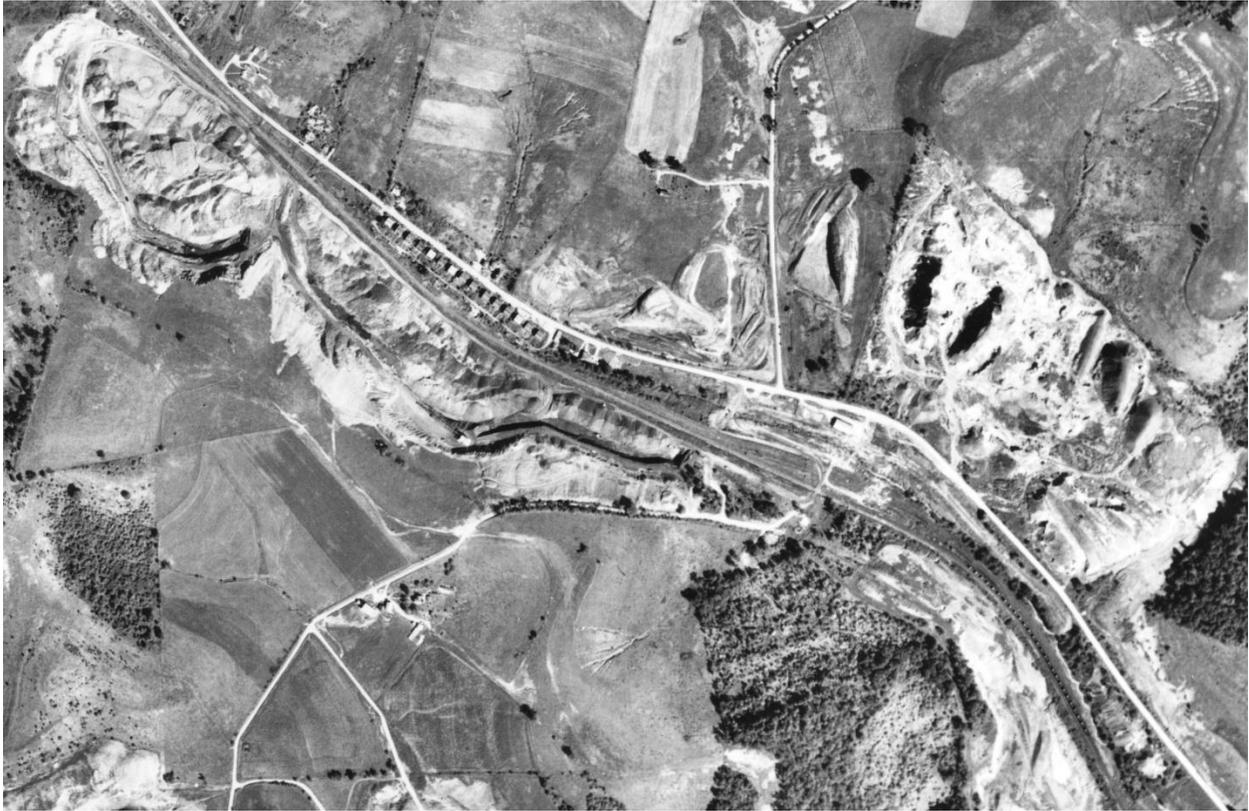
The tipple is gone in this 1956 photo and a major stripping operation is underway northwest and southwest of the mine. Note that the bridge over the Montour tracks is also gone. There is a string of empty hopper cars in the lower left corner of the photo, but no evidence of where they would be loaded.

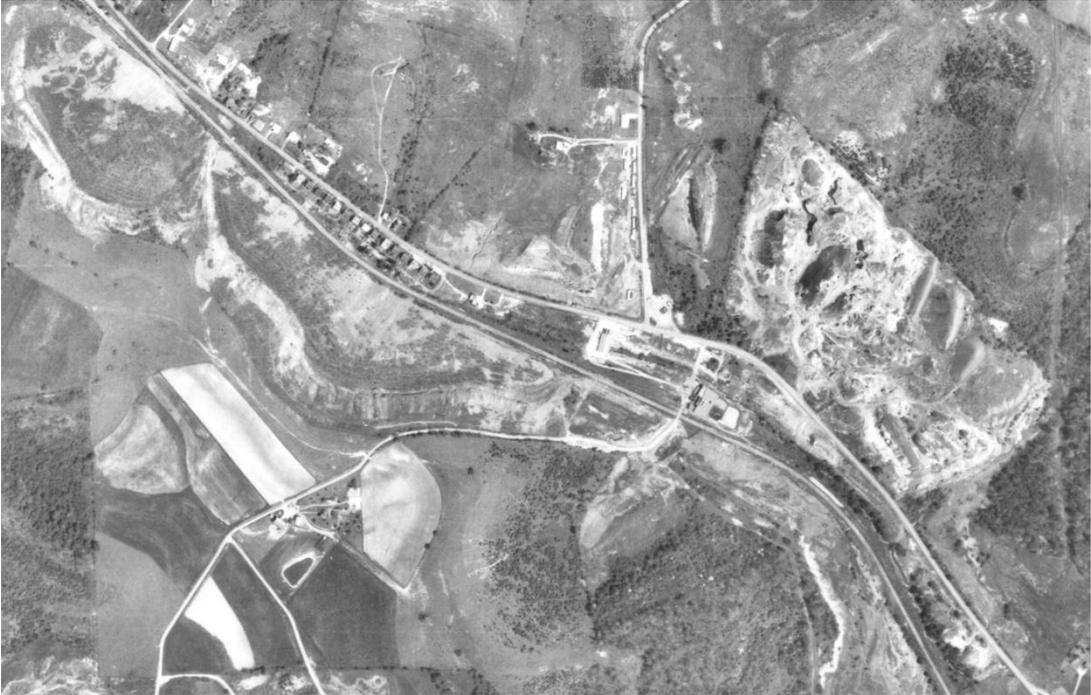
This 1973 aerial photo is taken from a different angle with the view toward the northwest. The McAdams miners' patch is at upper center and the old mine site is in the lower center. The former strip mine highwalls and the waste dump dominate the scene.

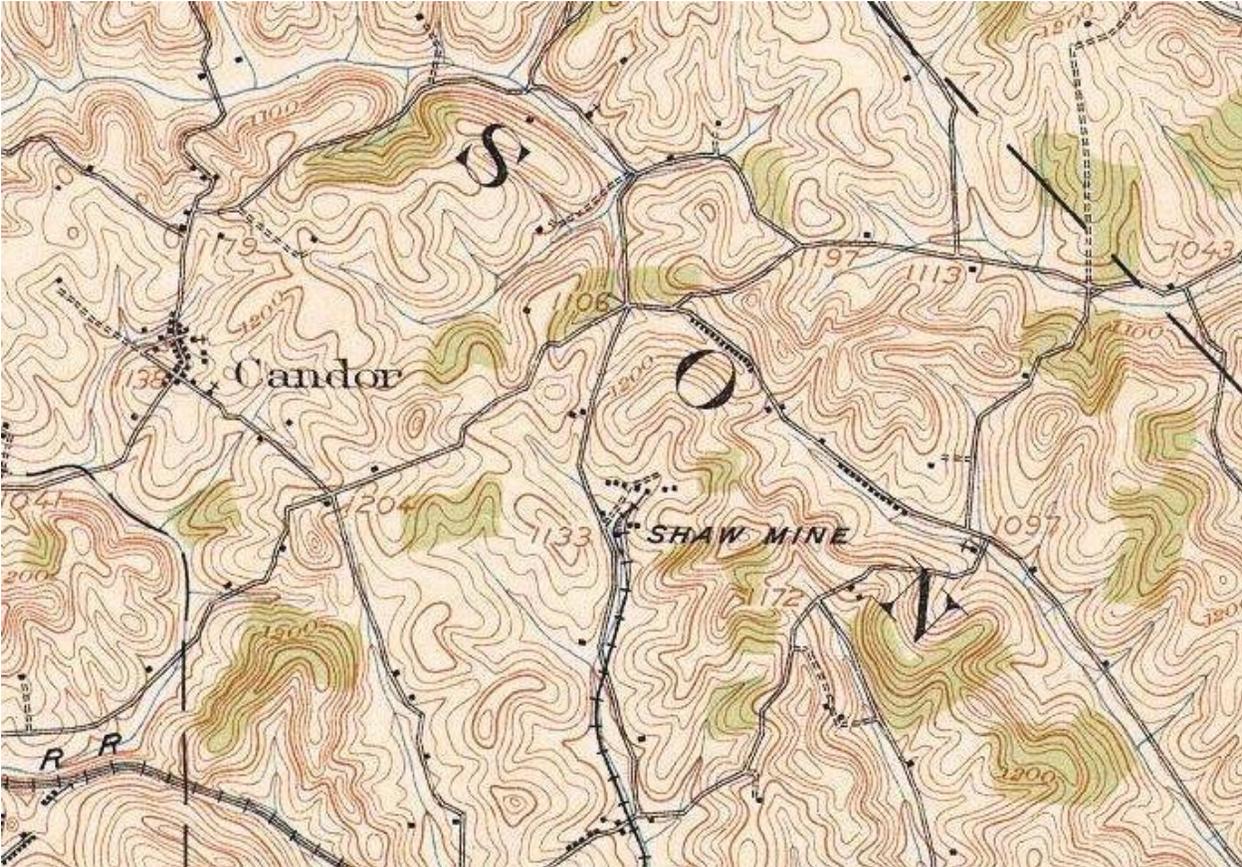
This 1906 topographic map shows miners' houses along Route 980 east of Shaw Mine, but no sign of Montour No. 9. This may be an indication that there was an entry, or multiple entries, into the Shaw Mine near the highway. The PRR Panhandle Division's Midway & Oakdale Branch can be seen going up to the tippie at Shaw Mine. The rail spur was originally built by the Shaw Coal Company but was taken over by the PRR when the Pittsburgh Coal Company leased the Shaw operation.

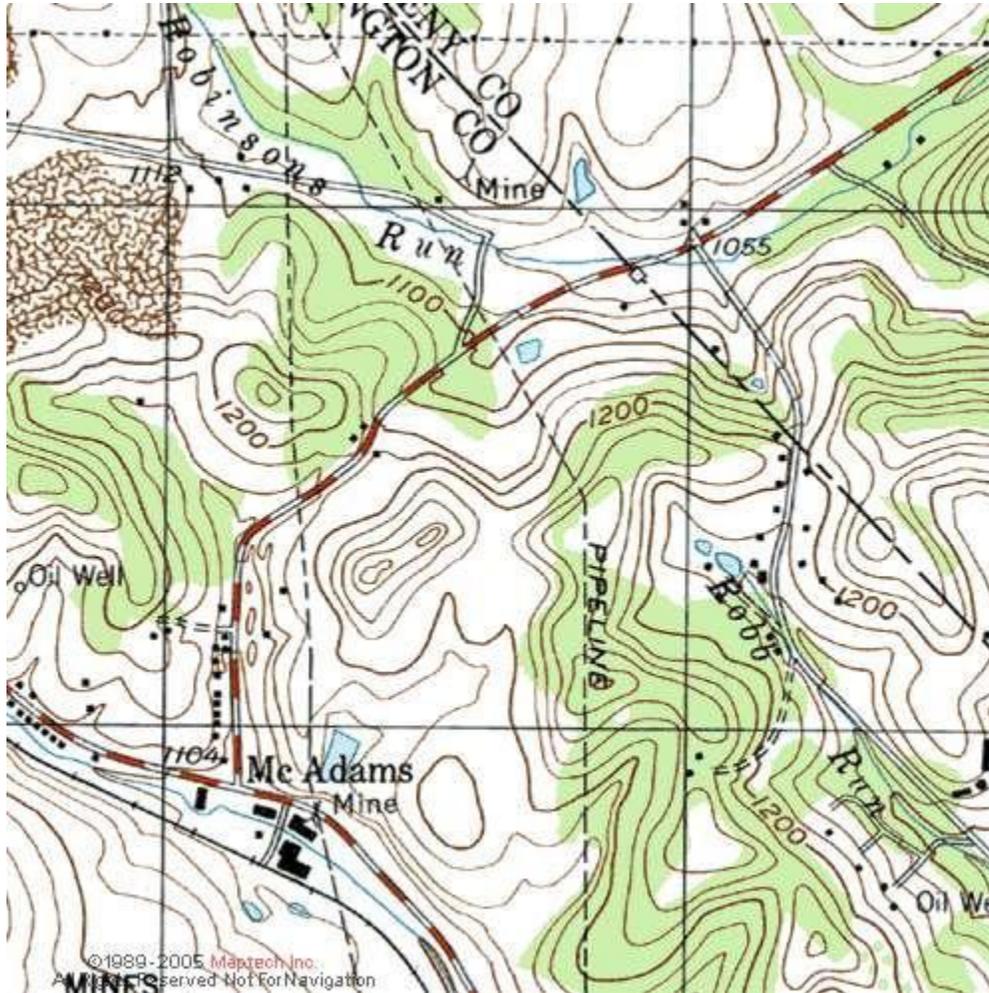
A more recent topographic map, which has obviously not been updated since the Montour Railroad was abandoned, shows the old entries for Montour No. 9. The mine entry shown to the north below the "O" in Washington County was the point where Montour No. 9 exited the seam to the southwest of Robinsons Run and then re-entered it on the other side of the road. The next photo shows the mine tracks crossing the road at this location.

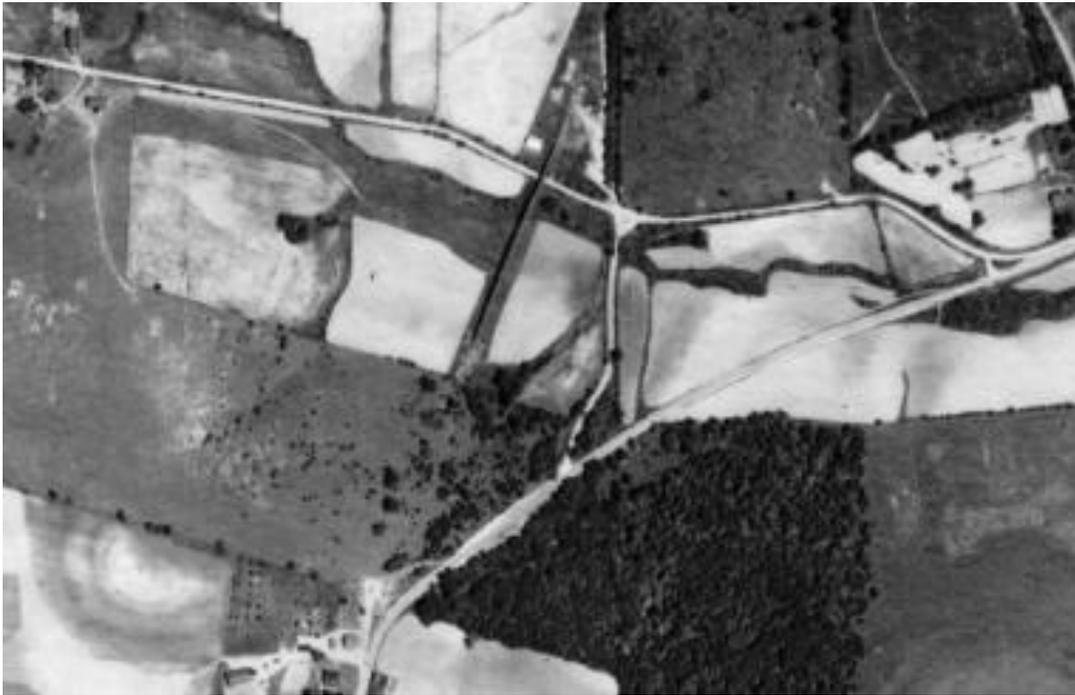
This close-up shows the trestle where the mine trains for Montour No. 9 crossed Donaldson Road to enter the second hill. The entry to the southwest became a major source of acid mine drainage as shown in the next photo for the Operation Scarlift Report for Robinson Run.

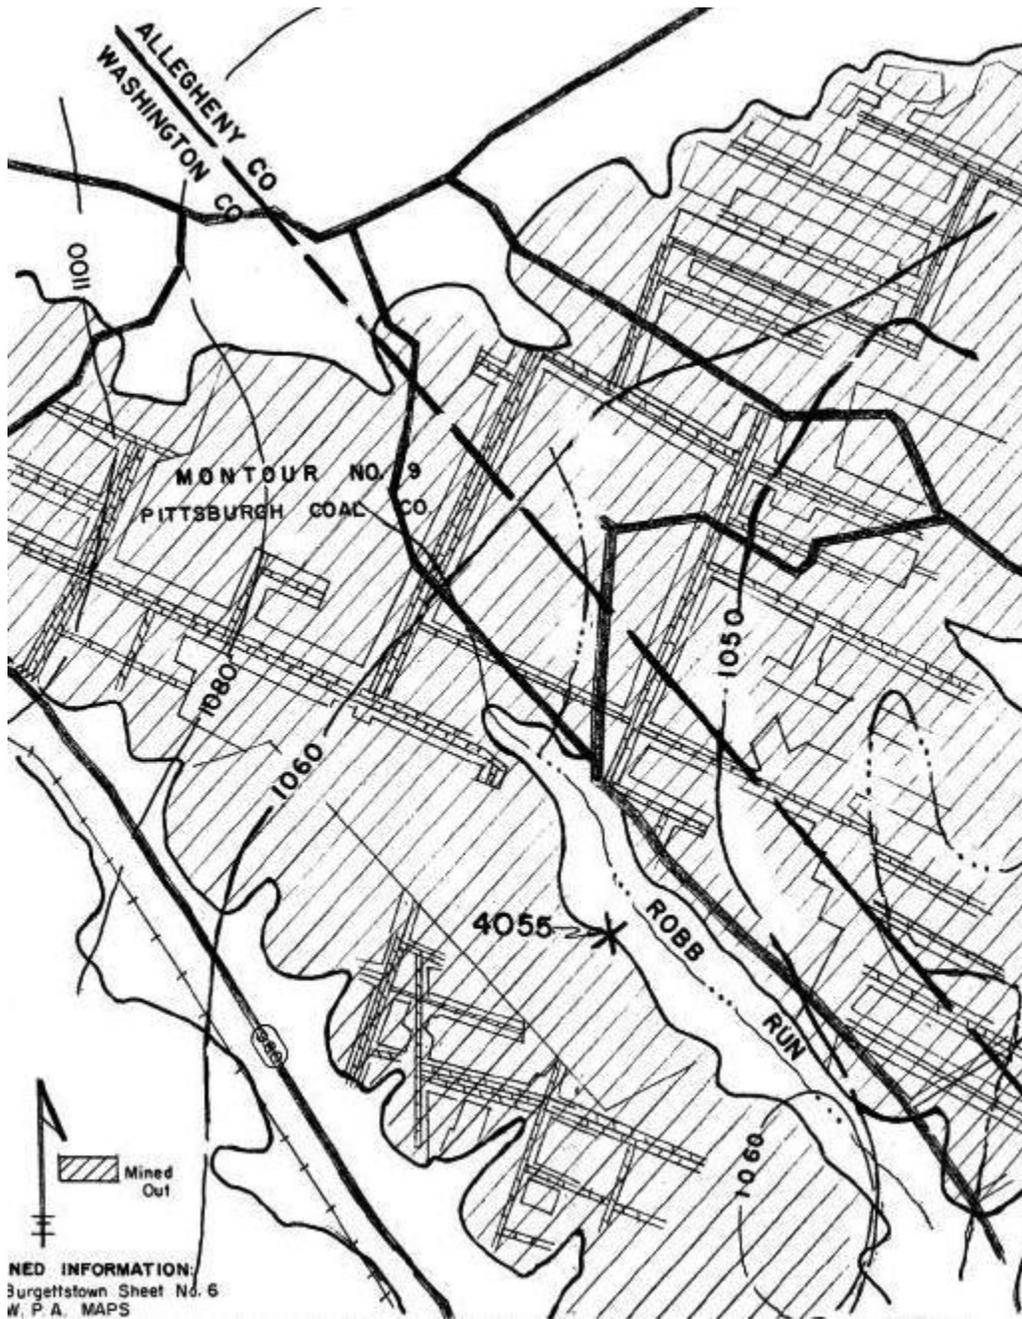
This map shows the drainage point from Montour No. 9 where the old mine trestle crossed Donaldson Road and Robb Run (Point 4055)

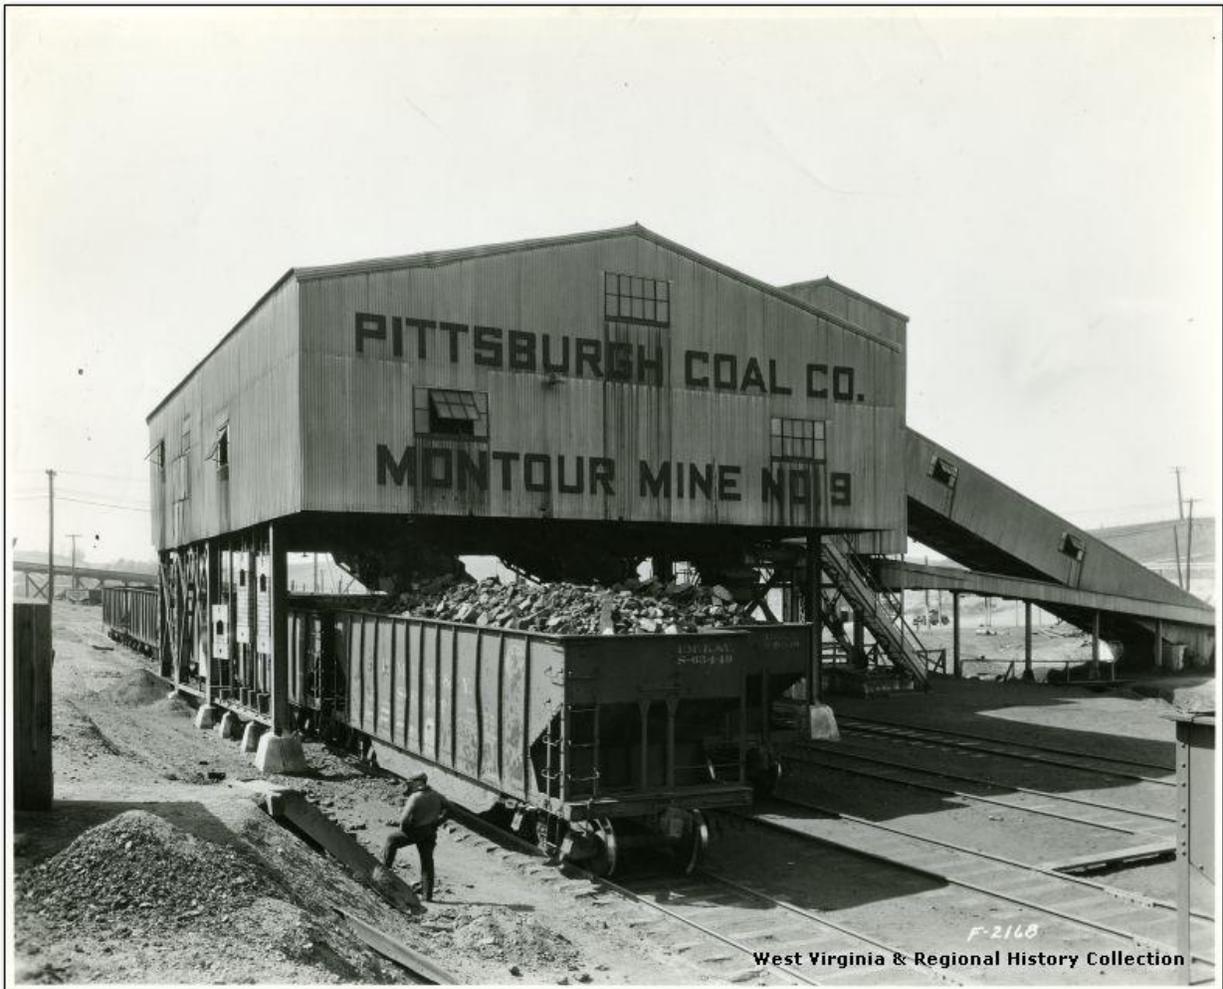
This photo shows the Montour No. 9 tipple. We are looking railroad west toward Champion. Note the bridge crossing the tracks in the background. The loaded hopper car is a PRR car and may or may not go back to Champion for cleaning.
