The Morris Mine was located on the Montour Railroad's Midland Spur (Westland Branch) timetable east of Southview. Trains reached Morris Mine via Gilmore Junction, named for the Gilmore Coal Company who built the mine. The mine was on the south side of Route 50 north of Millers Run. The village of Gilmore was located on the hillside north of the mine.

The Morris Mine was described in great detail in a 1922 article in *Coal Industry* magazine.

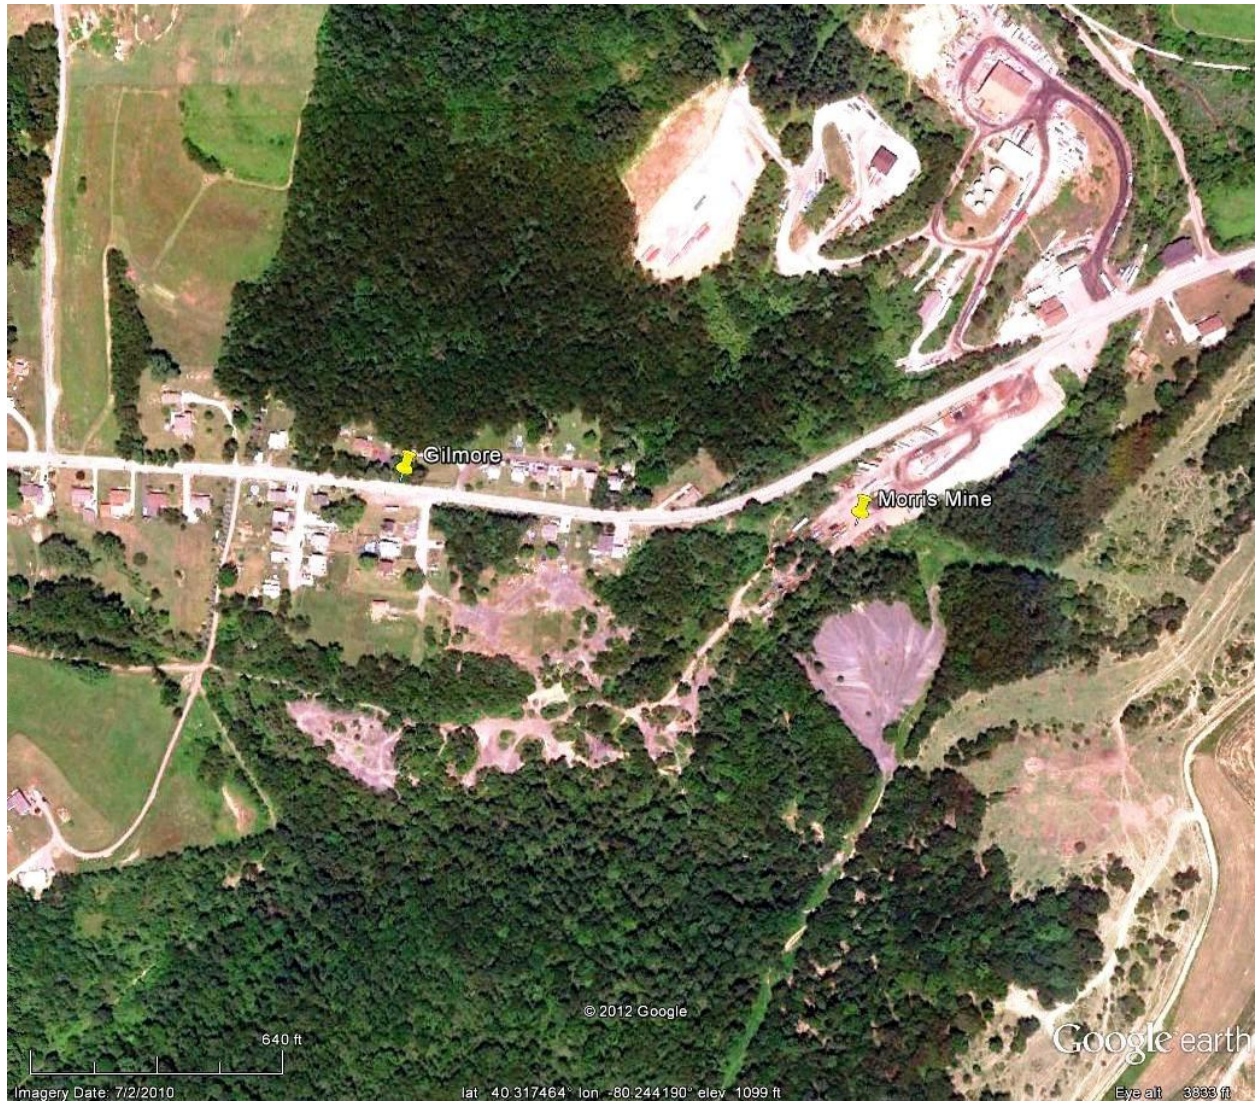
A 2010 satellite image from Google Earth shows the former Morris Mine location and the village of Gilmore. The old Montour Midway Spur from Gilmore Junction is barely visible between the paved road and dirt road in the upper right. The Morris waste dump can be easily spotted.

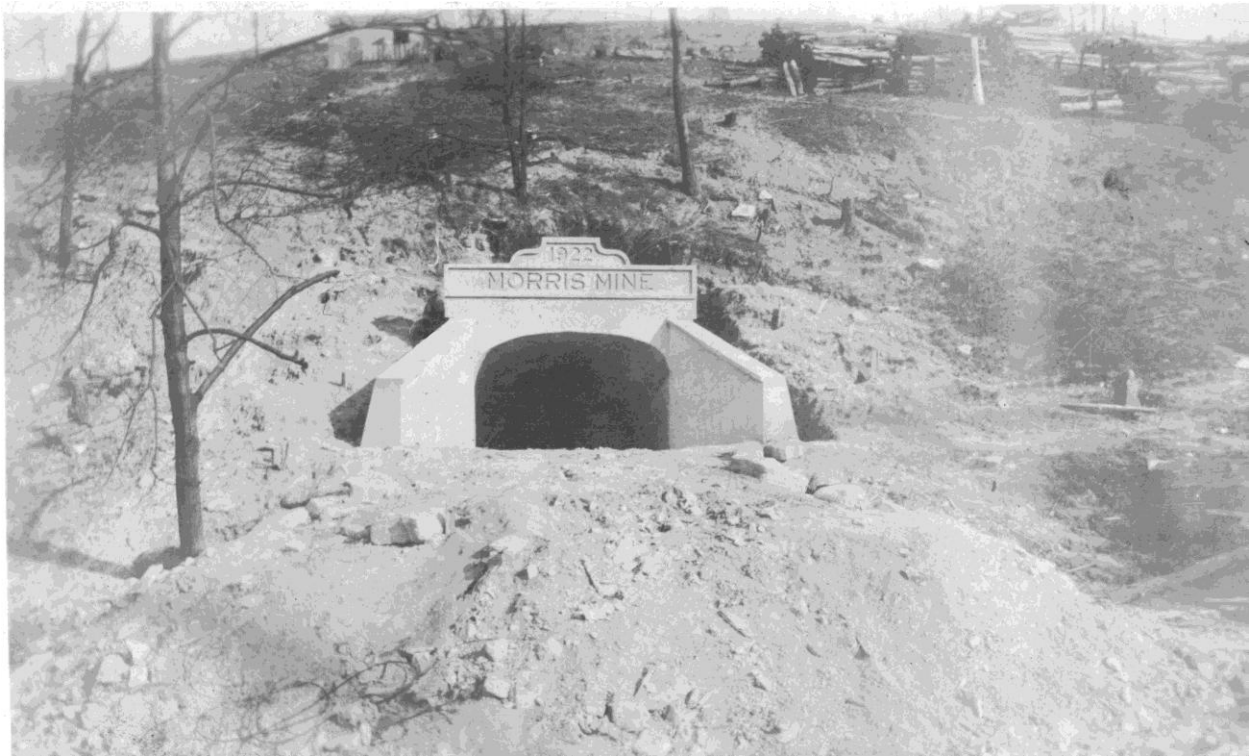
This is a photo of the slope entry for the Morris Mine taken in 1922 when the mine was under construction. (Courtesy of Alan Hinton)

At this point the coal lies at a depth of approximately 140 feet, necessitating shaft mining. The hoisting shaft is 130 feet in depth, two compartments, and concreted throughout its depth. The air shaft is located a short distance from the hoisting shaft, and exhaust fan being located at the mouth of the former. In addition, a slope is provided for the use of men and material. This is likewise concreted, and lies at an angle of 25 degrees, being 525 feet in length.

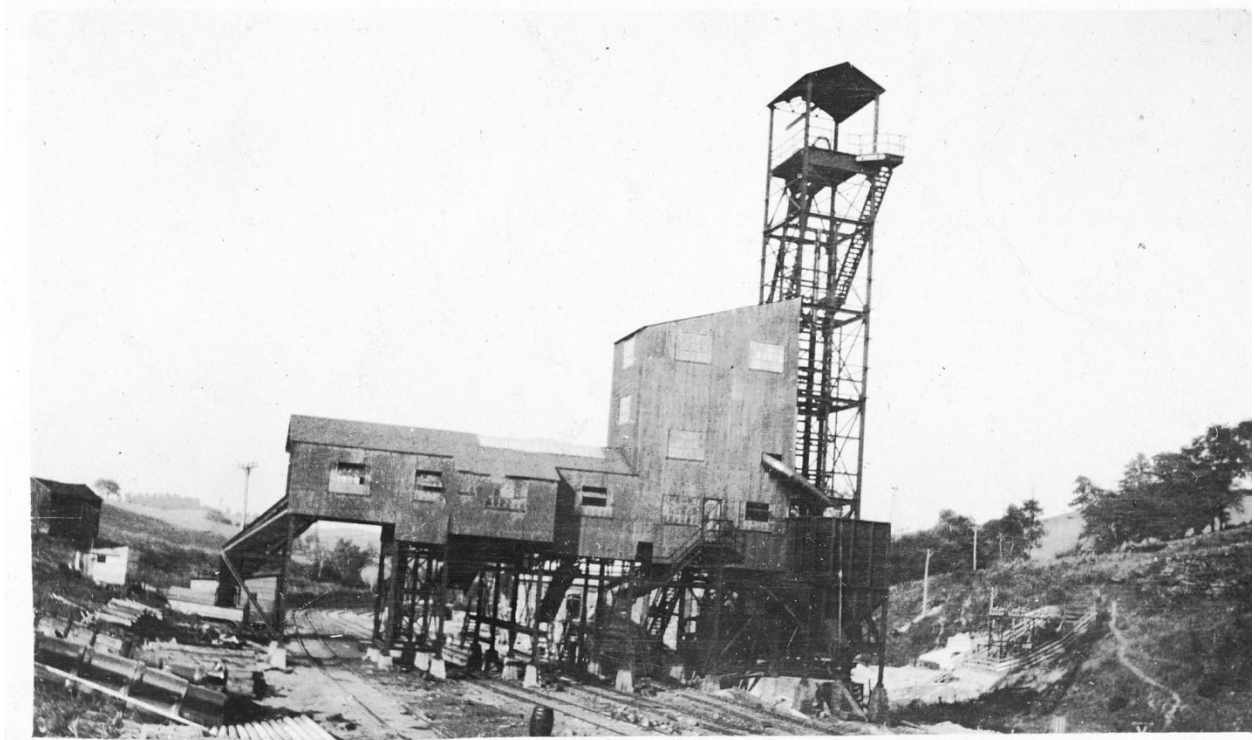
FIG. 3—ELEVATION OF TIPPLE.
Showing arrangement of dump, shaking screens and loading booms.

Another 1922 photo shows the newly completed tipple for Morris Mine. The main track of the Montour Railroad is on the far left beneath the tipple.

The entire plant is designed and guaranteed to operate making three sizes of coal at the rate of 325 tons per hour."

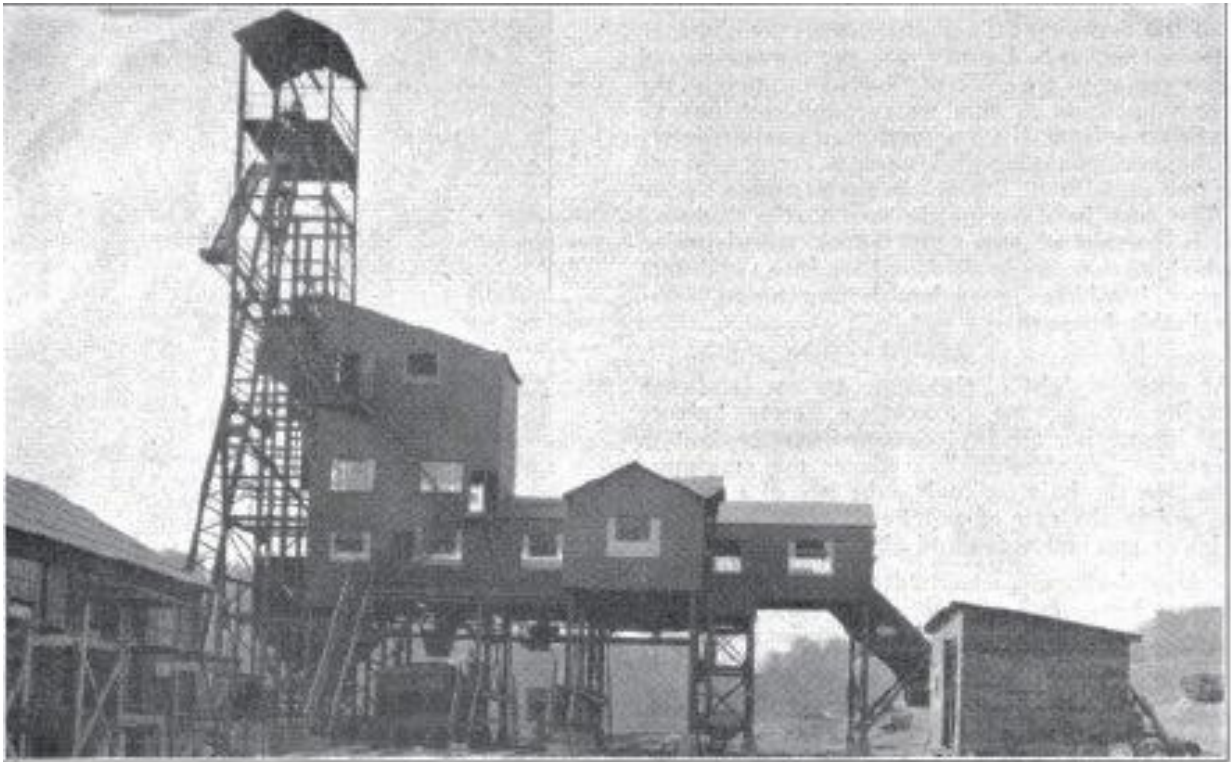
FIG. 1—TIPPLE AND HOIST HOUSE

This is a view of the east side of the newly completed tipple. The hoisting engine, offices and miners' washroom are in the building on the left.

Three tracks are provided for loading, while to the right is shown the chute and bin which supplies coal for local use.

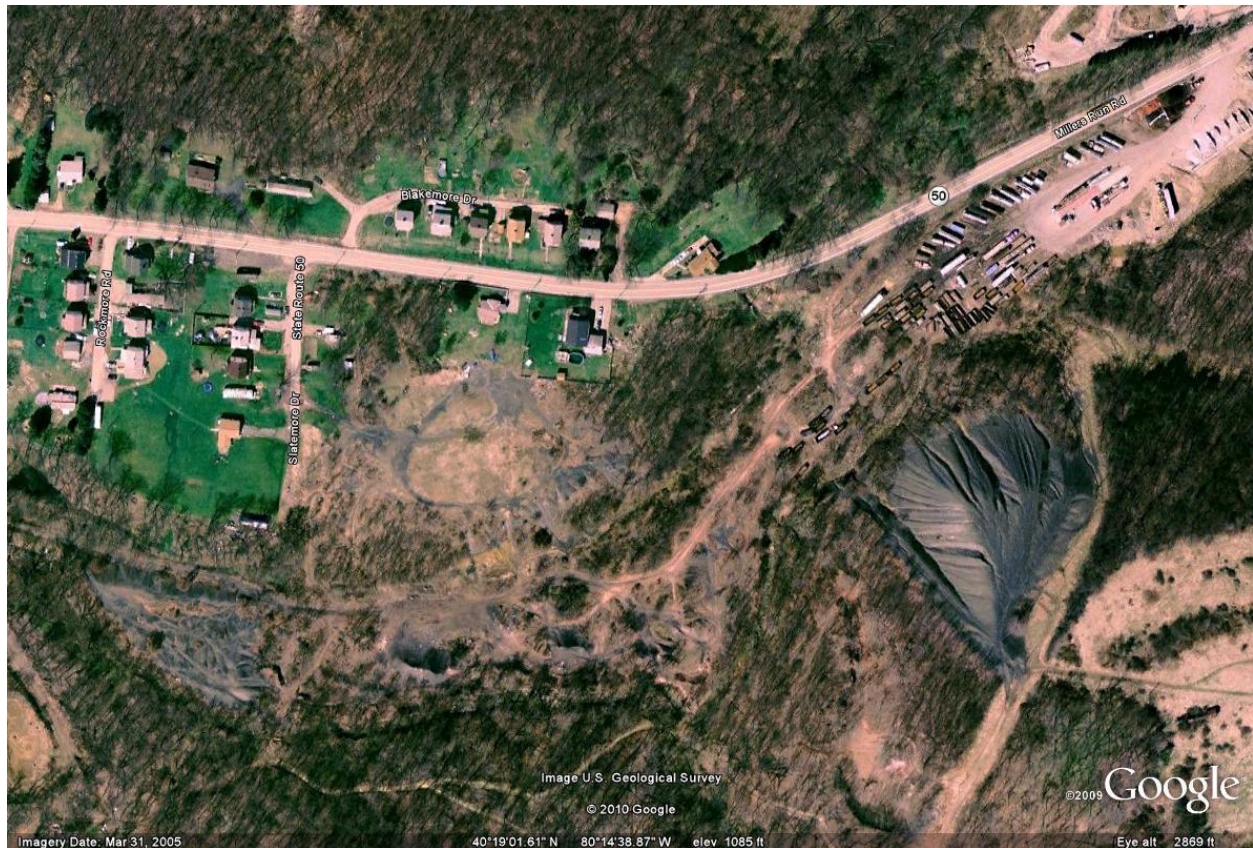
This is a close-up from a 2005 Google Earth satellite image of the Morris Mine and the village of Gilmore.

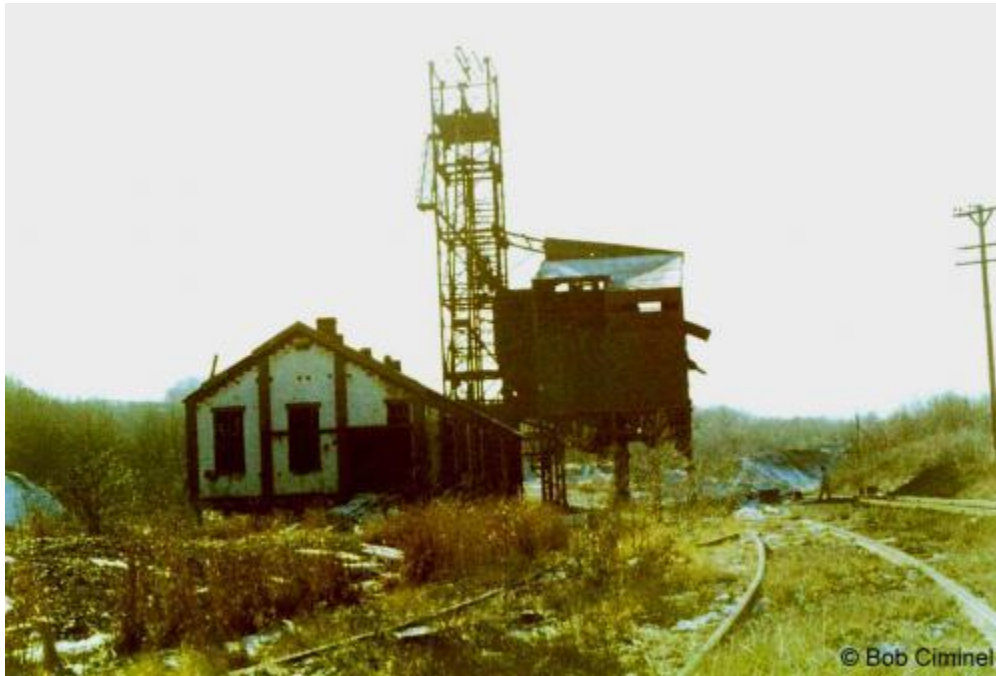
The following photos were taken in the early 1970s and show the condition of Morris Mine before it was permanently sealed and torn down. Although the slope entry was fenced, trespasser had cut a hole in it. The mine was flooded, so you could not go very far down the slope. The hoisting shaft was covered, but not sealed.

This view is looking timetable west, with the still active Montour Westland Branch on the right.

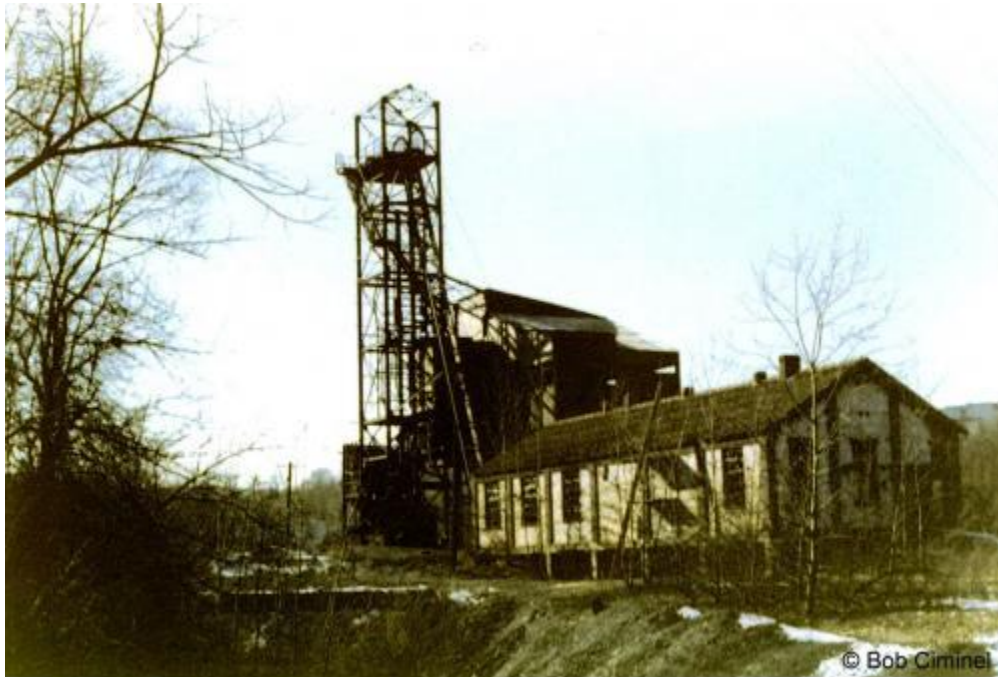
This is another view of the hoist and office building looking toward the northwest. The bridge over Millers Run to the slope entry is at center right. The hoist equipment was already removed by the time the photo was taken.

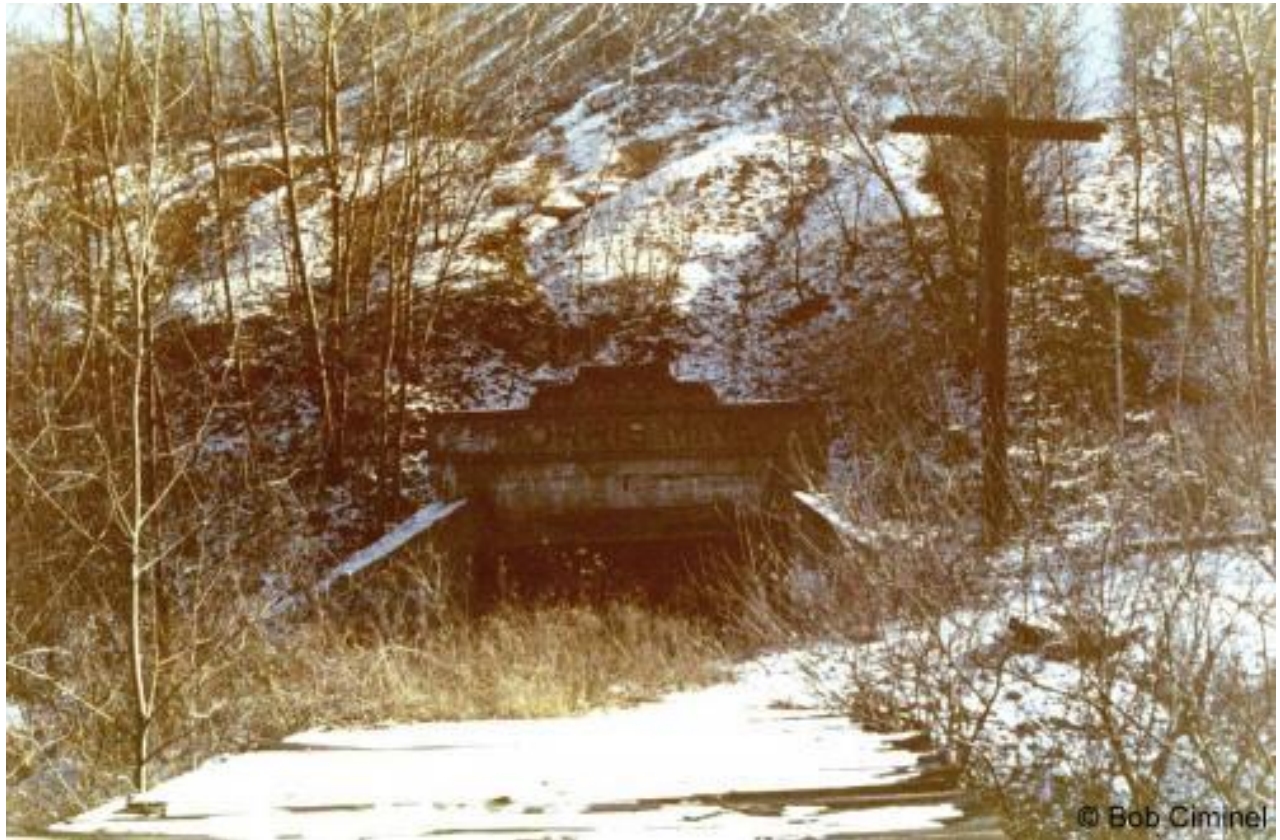
This was the slope entry as seen from the north side of Millers Run. The waste pile sits above the entry.

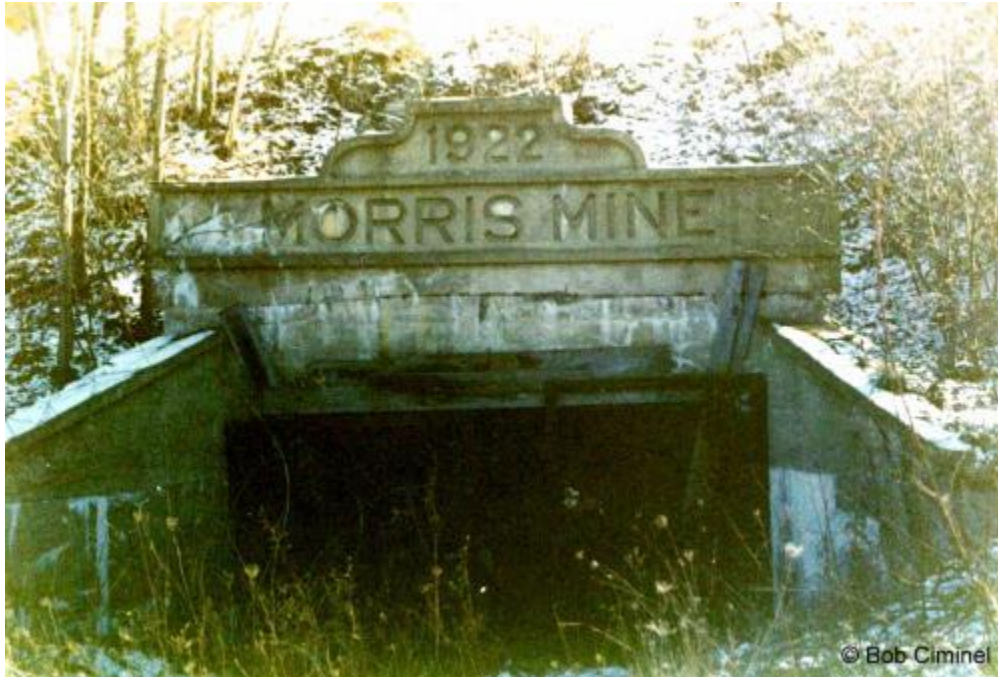
This is a close-up shot of the slope entry.

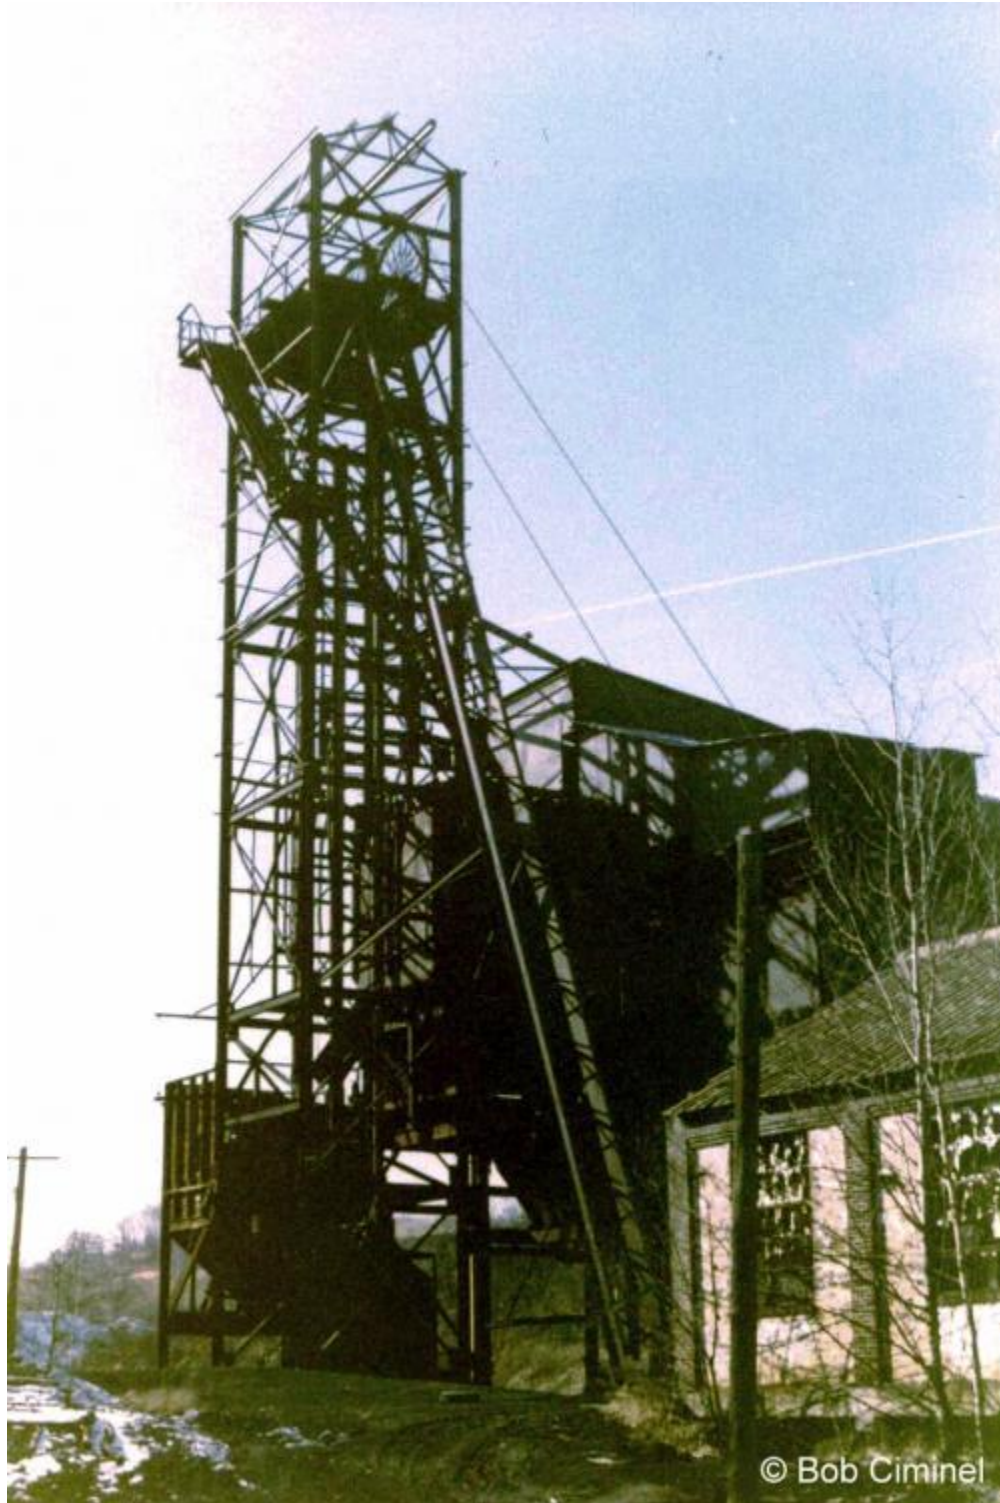
Another close-up looking northwest with the hoist cables shown.

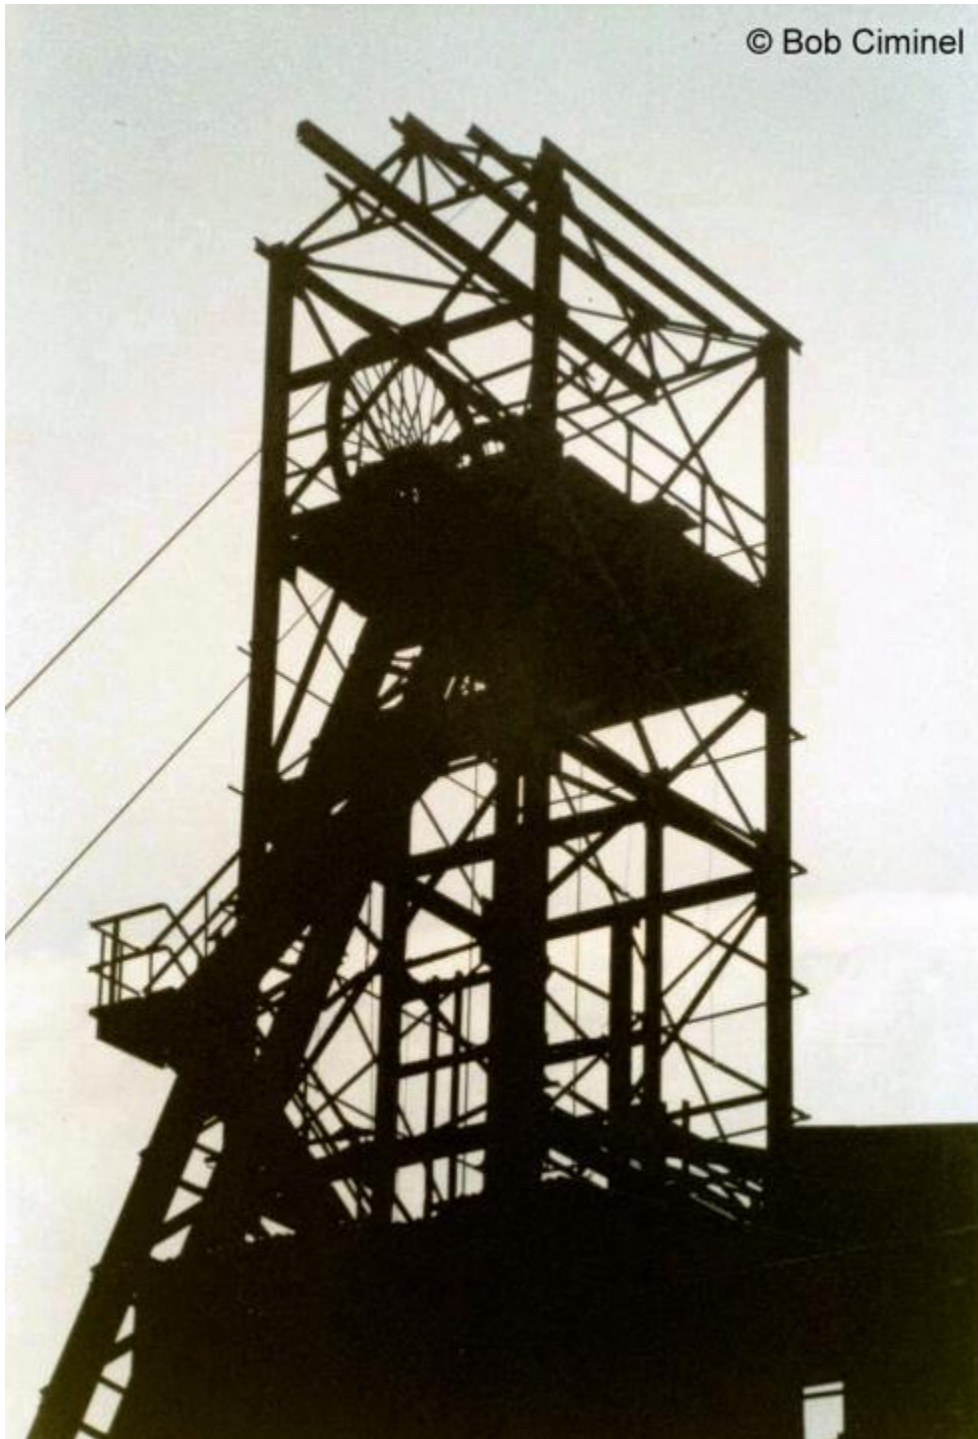
A telephoto shot of the winding wheels.
