Montour No. 2 Mine (Bob Ciminel ©2012)

The Montour No. 2 Mine was opened by the Pittsburgh Coal Company in conjunction with the completion of the Montour Railroad Mifflin Extension in 1914. Both Montour No. 1 and Montour No. 2 were constructed and developed at the same time, with almost identical surface facilities, which included a railroad tippie with hoist for mine cars, a rock and supply shaft connected to a large brick building that contained the offices and miners' washrooms and lamp racks, and a nearby ventilation fan. As with Montour No. 1, the Montour No. 2 shaft was about 150 feet deep.

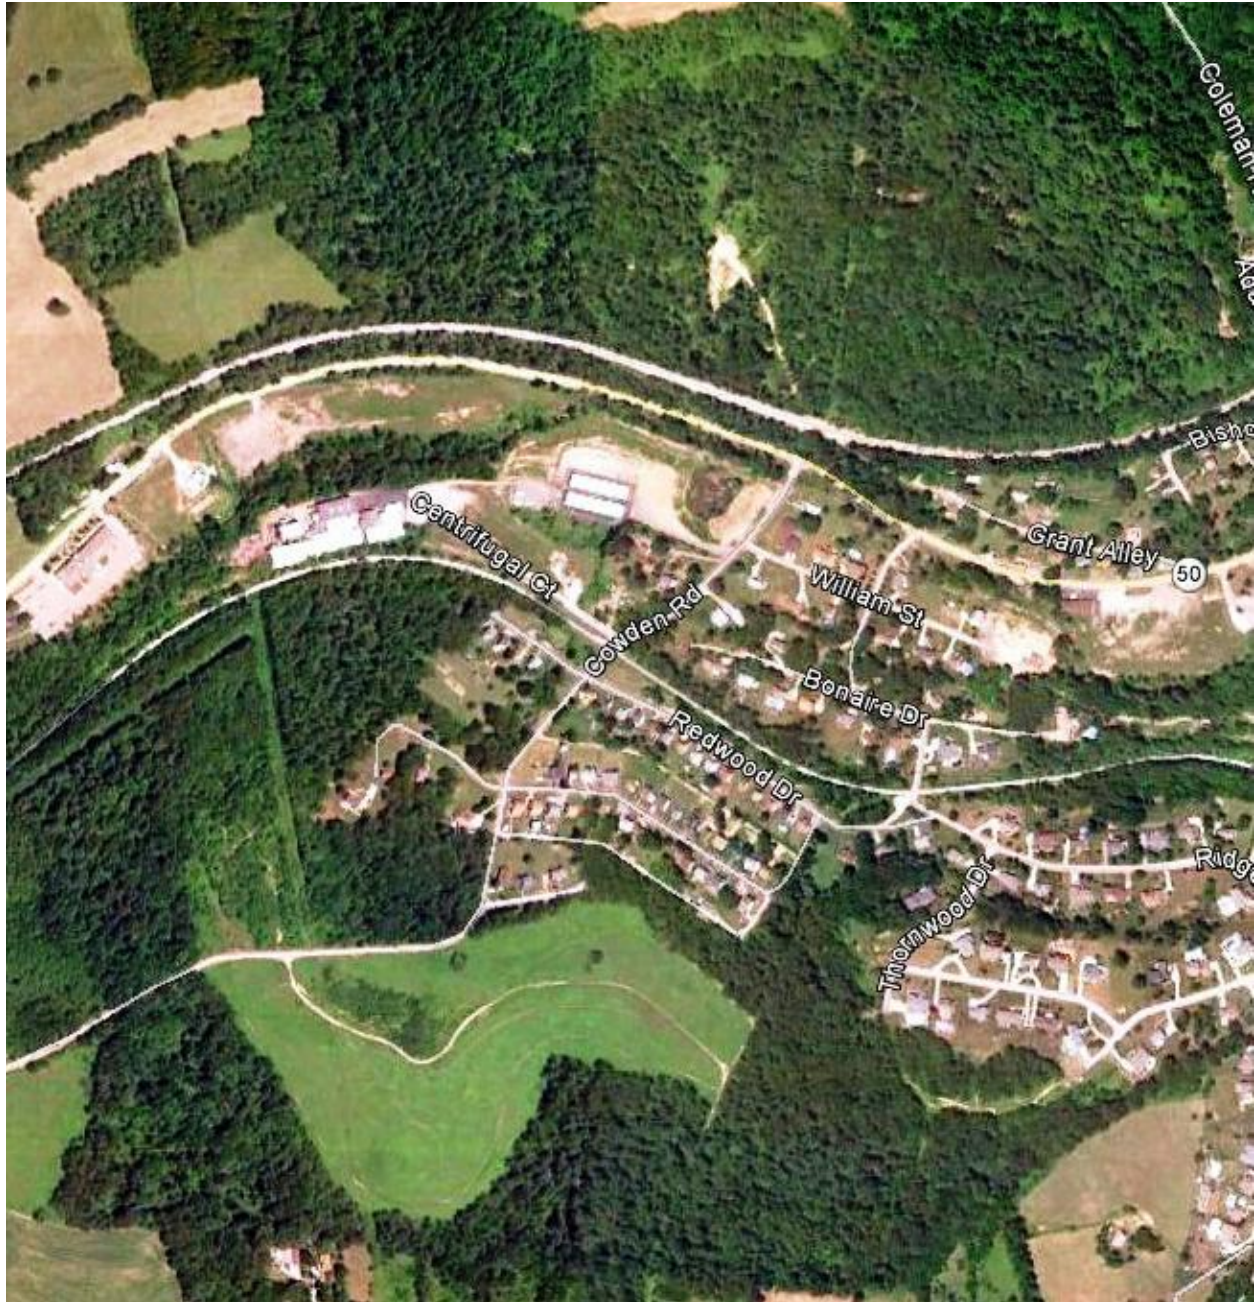
This Google Earth image from 2010 shows the present location of Montour No. 2. The tippie and other structures were located next to the "C" in Centrifugal Ct., and the miners' village was the group of houses along and southwest of Redwood Drive. The Montour Trail curves around the former tippie location.

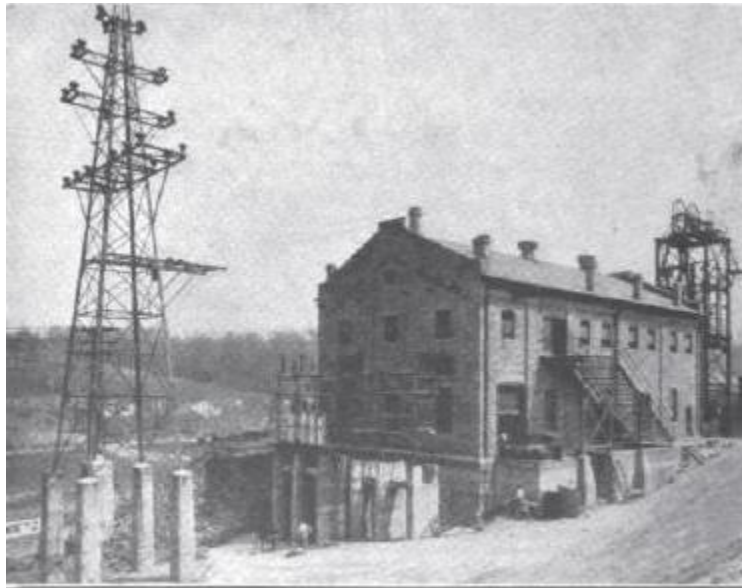
FIG. 3. REAR VIEW OF SUBSTATION AT MONTOUR
MINE NO. 2

This photo from *Coal Age* magazine shows the substation and service building with the rock shaft in the background. It was about this time that the Pittsburgh Coal Company stopped generating electricity at its individual mines and began purchasing power from the West Penn Power Company, who's Board of Directors was comprised of many of the coal company's executives.

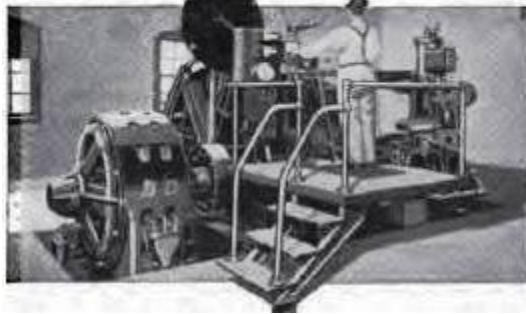
This advertisement by the Vulcan Iron Works shows the main coal hoist that was installed at Montour No. 2.

This new installation at Montour Mine #2, Cowden, Penna., is interesting in that it shows the main hoist.

The motor develops three hundred h.p. on a line current of twenty-two hundred volts.

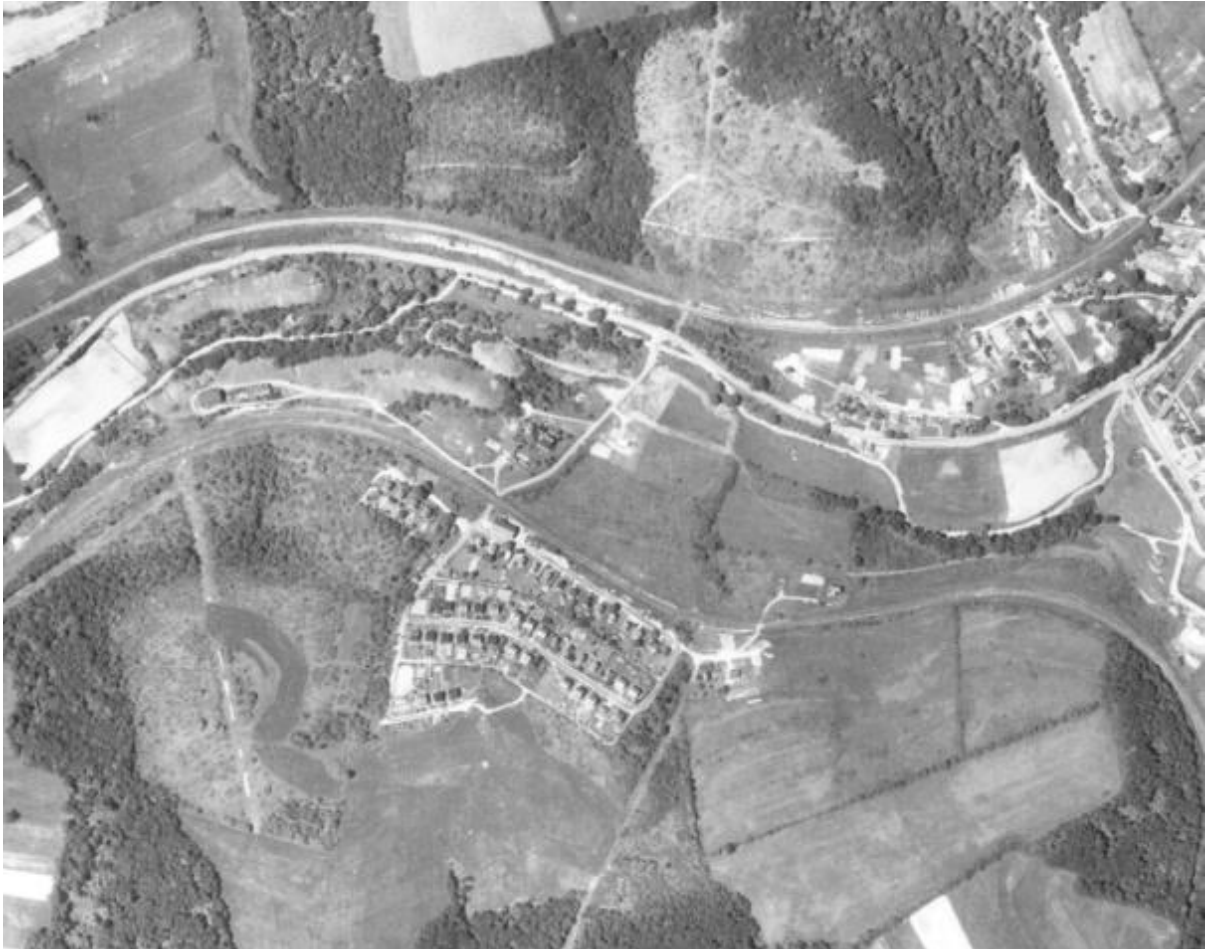
Not much has changed in this 1958 aerial photo; however, the village of Cowden is looking more like a community than a cluster of miners' homes. As with most of the abandoned mines from this period, the waste dumps have not been remediated.

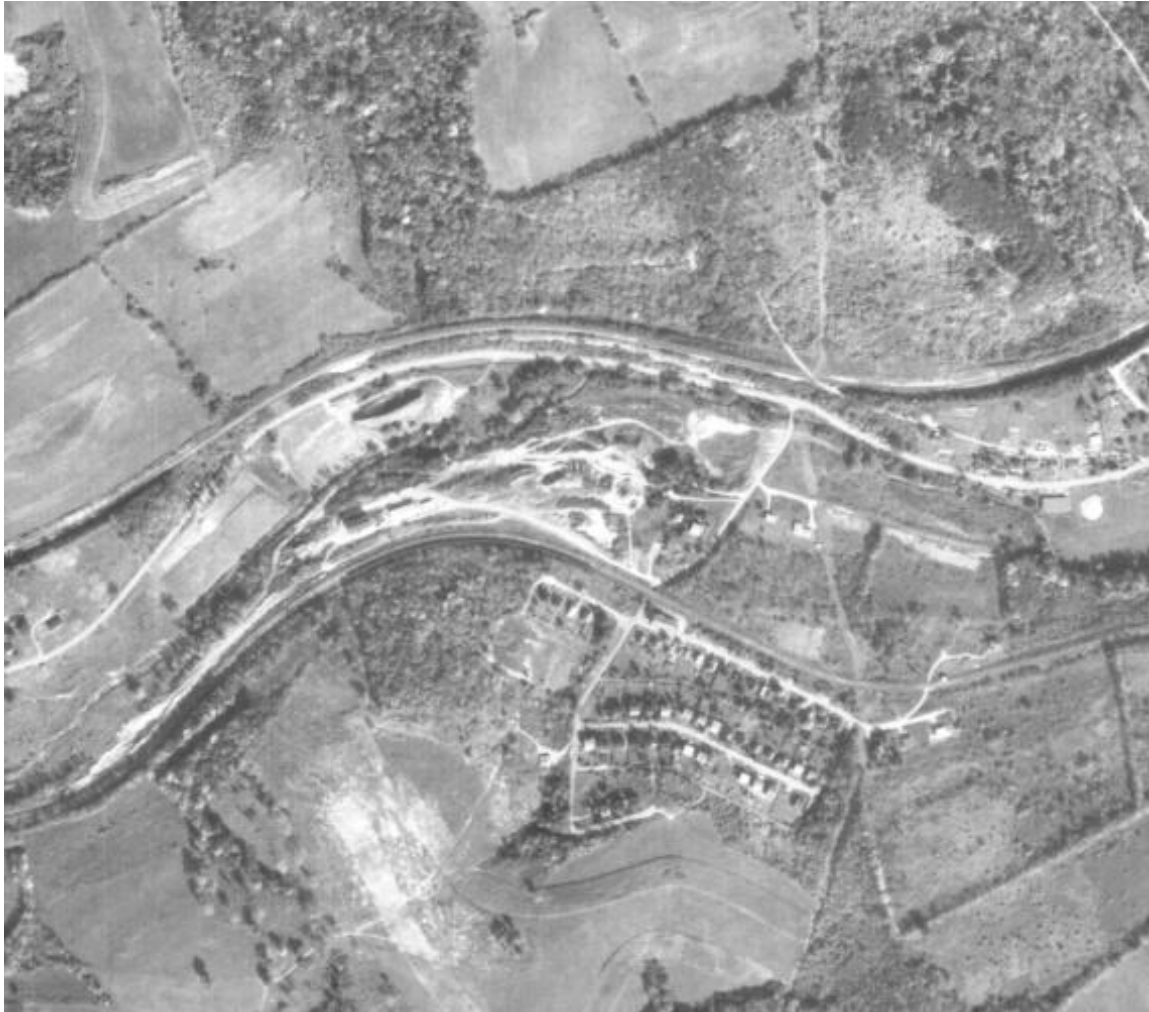
This 1967 photo shows some changes to the waste dump on the east side of the former mine site. I recall from trips out to Southview in the late 1950s that the dump had spontaneously combusted and had become a source of red dog for the local roads and alleys.
