Henderson No. 1 (Bob Ciminel ©2012)

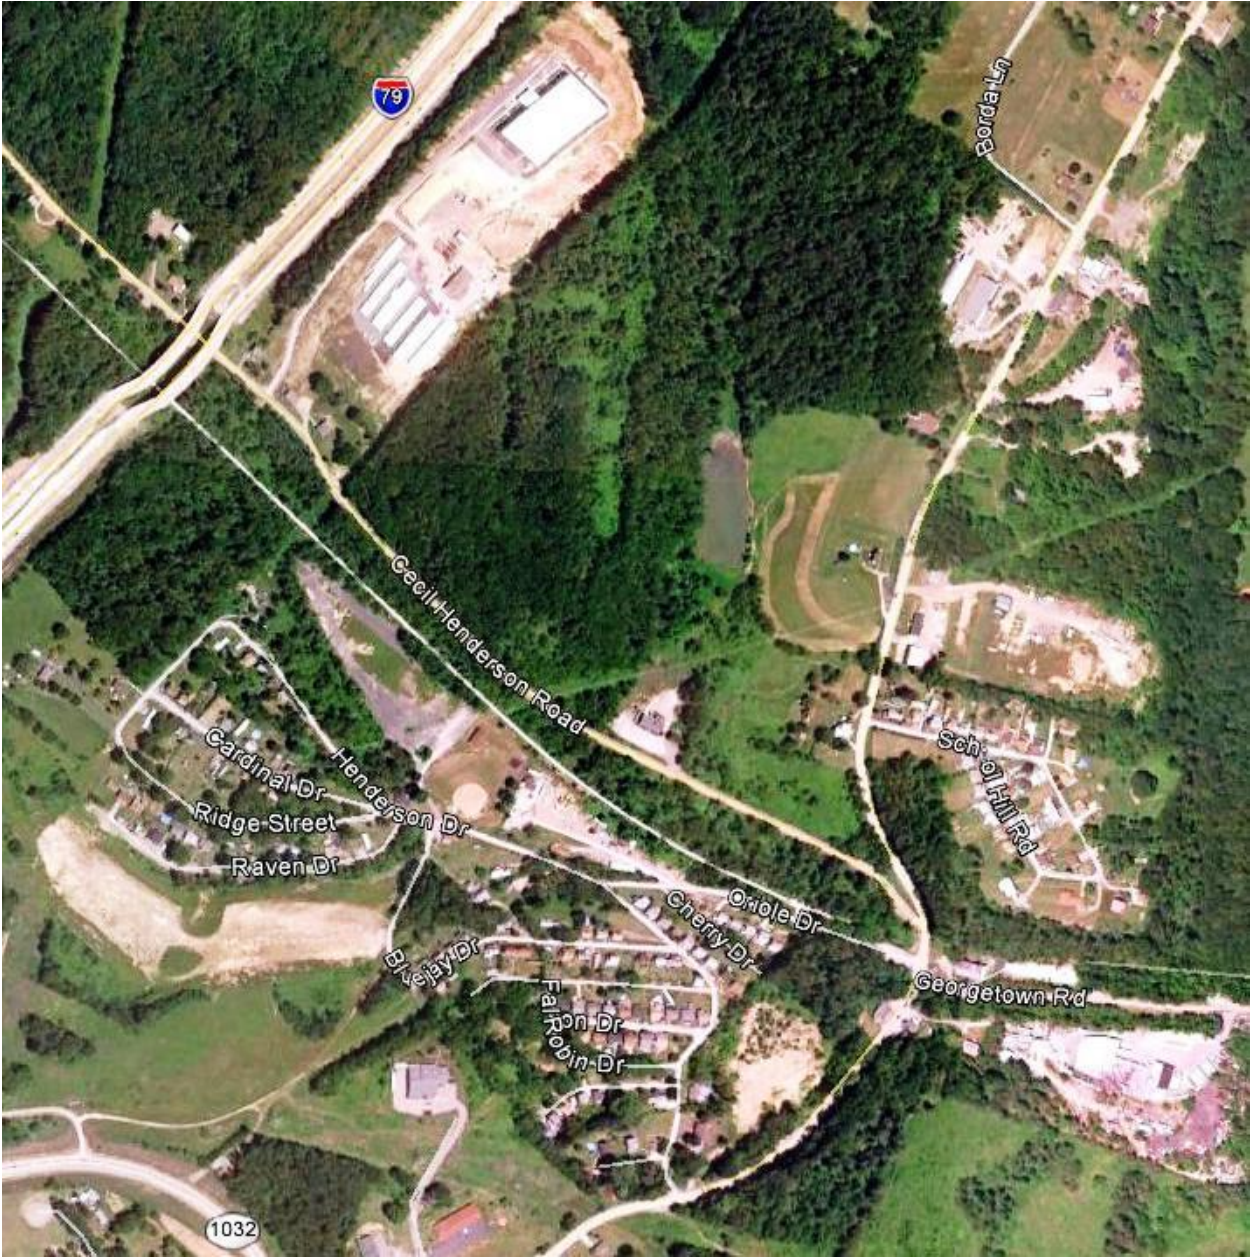
This Google Earth image shows Hendersonville in 2012. The two waste dumps associated with the mine are visible to the northwest and southeast of the village. The dump at lower right was leveled for an industrial building.

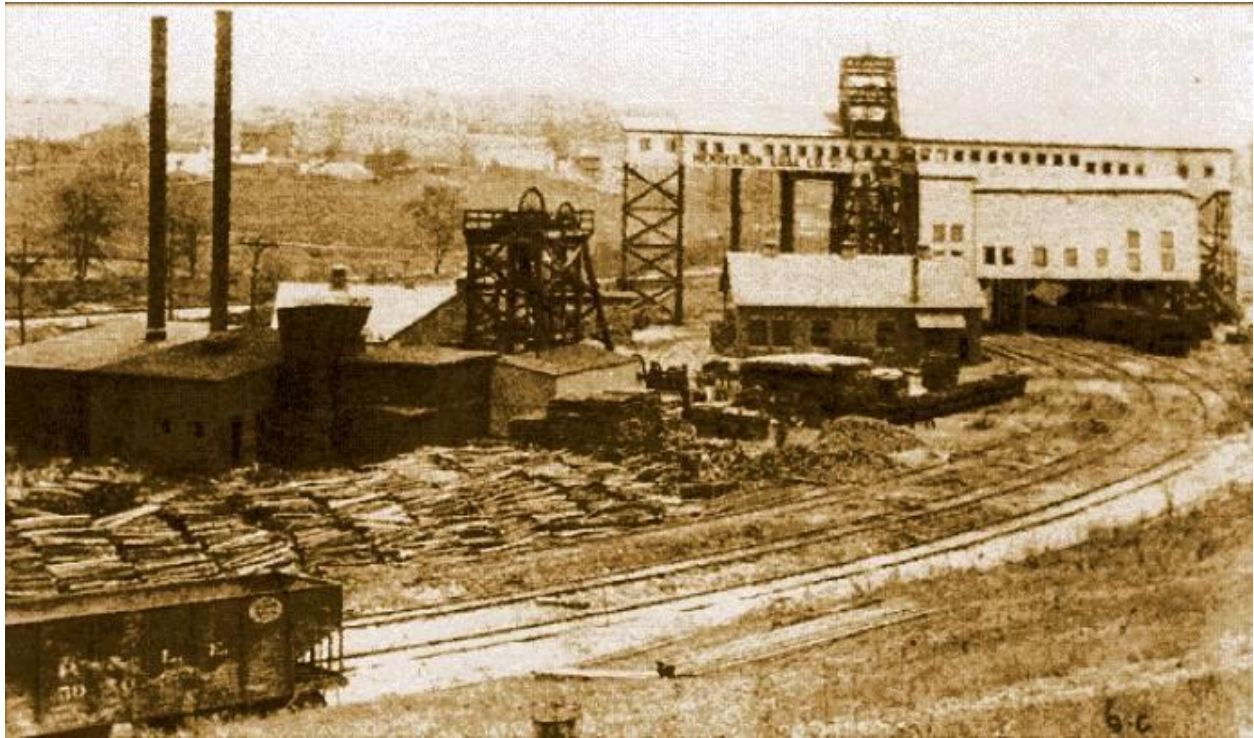
Henderson No. 1 looking toward the southeast. Note the large number of mine posts between the tracks and the fan and power house. The length of the posts is an indication of the thickness of the coal seam, which averaged 67 inches at this location. The smaller hoist was for men and materials. The Montour tracks are visible in the background.

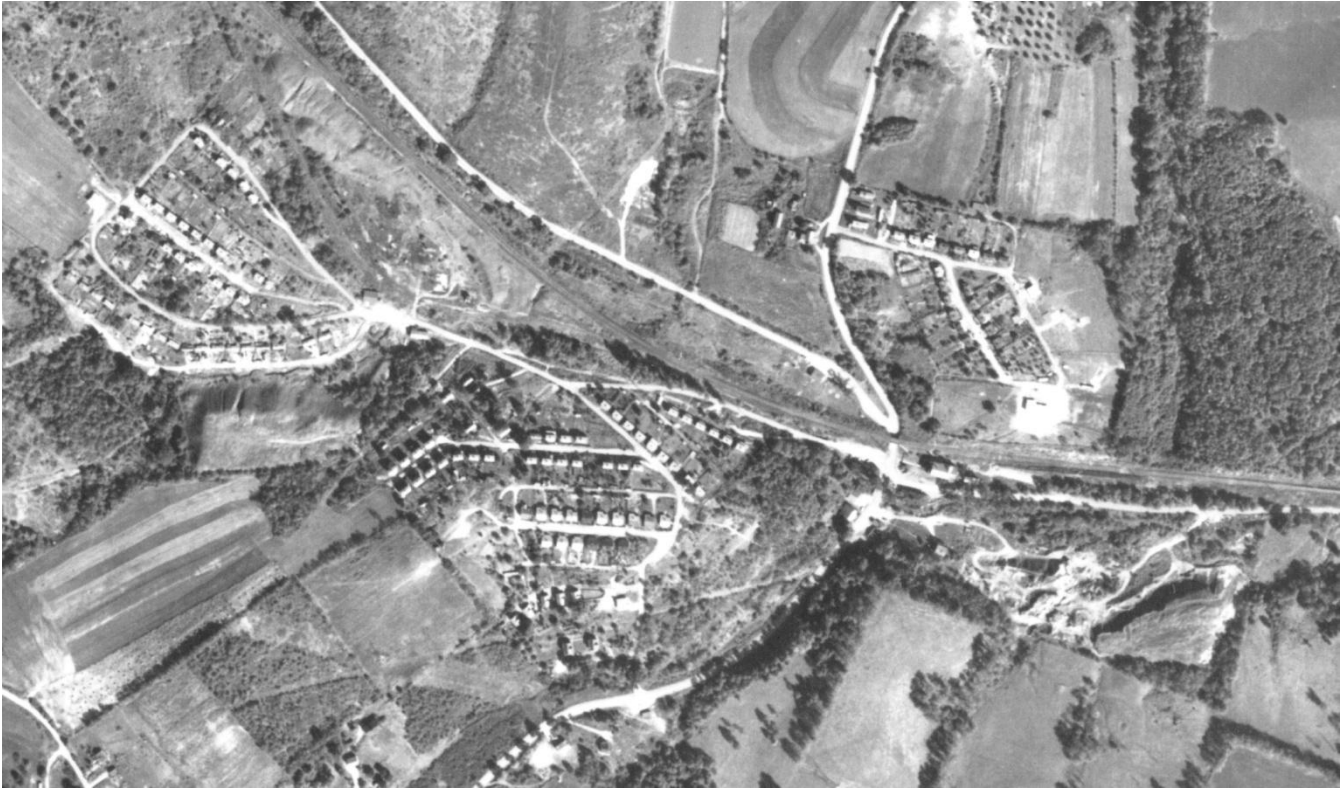
This 1957 photo shows all the evidence that the mine has been closed and abandoned. The tippie is gone and the yard tracks are removed.

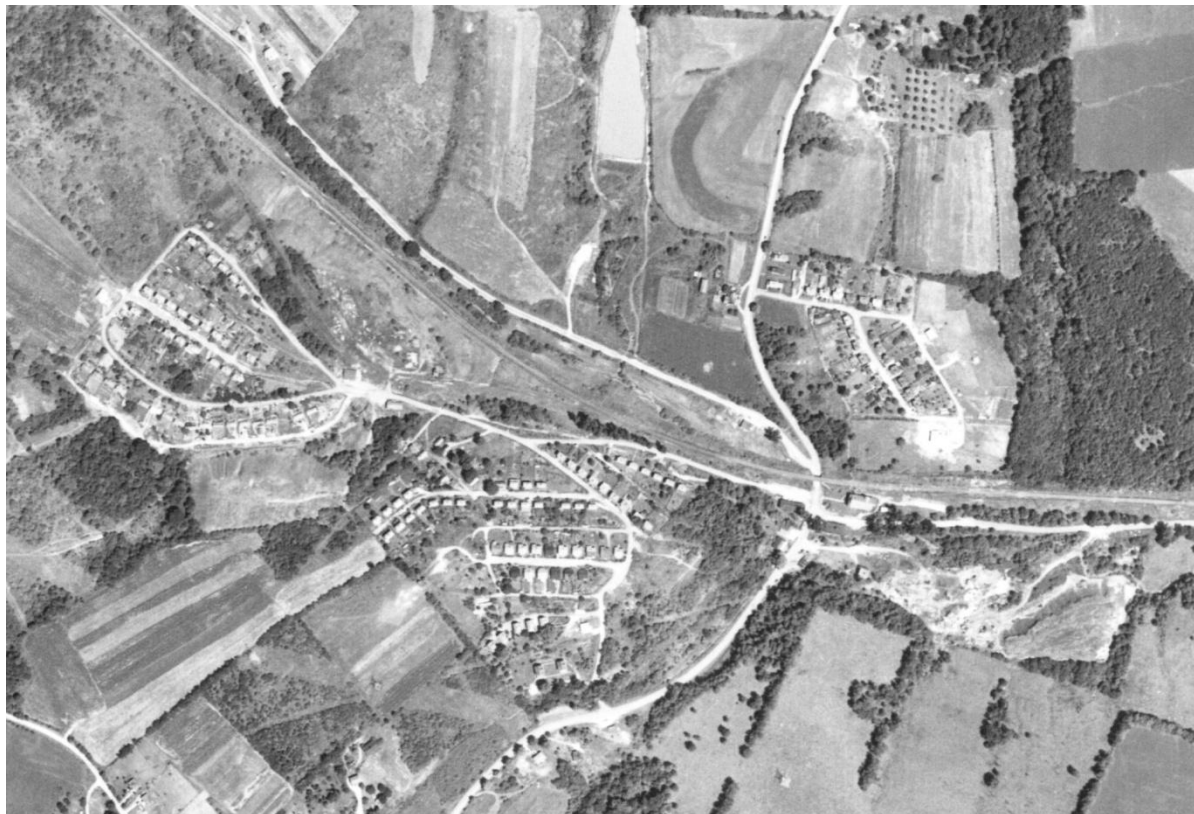
By 1958, the siding into the mine is returning to Nature, as evidenced by the vegetation growing down the center of the old siding.

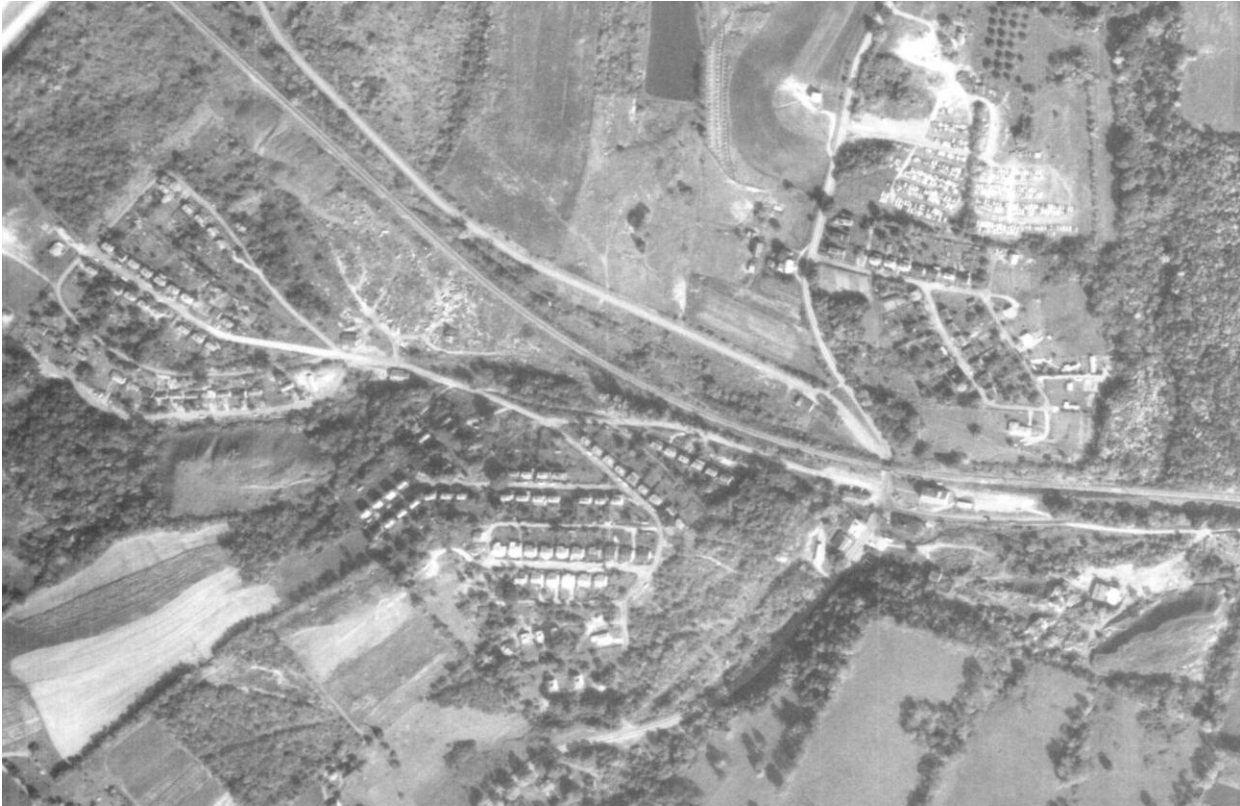
By 1967, hardly anything remains of the mine except for the waste dumps, and Hendersonville has all the marks of a well-established community.
