Montour No. 4 (Bob Ciminel ©2012)

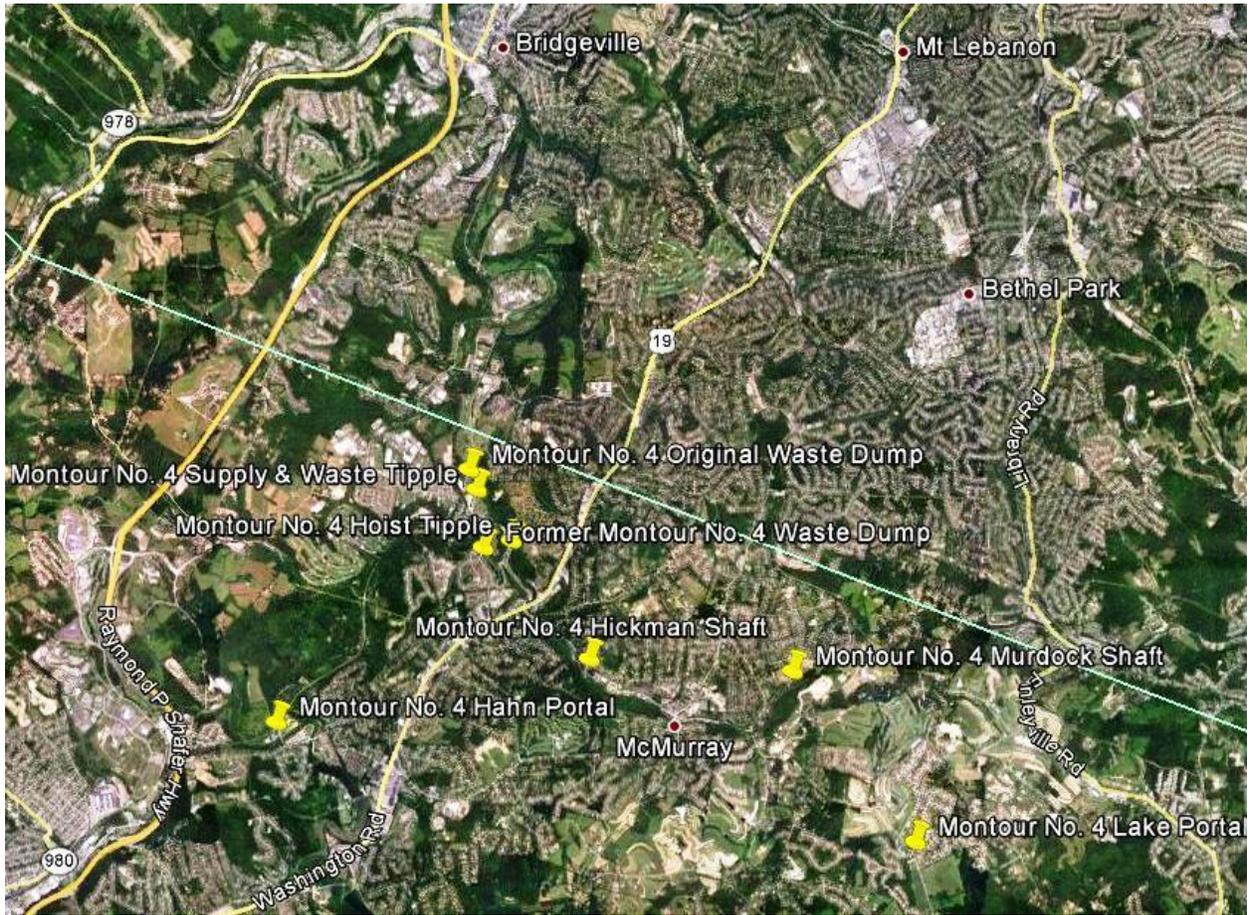
This is a Google Earth image of former and current facilities associated with Montour No. 4 Mine

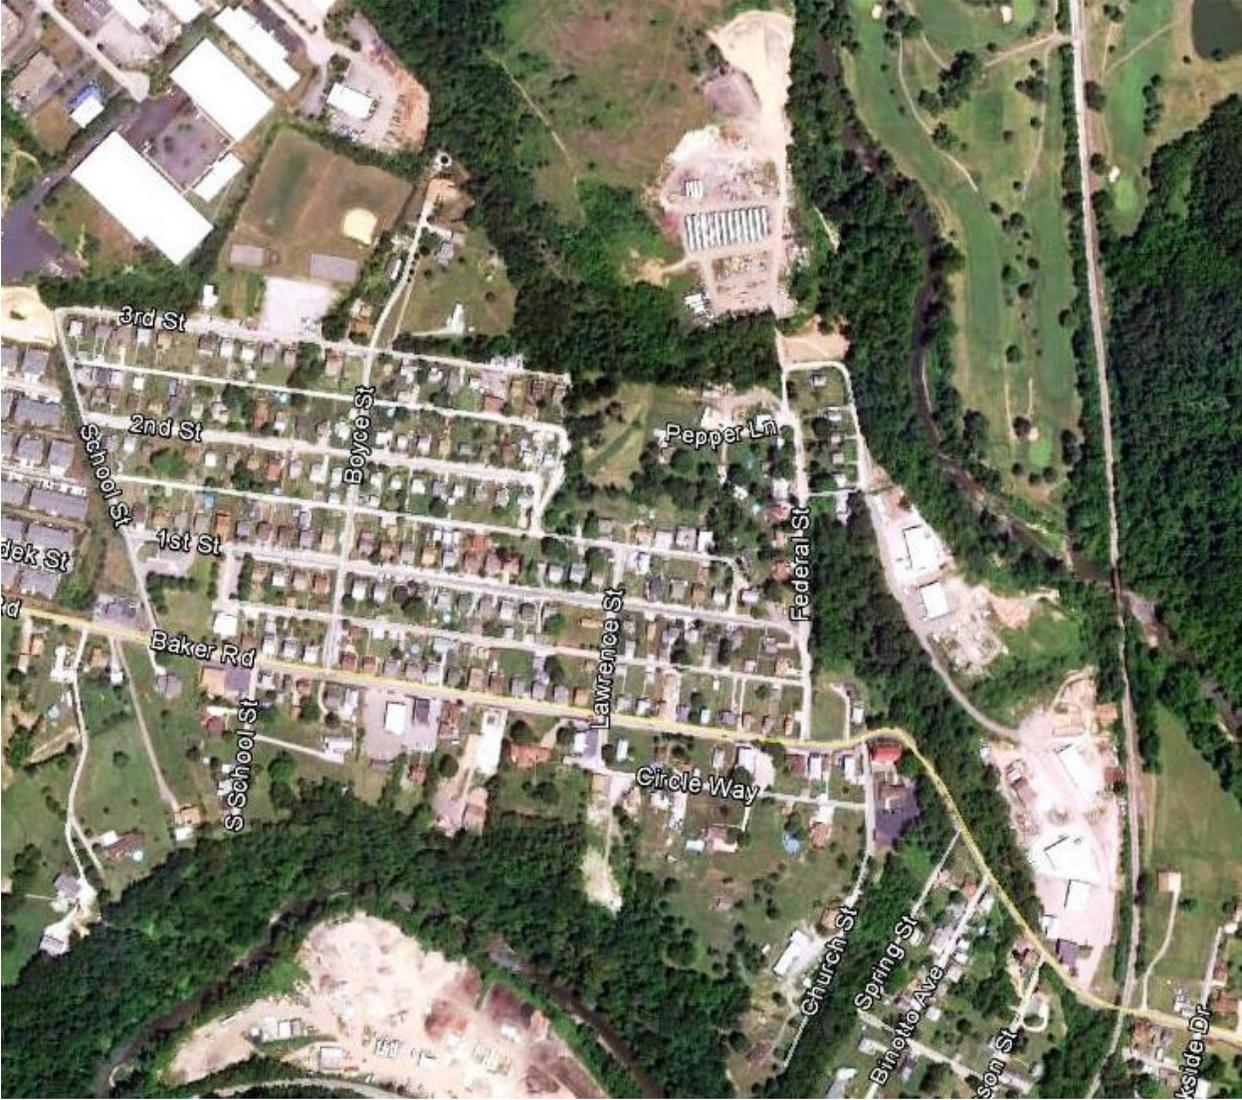
This is a closer view of Lawrence, the former miners' village for Montour No. 4. The Supply Hoist, Fan House and other surface structures, some of which are still in use, are at the lower right and the former waste dump is at the top, right of center.

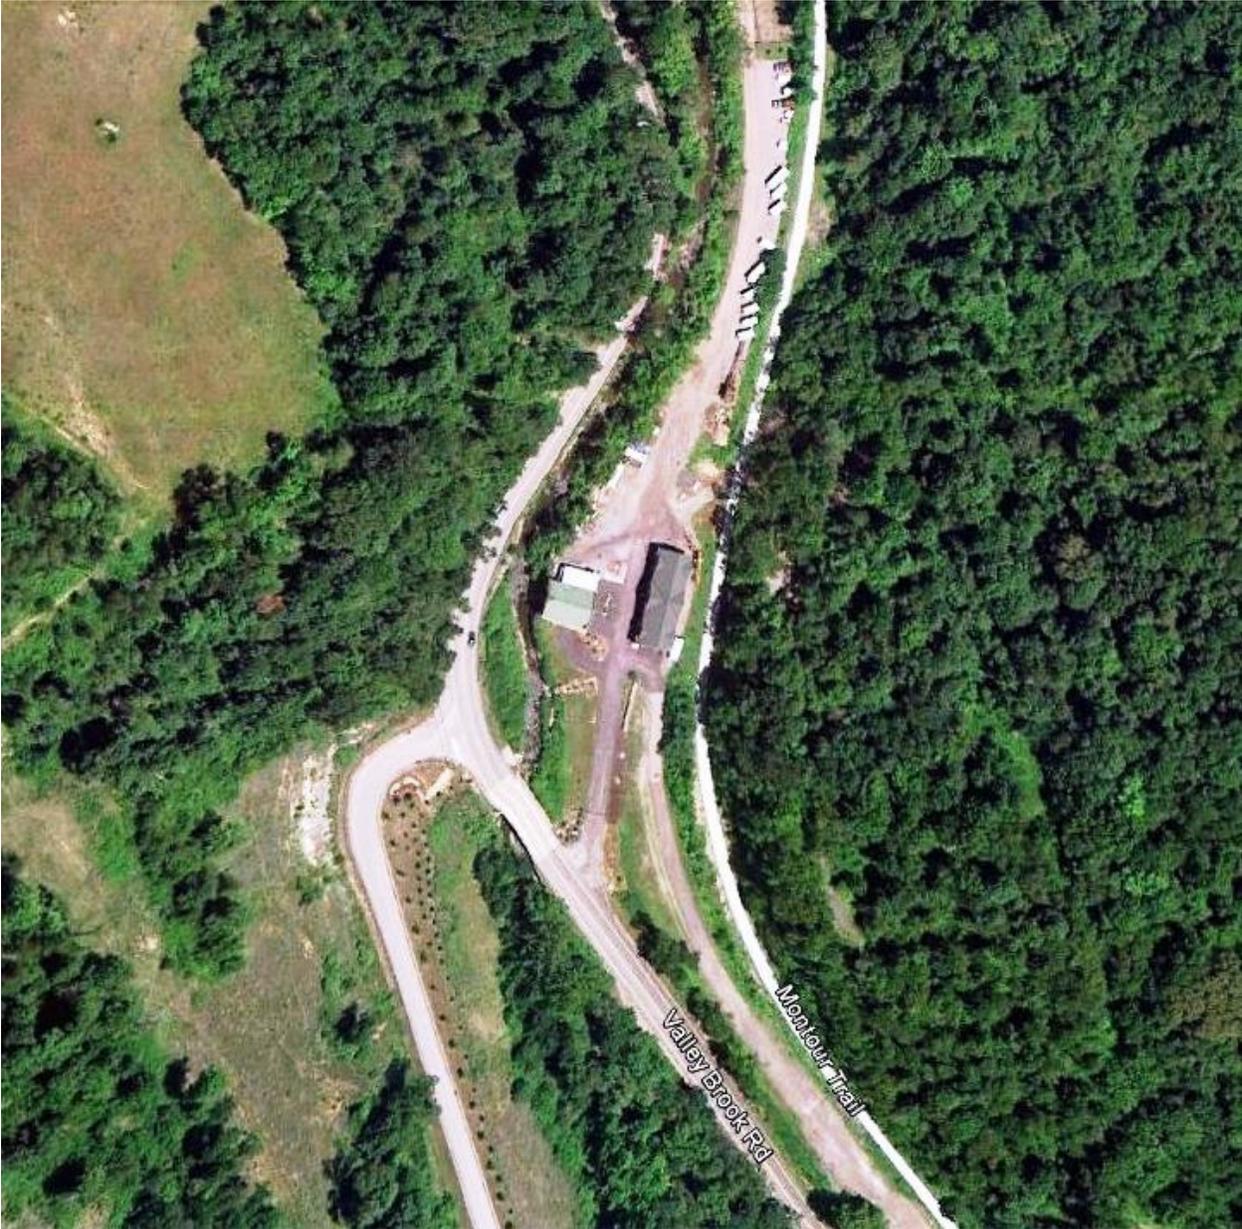
This is a closer view of the site of the former Hoist Tipple along Valleybrook Road. The hoist house is the building with the green roof in the center.

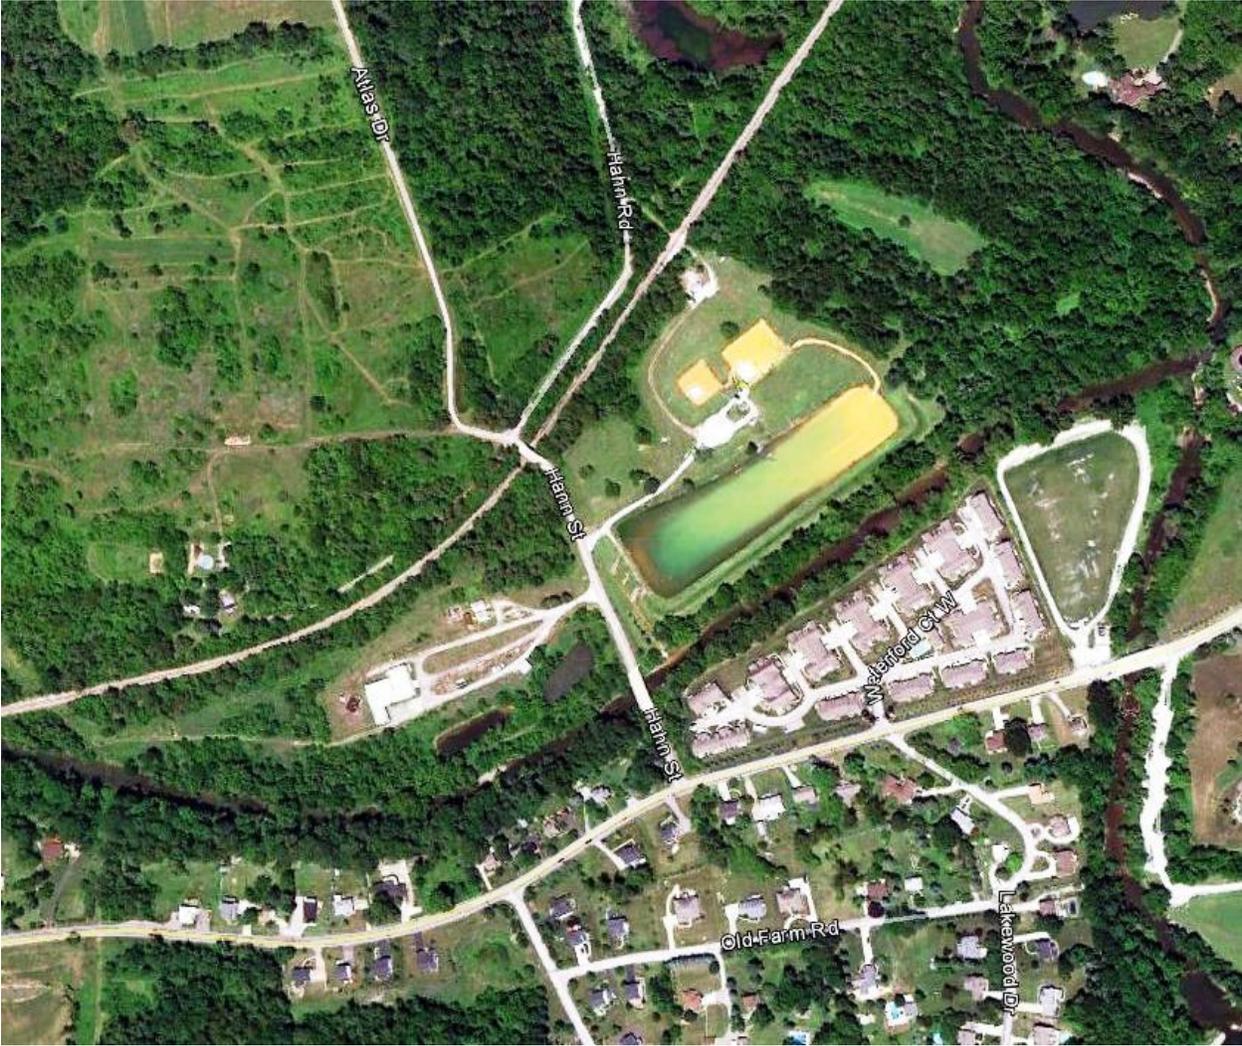
This view shows the Hahn AMD Plant and treatment ponds. The shaft and elevator were in the white-roofed building, with a parking lot to the east.

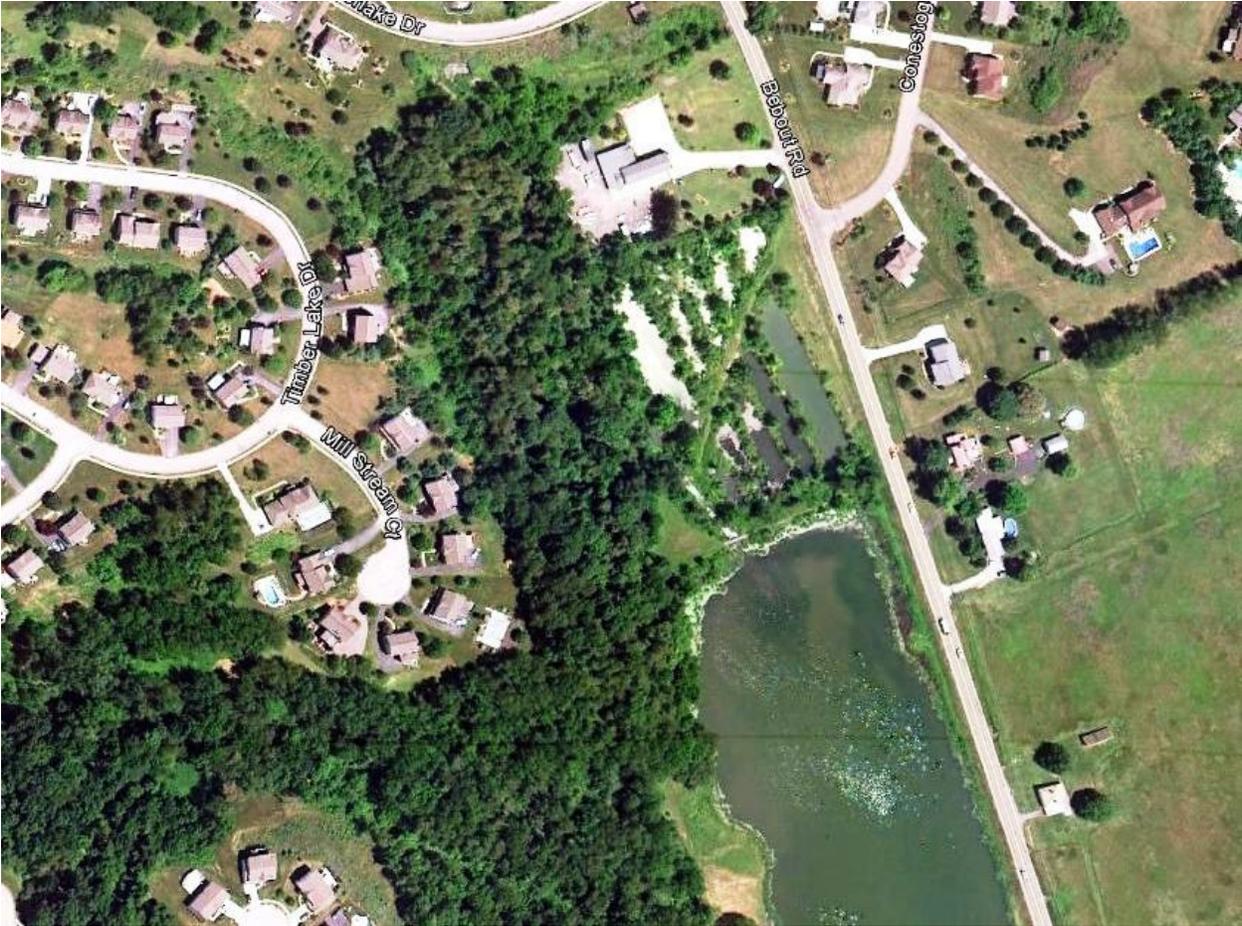
This view shows the site of the former Lake Portal at Lake Jo Ann on Bebout Road. The building in the upper center would have been where the elevator was located. The ponds to the south of the building may have been former treatment ponds for waste water.

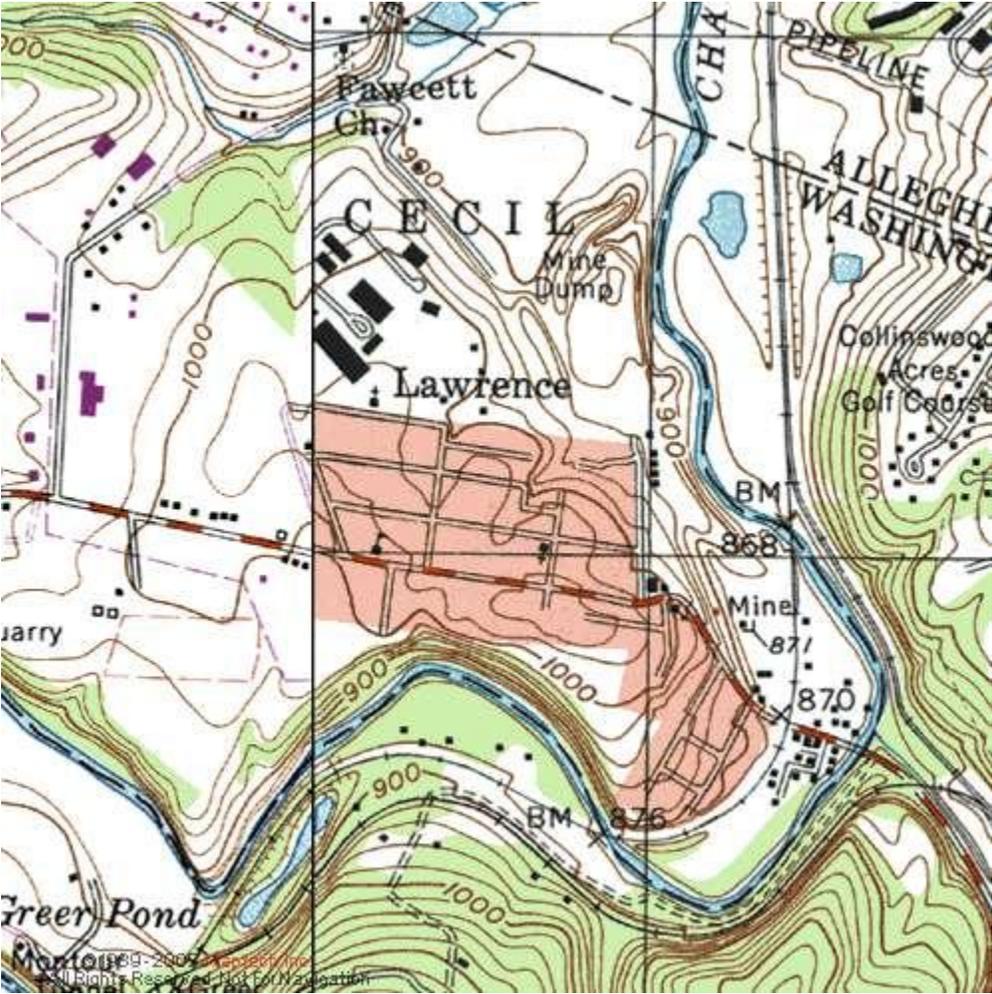
This is a topographic map of the Supply Hoist at Lawrence. Note that the map shows the mine entry as a drift or slope entry, not a shaft. Miners could reach the coal seam using stairs at this location. The tibble and hoist were used for removing waste and delivering supplies, such as mine props.

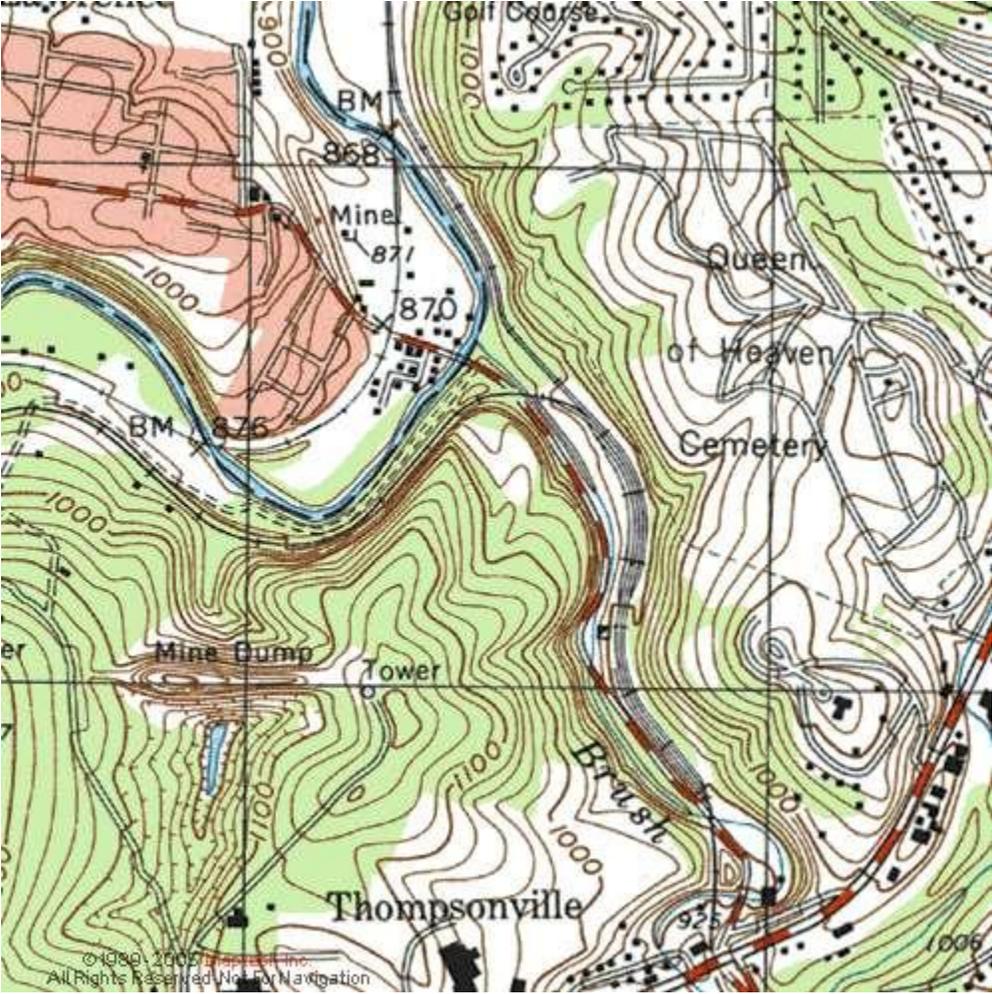
This topographic view shows the Hoist Shaft at Hills and the second waste dump. The empty and loaded yards and the Montour/PRR interchange are also visible. The Montour main track comes in from the west, skirting Chartiers Creek.

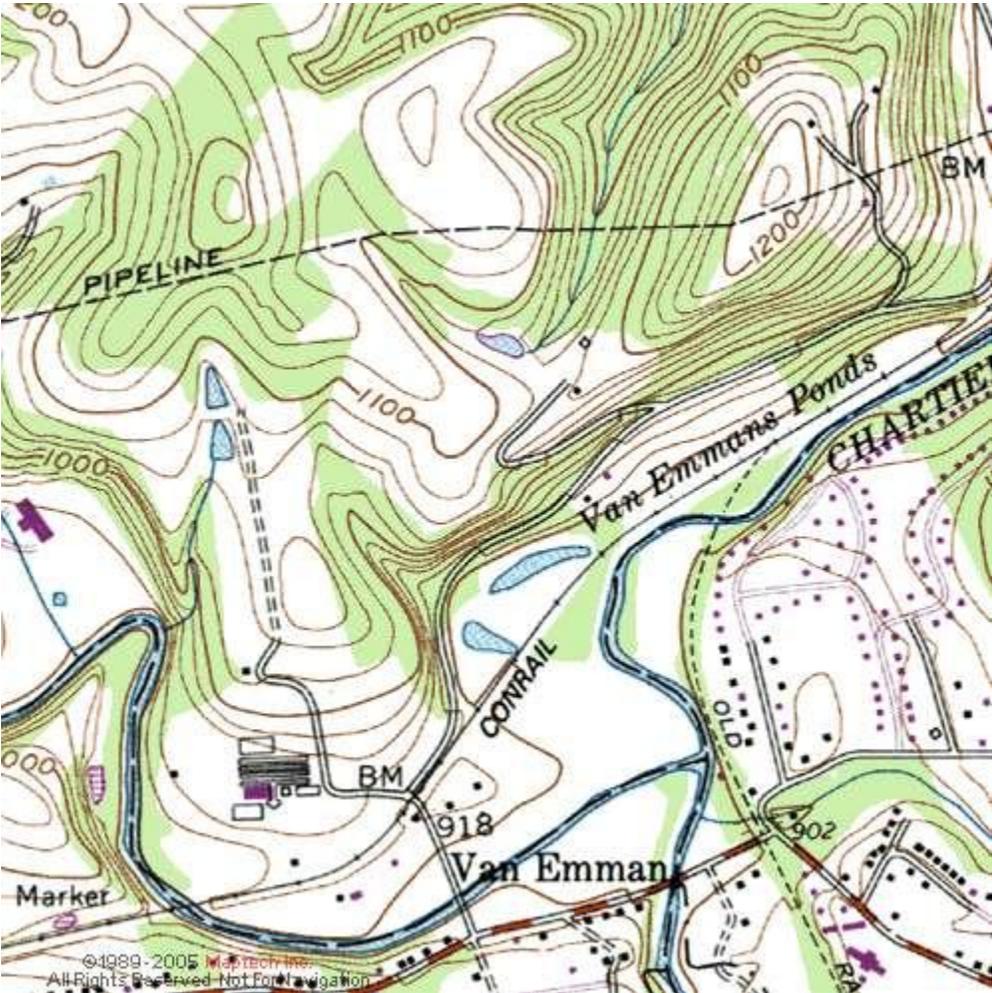
The Hahn Portal was located across from the “V” in Van Emman. Note that the surface elevation is 918 feet here. The coal seam was at 660 feet and was the lowest point in No. 4 mine, hence the reason for putting the AMD plant at this location.

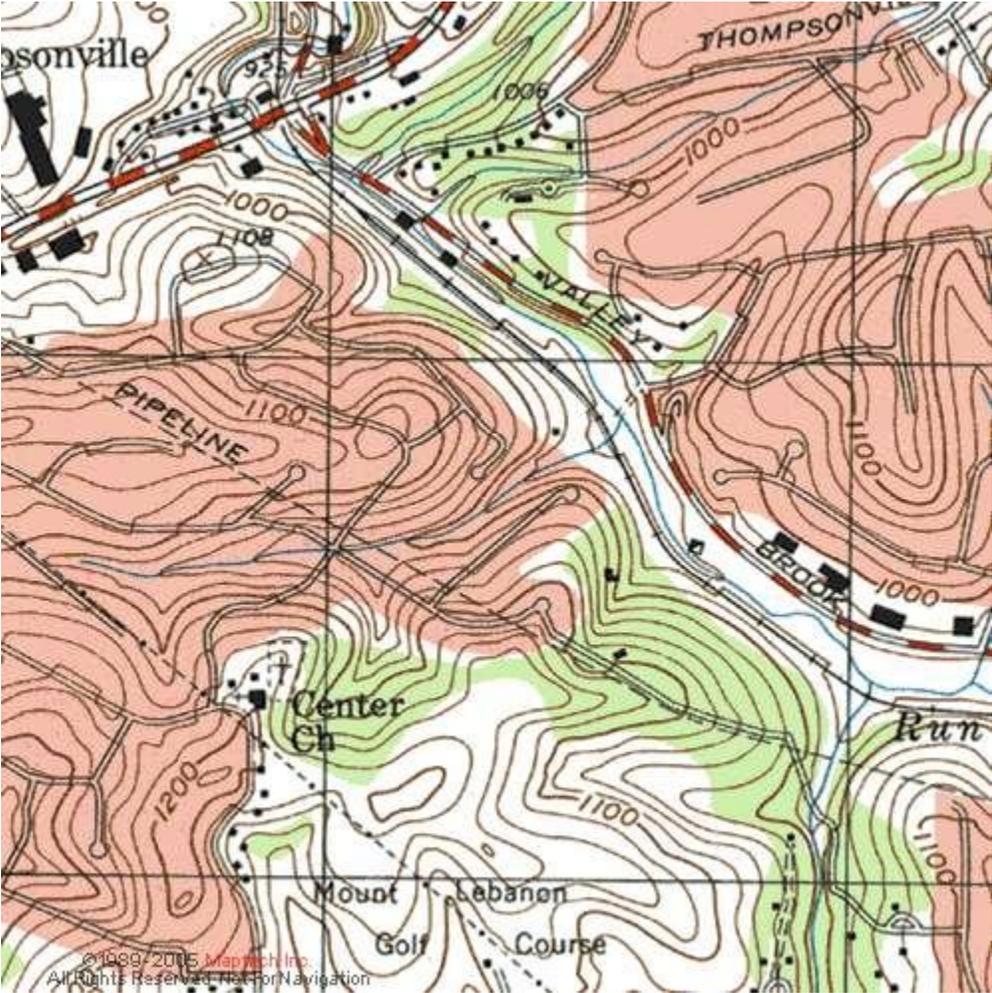
The Hickman Shaft is the black and white square next to the "B" in Brook.

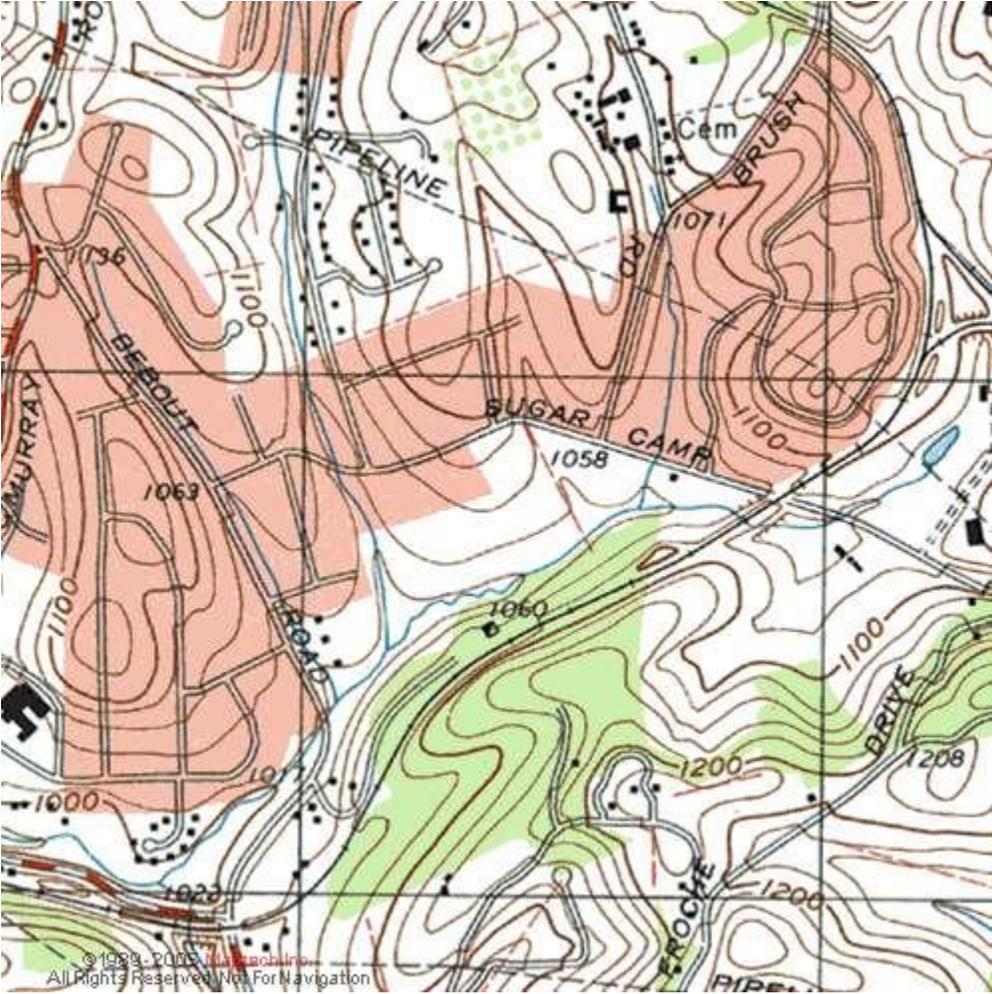
The Murdock Shaft is shown at elevation 1060 on this map. The coal seam was at elevation 810 at this location, and Montour No. 10 Mine abutted No. 4 at this point and was the most likely origin of the 1980 breakthrough and flood.

The 1980 flooding of No. 4 mine spelled the end of its tenure as a working mine. For some reason, a barrier between No. 4 and Montour No. 10 mine, which was closed in 1970, failed and water from No. 10 poured into No. 4, flowing downward toward Hahn Portal, the lowest point in the mine. Although the coal company spent two weeks trying to pump out the mine, they eventually gave up and shut it down. The closing of No. 4 mine allowed the Pittsburgh & Lake Erie Railroad, which took over the Montour Railroad in 1975, to file for abandonment of the main line between Gilmore Junction and Hills.

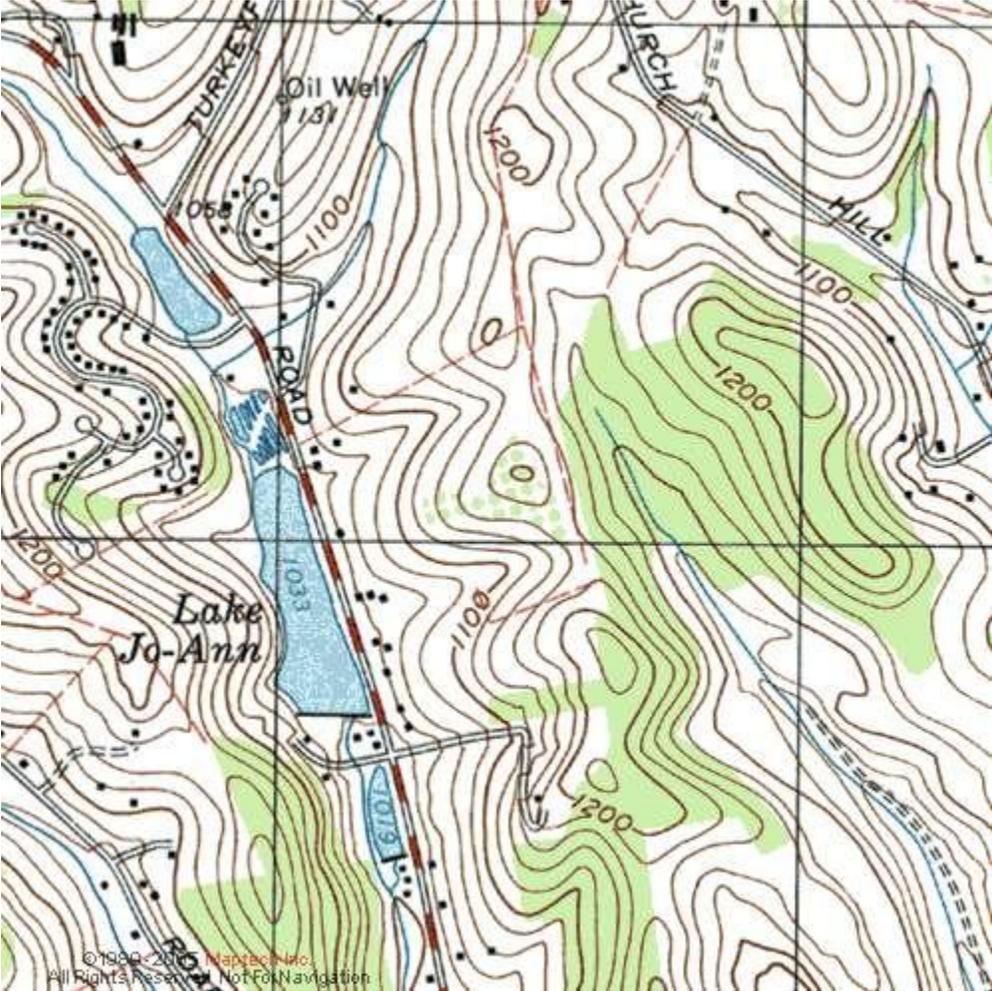
The Lake Portal was located next to the word "Road" and above the series of small ponds next to Lake Jo-Ann.

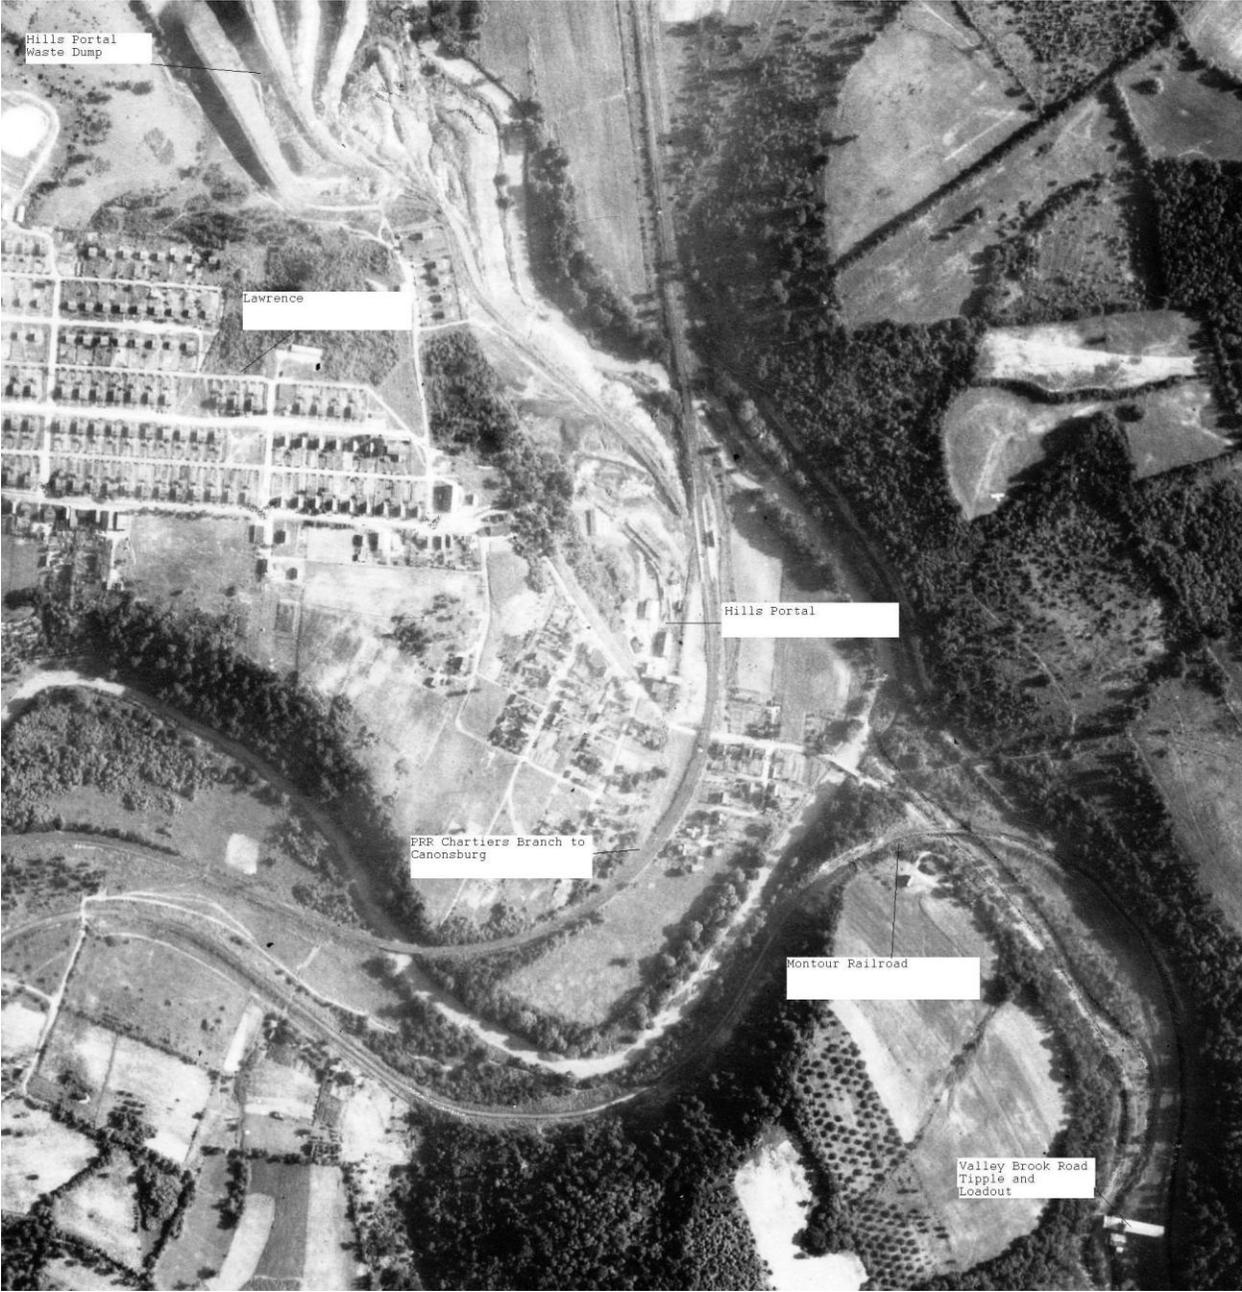
This 1939 aerial photo shows both tipples for No. 4 mine and the active waste dump north of Lawrence.

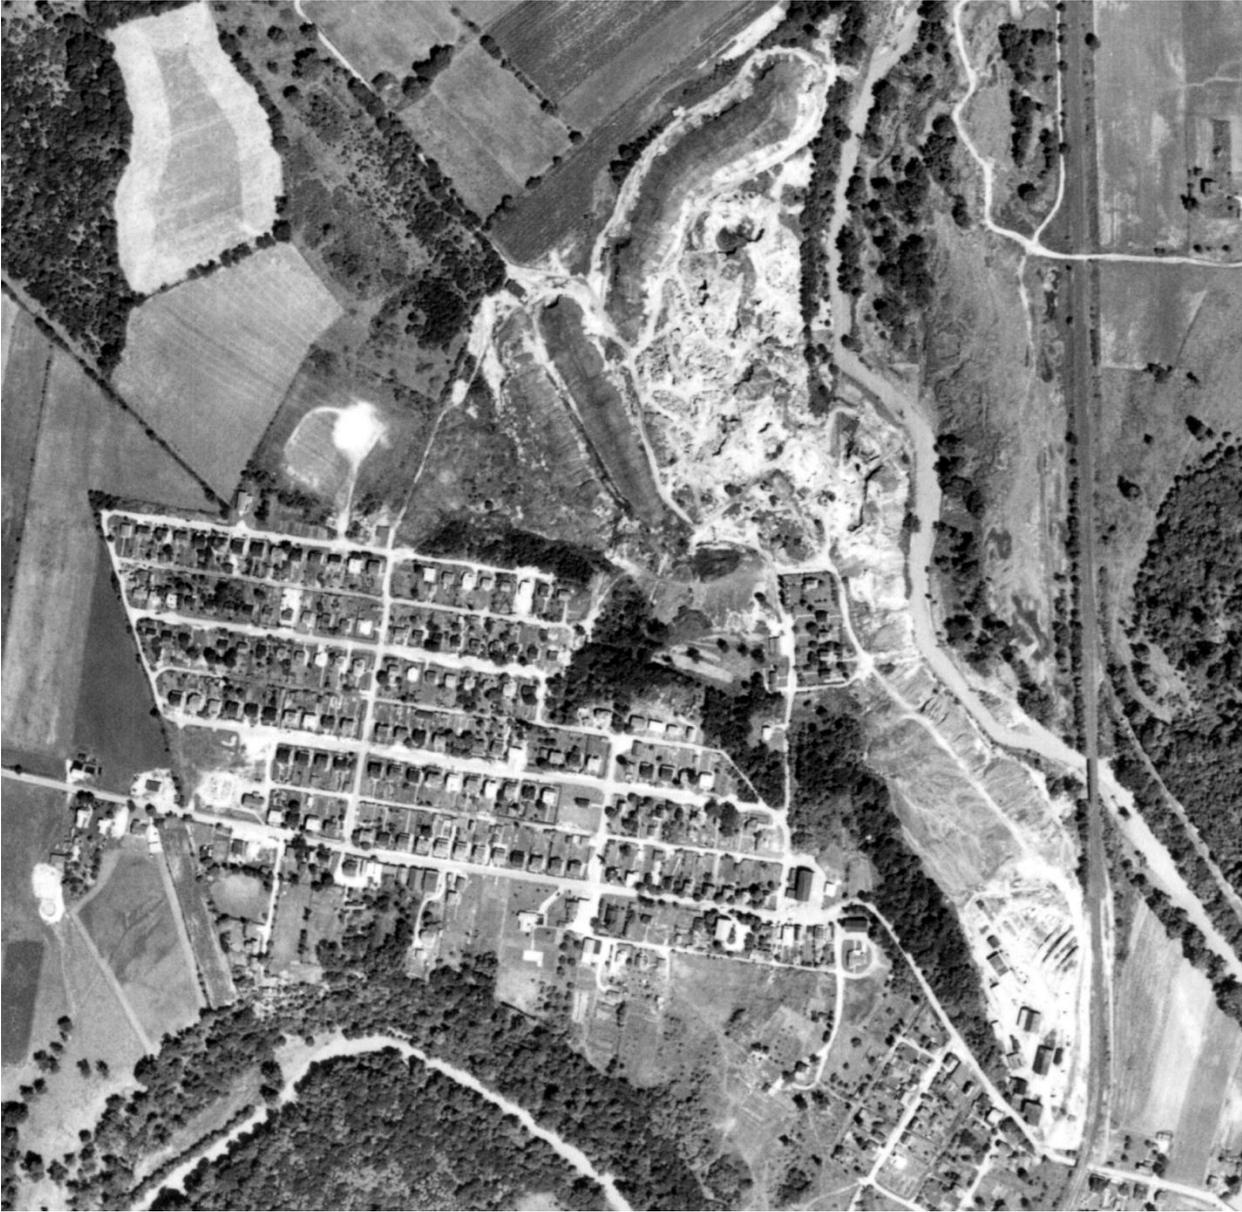
This 1958 photo shows the inactive waste dump at Lawrence and the Supply tipple has been removed.

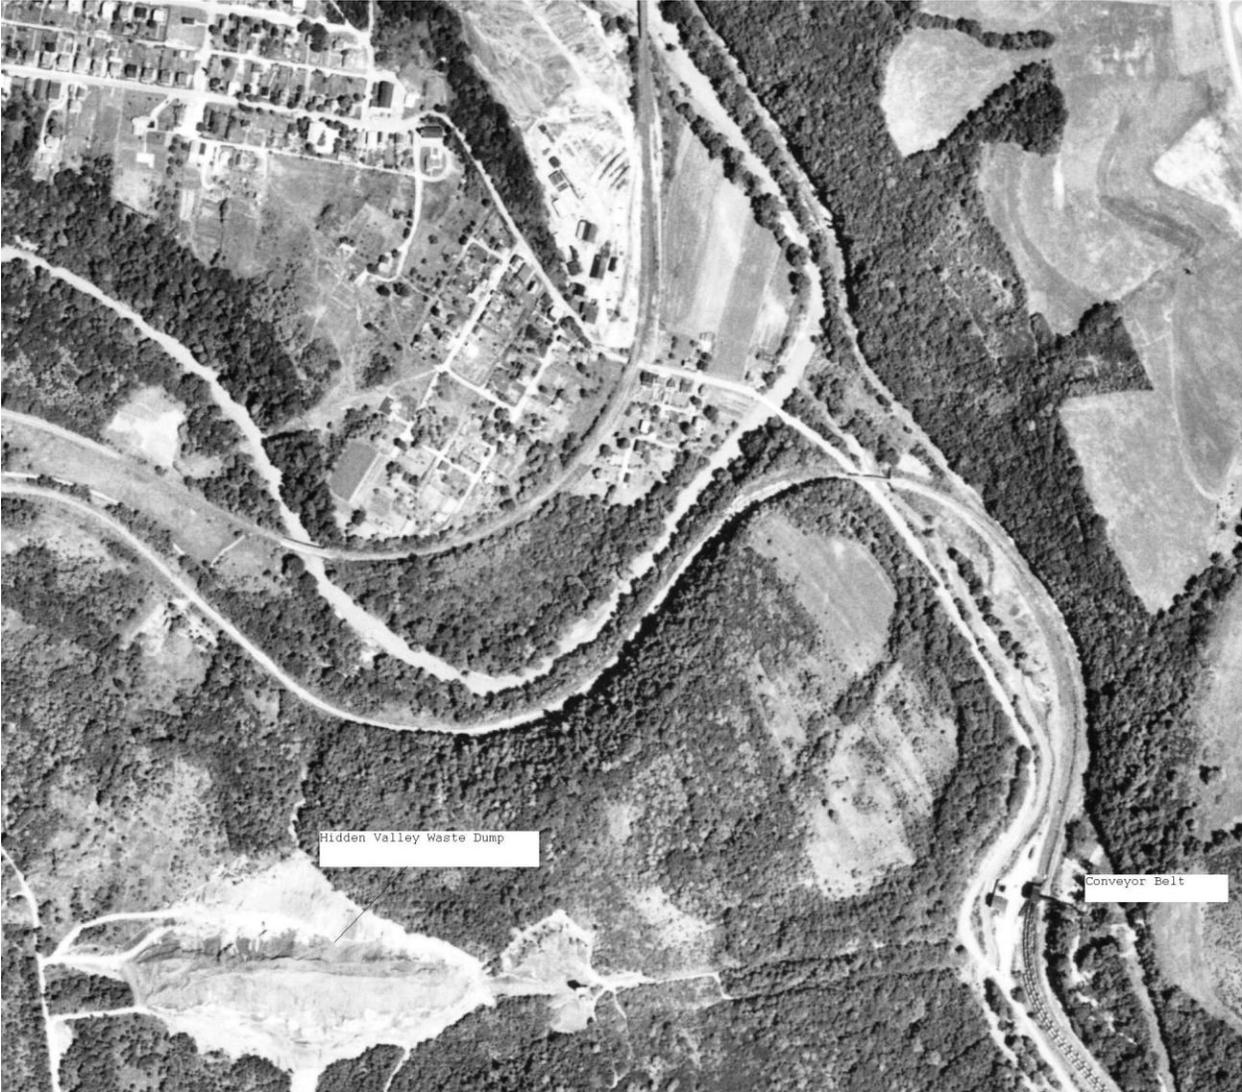
By 1962, the new waste dump west of Valleybrook Road has been active for about 20 years. The slope entry and conveyor belt installed in 1953 are also visible.

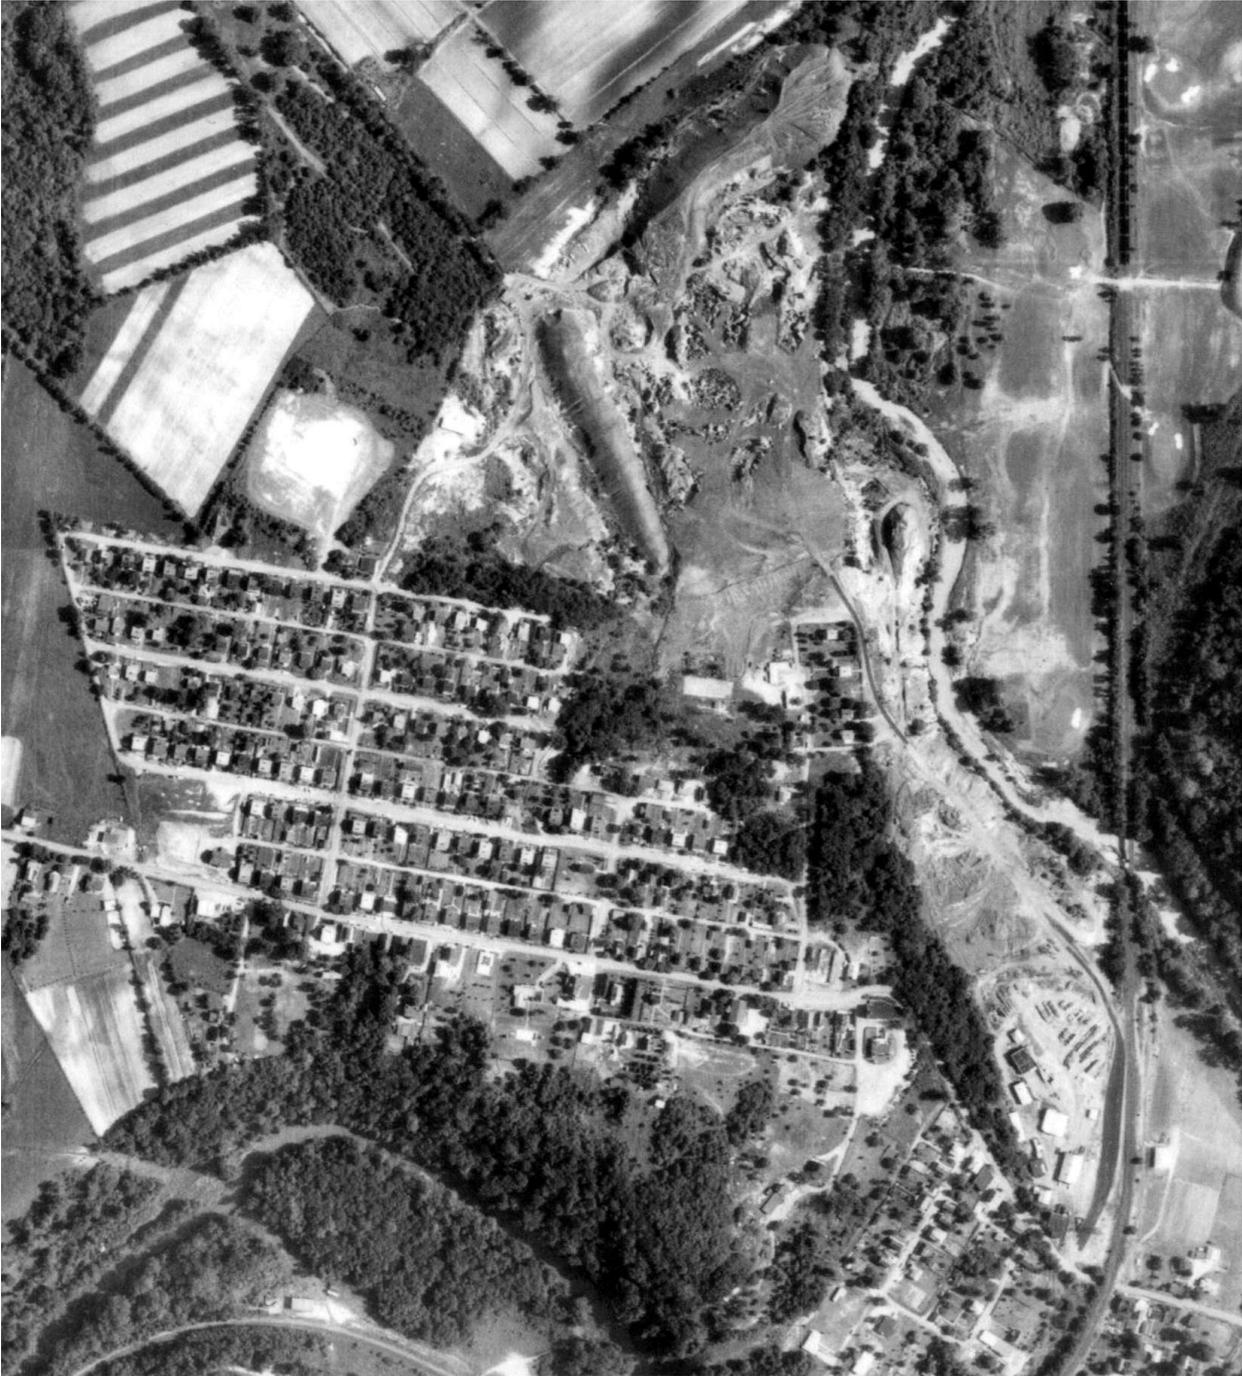
This 1967 view shows the Hahn Portal before it was converted to a waste water treatment plant. The cars in the parking lot indicate that active mining was going on at this time.

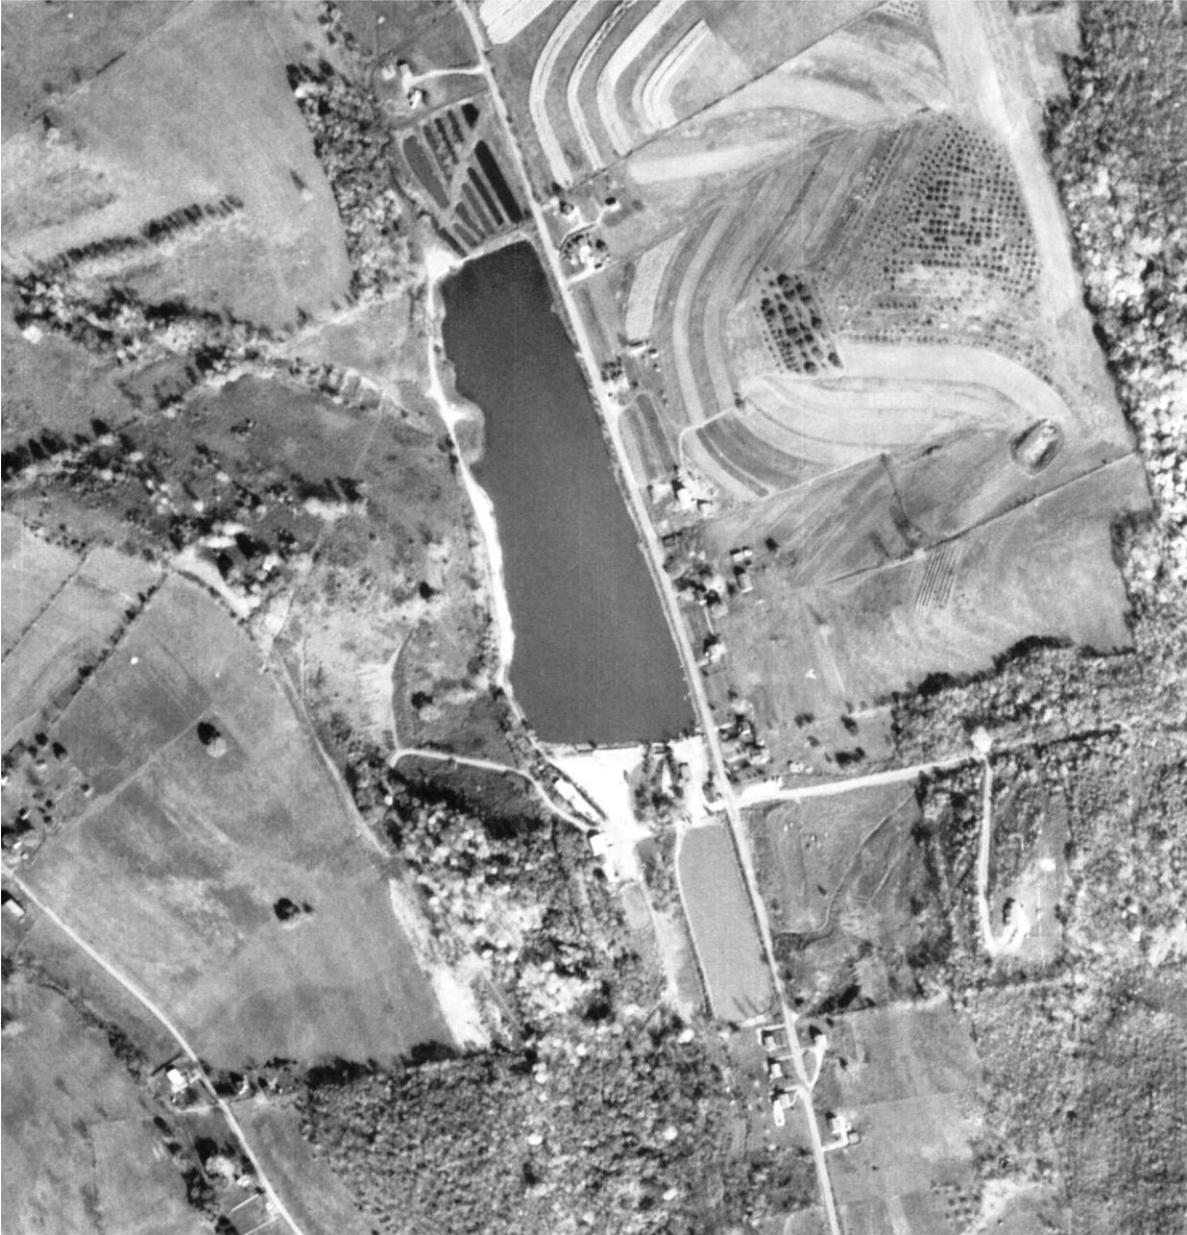
In 1967, the Lake Portal was primarily being used for drainage, based on the absence of any parking facilities at the shaft.

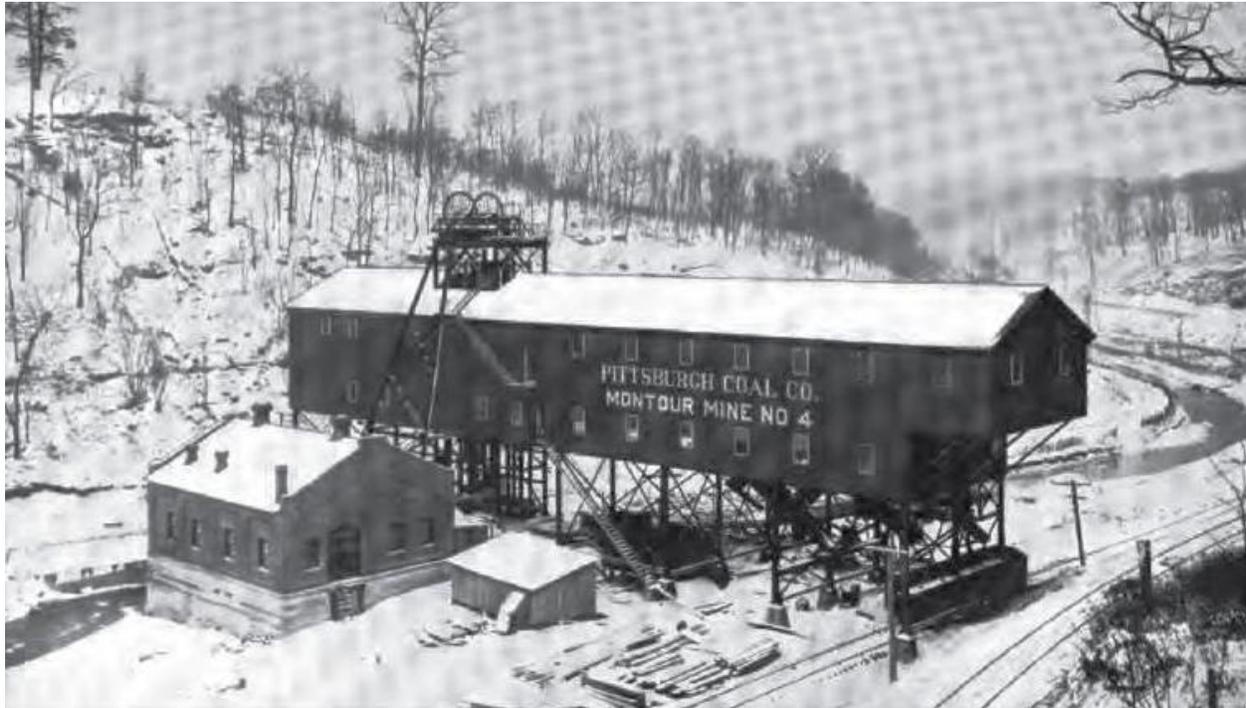
This 1914 photograph shows the newly opened tipple at Hills on the Montour. The mine is still being developed, as evidenced by only a single loading track under the tipple and only one coal car with a partial load. There is also a lot of construction material around the tipple. The hoist house next to the tipple is the only building that remains today.

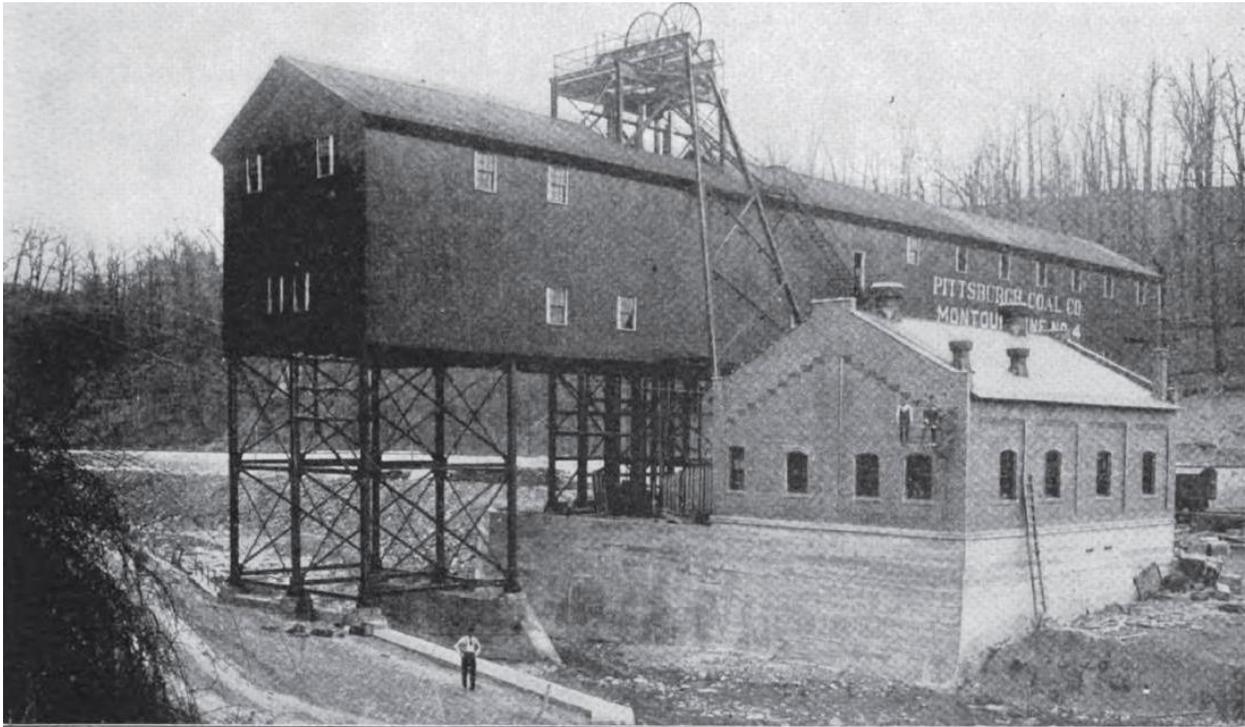
**MONTOUR MINE NO. 4 AT HILL STATION, PENN., ON MONTOUR R.R., OWNED BY PITTSBURGH COAL CO.
ENGINE-ROOM BUILDING IN FOREGROUND**

This view shows the Hills tibble looking toward the northwest. Note the workers standing on the side of the hoist house.
