Montour No. 4 (Bob Ciminel ©2012)

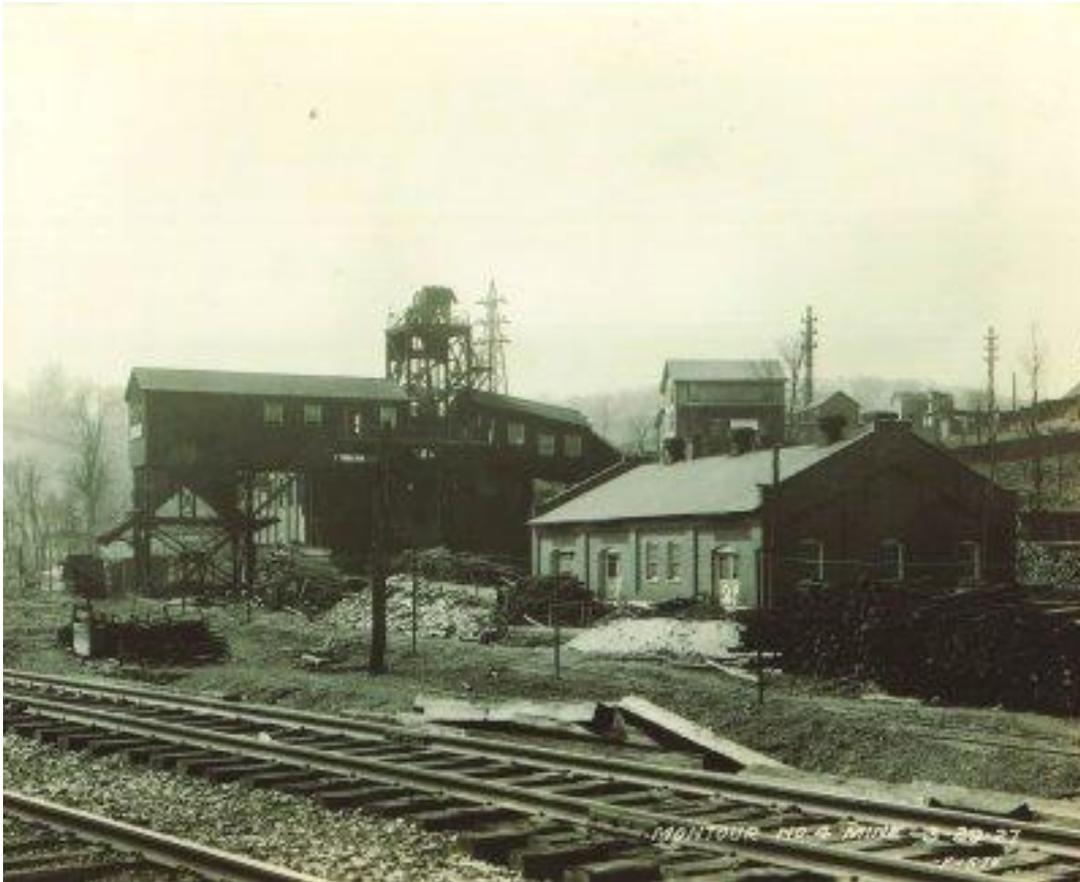
This 1927 view is of the Supply Hoist on the PRR Chartiers Branch. You can barely make out the tracks for the waste Larry cars and the power line next to the railroad tracks.

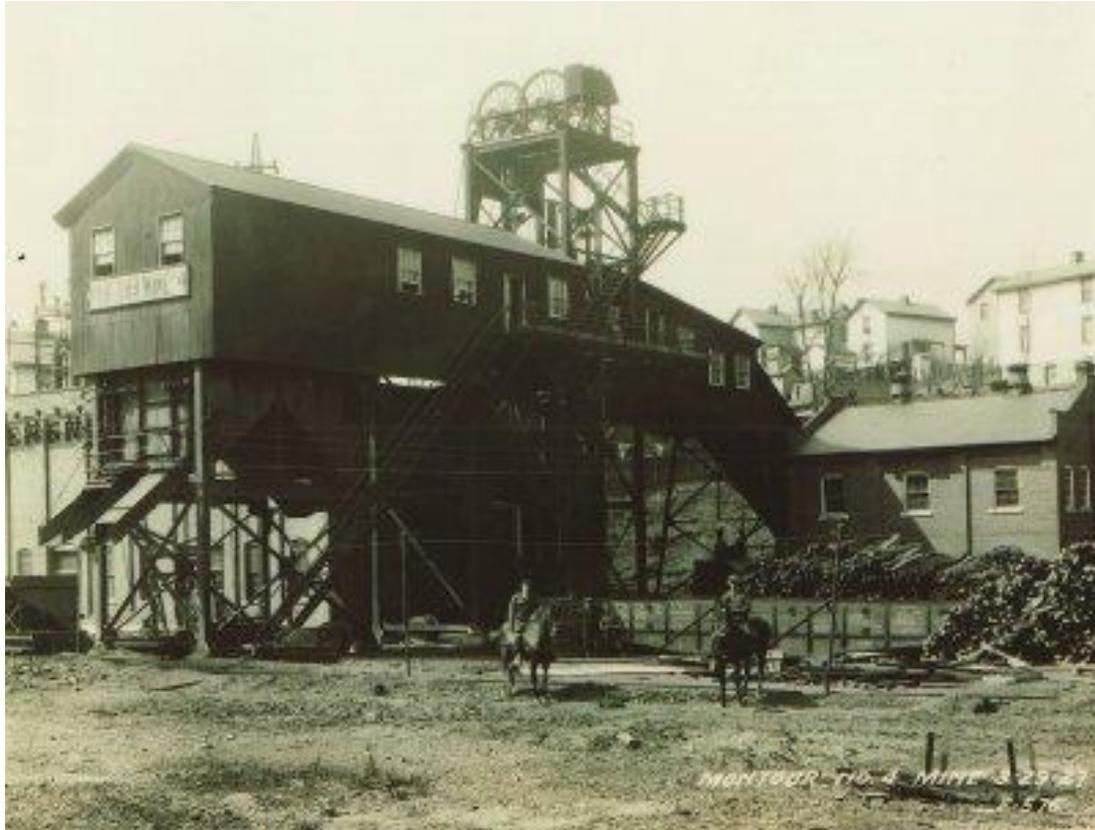
A closer view of the Supply Hoist at Hills Station in 1927. Those are policemen on the horses guarding the mine because of the ongoing miners' strike. Note the piles of mine posts in the background and the four chutes for dumping waste.

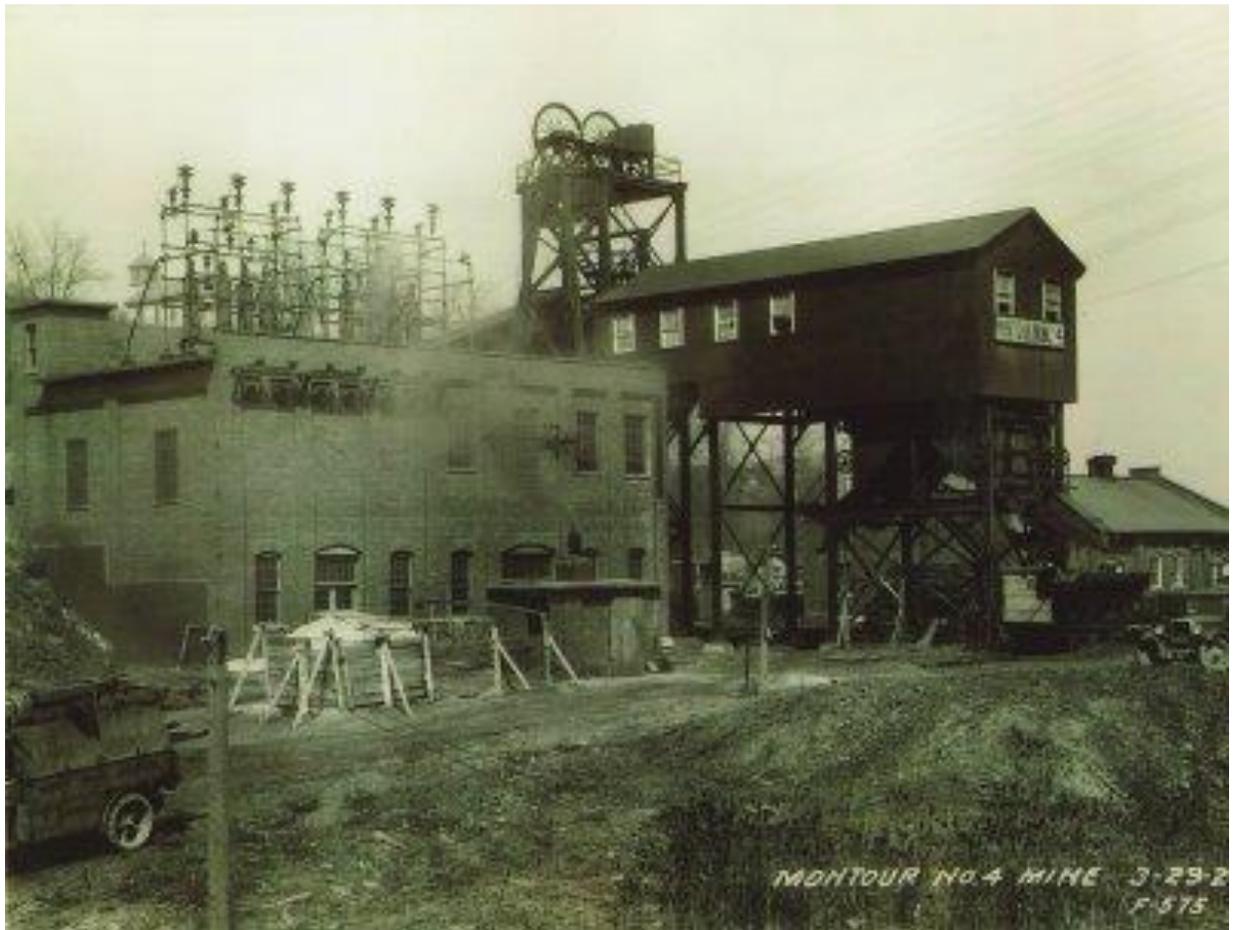
This is another view of the Supply and Waste Hoist. The building in the foreground housed the electrical equipment for the mine and tippie.

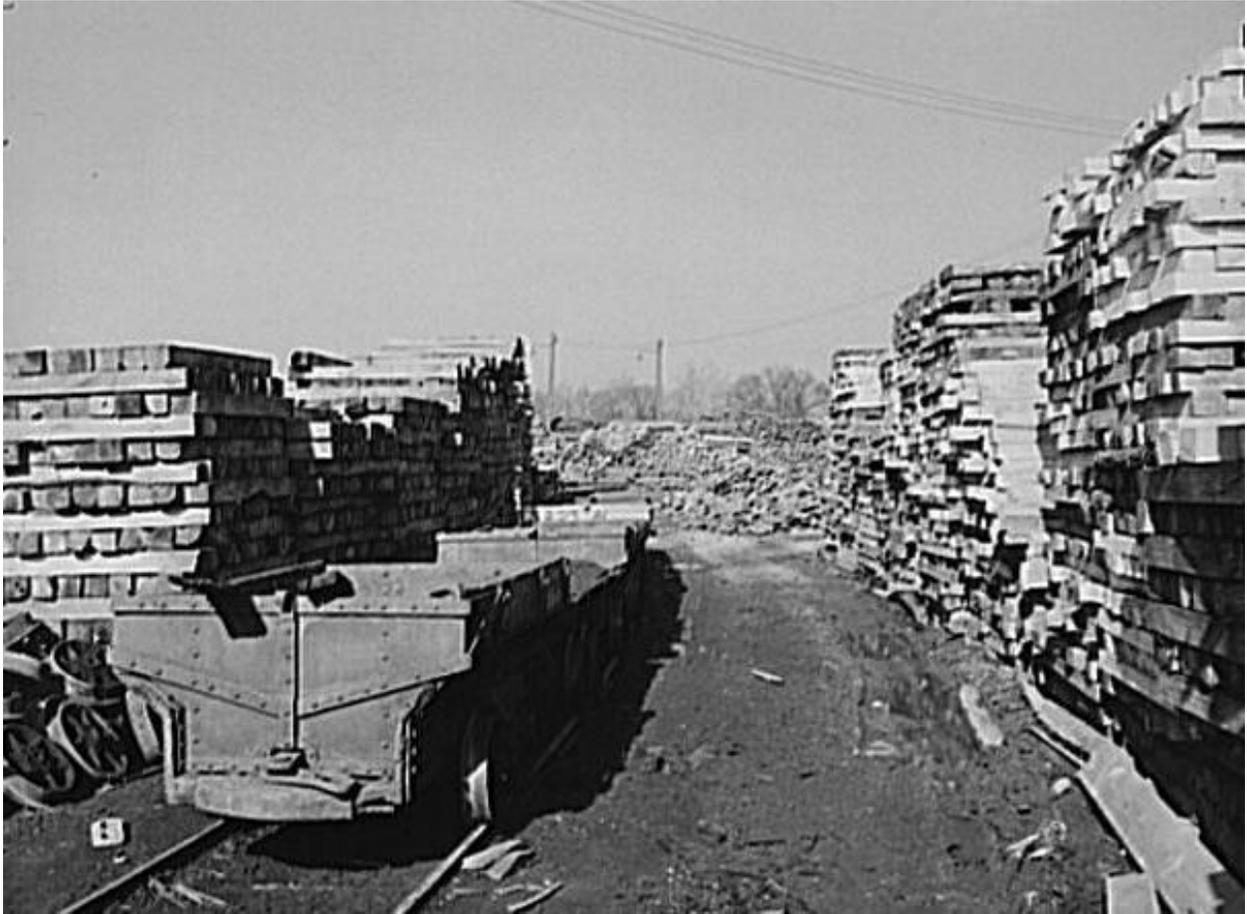
This is another 1942 view of the supply yard showing stacks of mine timbers. As mining became more mechanized, roof bolts replaced timbers in most mines.

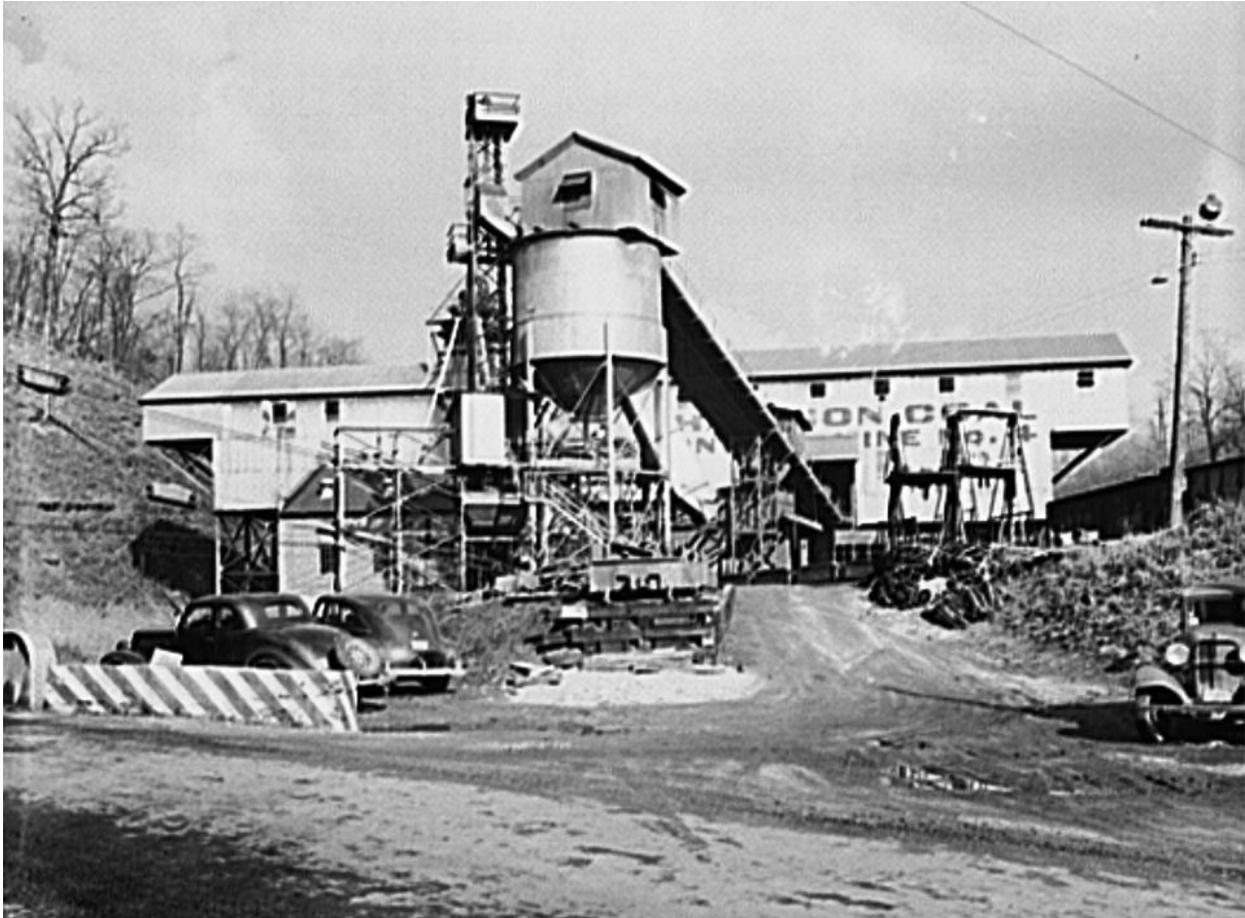
This is another view of the Hoist Shaft on the Montour showing the waste bin and tramway to the new mine dump across Valleybrook Road. It is obvious that this was an addition to the old tiple because the name of the mine is partially obscured.

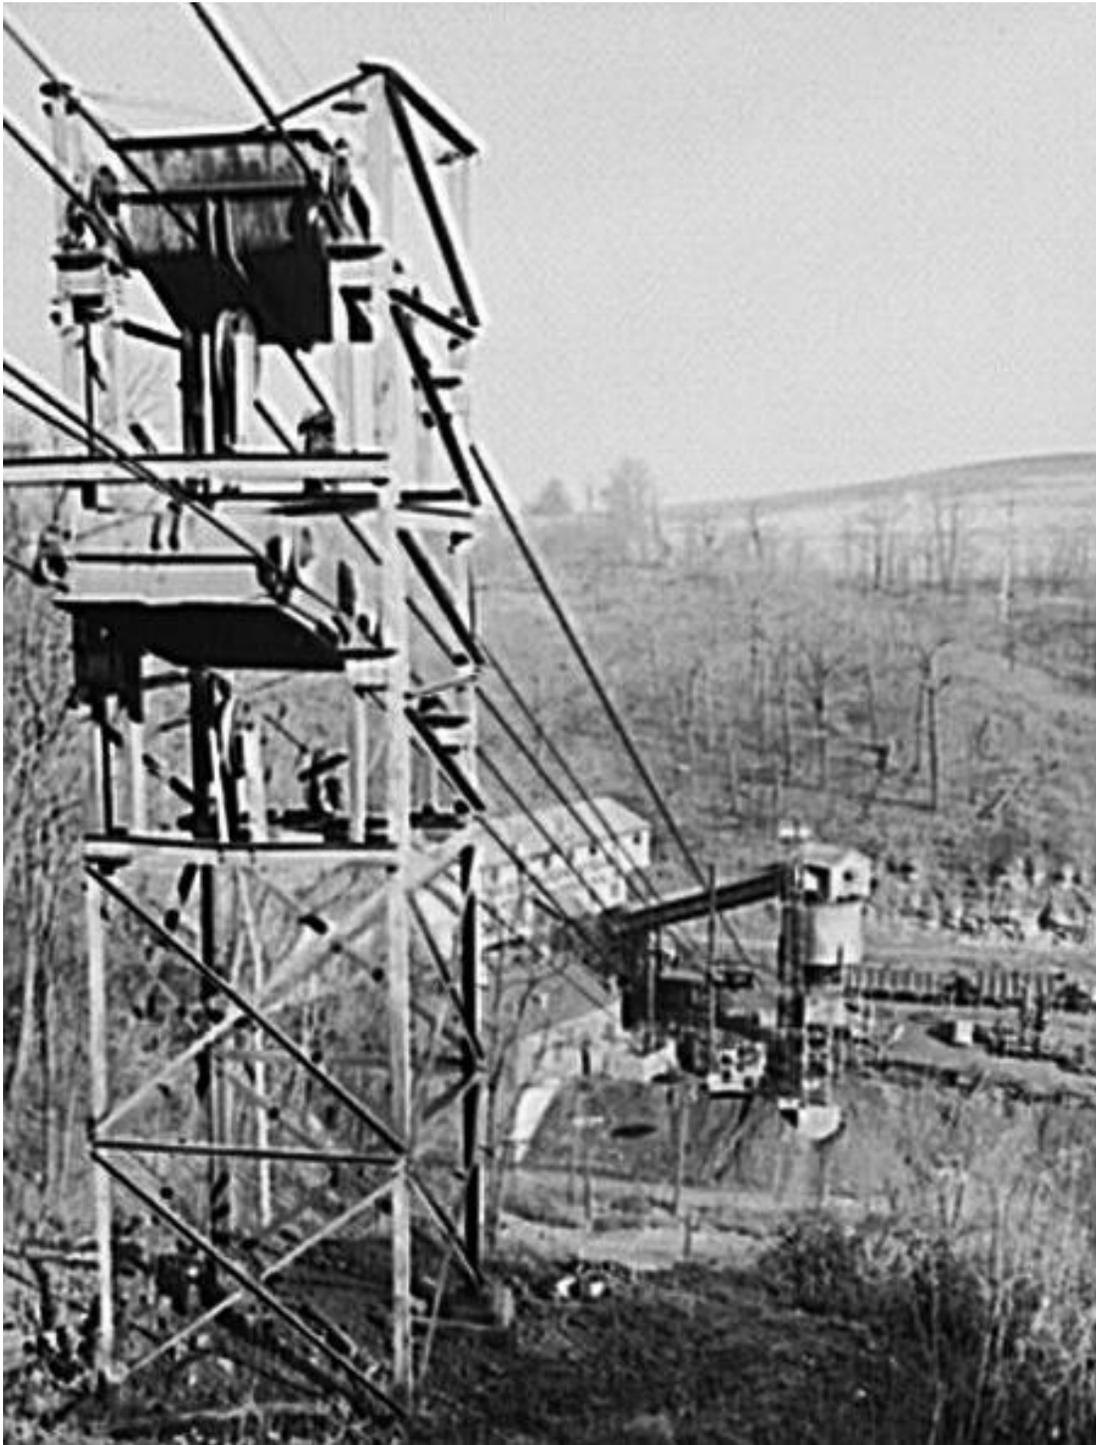
This photo was taken from the hill above the mine and shows how the tramway inverted empty waste buckets for the return trip to the waste bin.

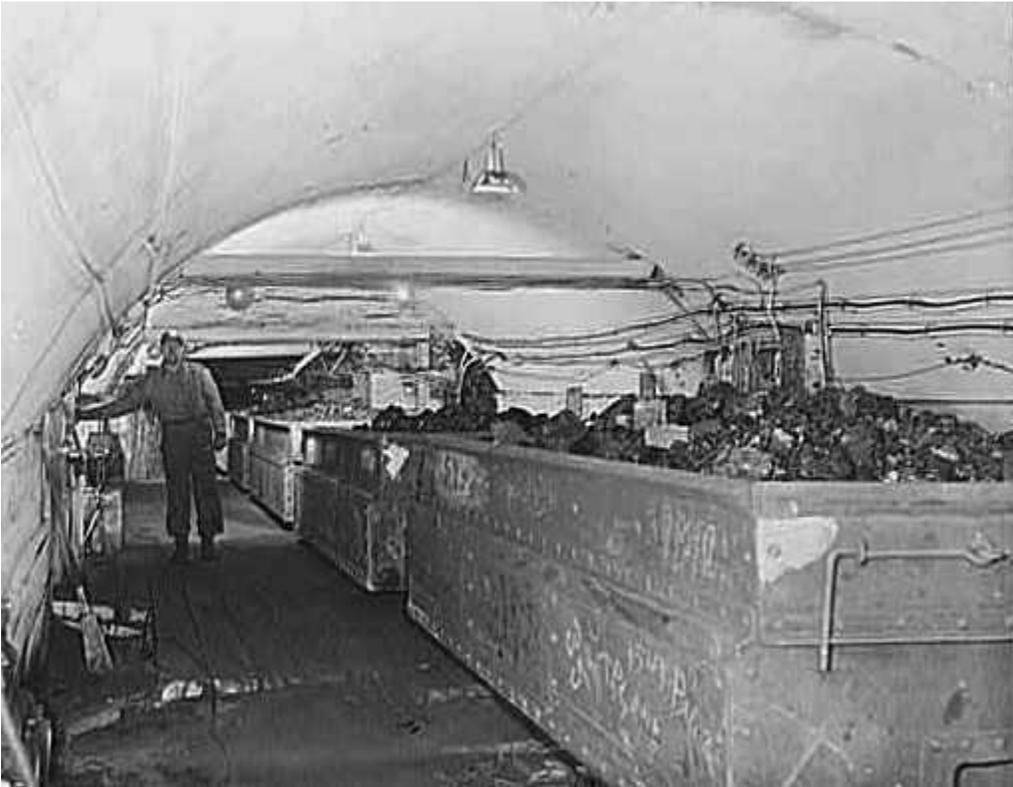
This is the bottom of the Hoisting Shaft showing a trip of loaded coal cars entering the hoist.

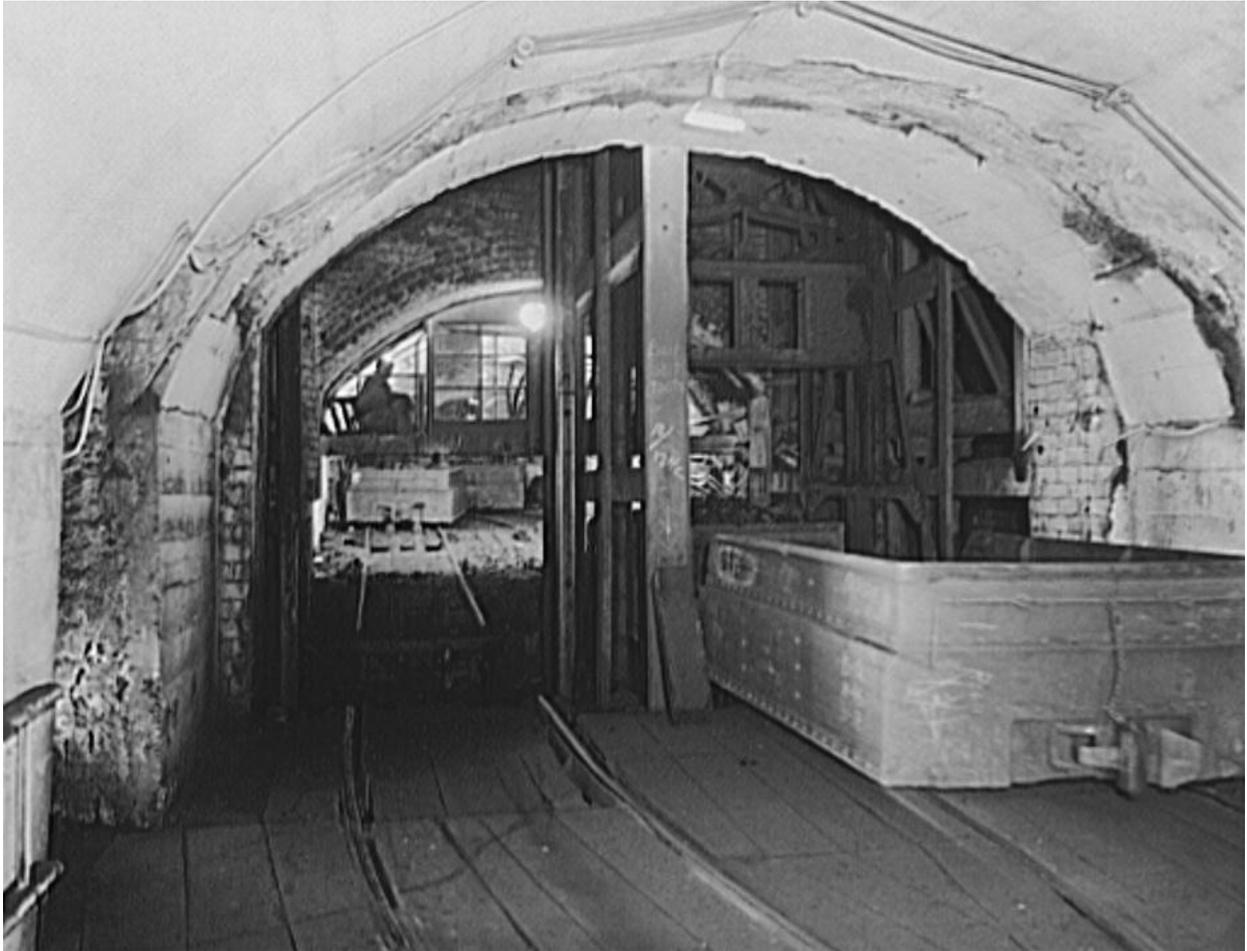
At the shaft bottom, loaded cars are hoisted up to the tippie as empty cars are returned to the mine. Here, an empty car is just now rolling off of the car hoist and rolling by gravity down the empty return track.

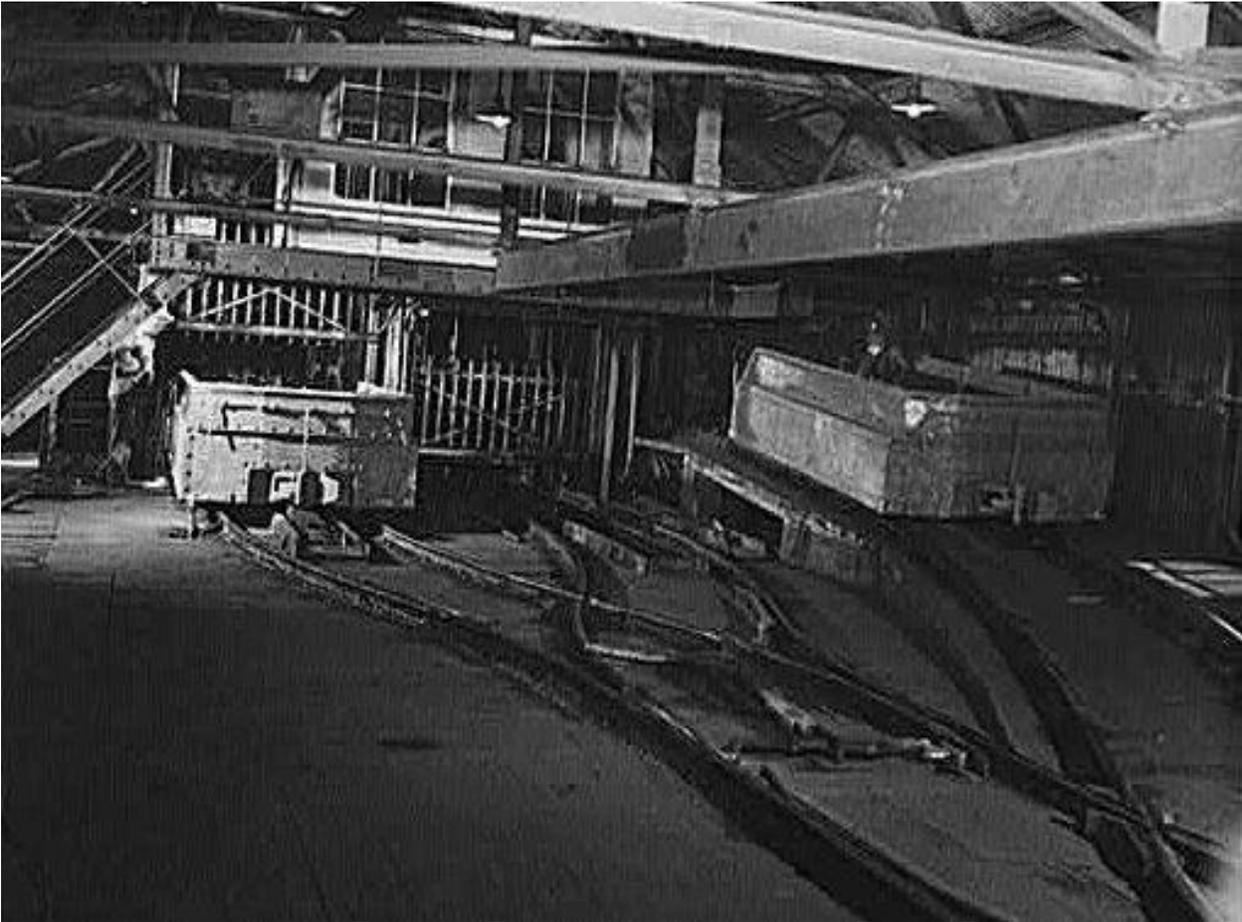
In the tippel, cars roll out of the hoist cages and into the rotary dumper.

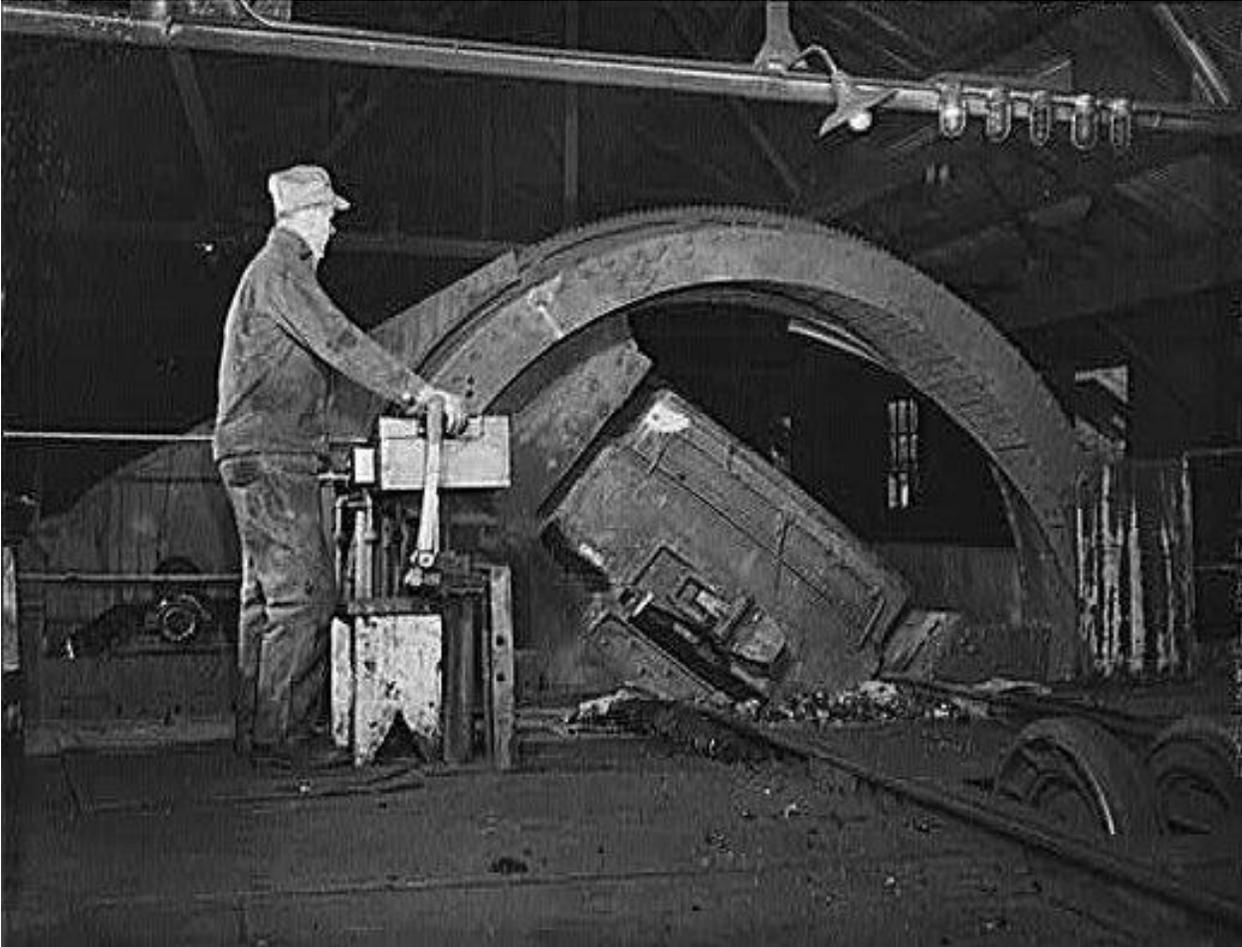
Cars are dumped at the top of the tippel. Note the row of signal lights on the right.

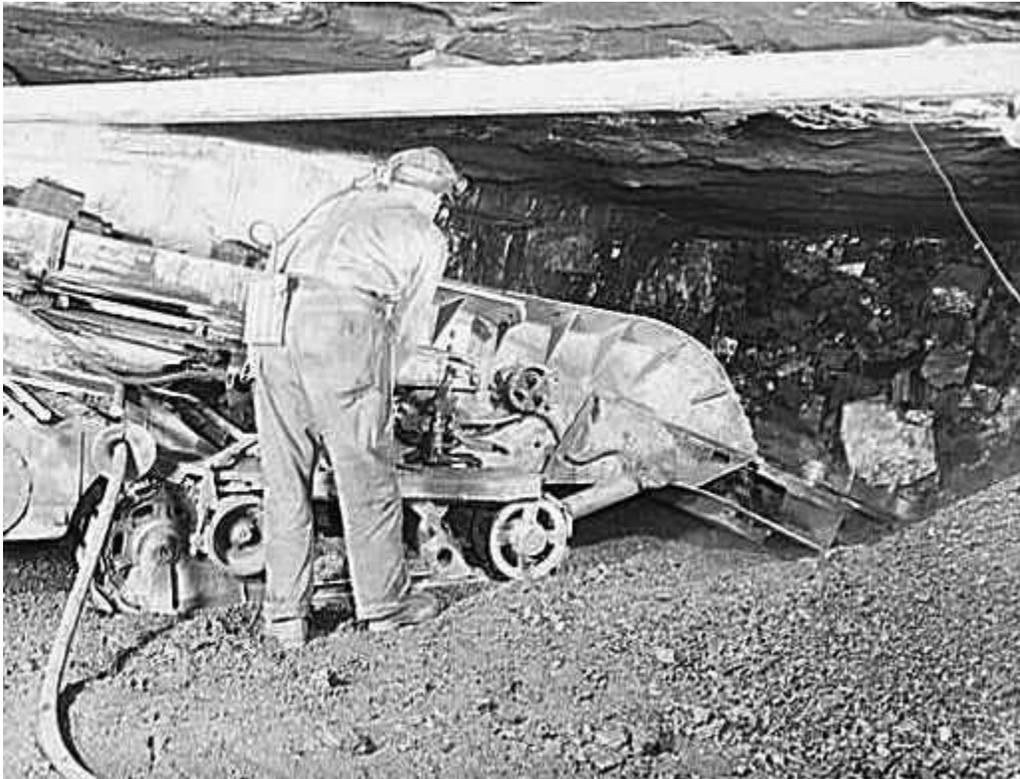
Down at the working face, a miner uses a mechanical loading machine to pick up blocks of coal recently shattered by a Cardox charge. Cardox was a shell of liquid carbon dioxide that was rapidly vaporized using an electrical squib and injected into the drill hole to shatter the solid coal.

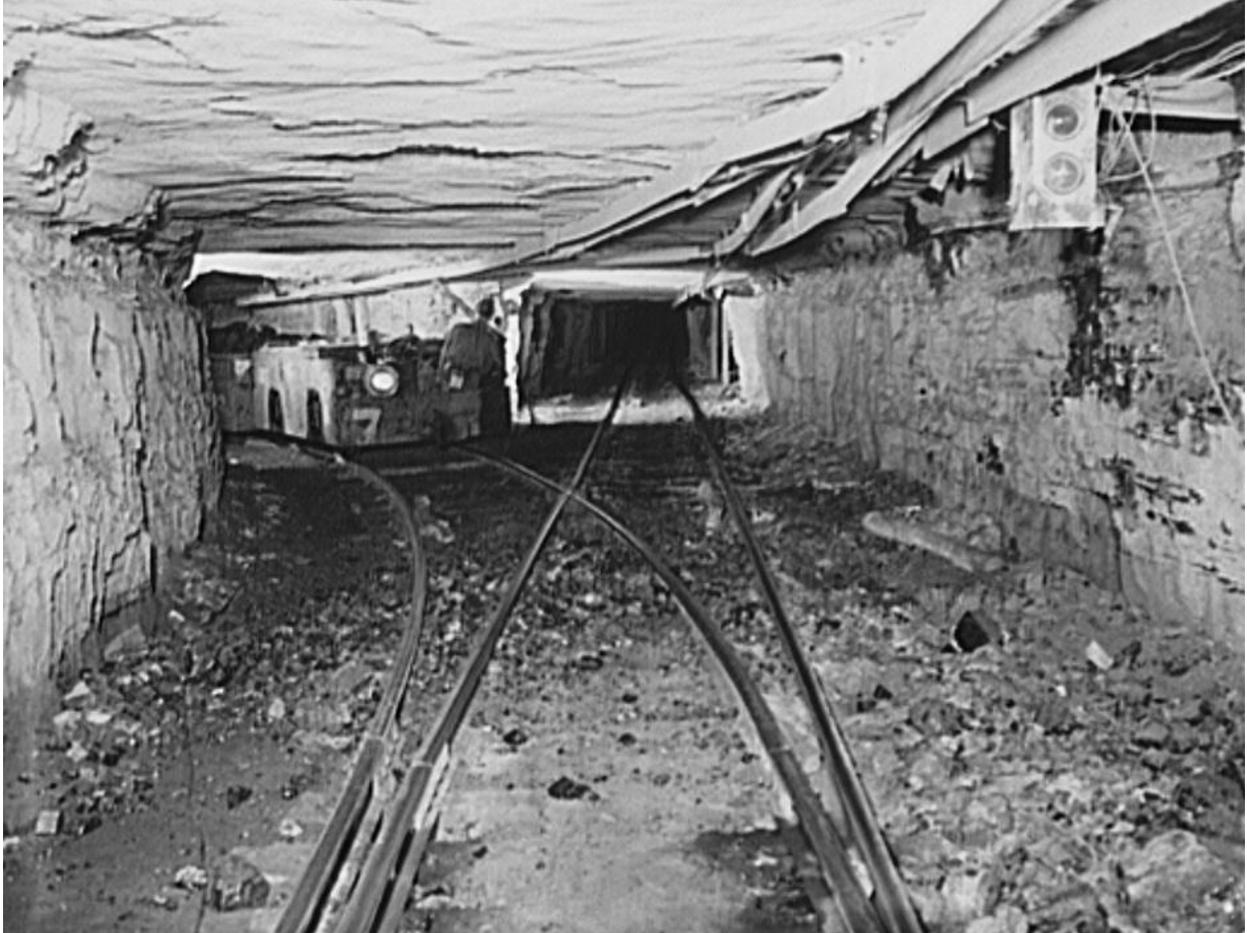
A loaded trip of coal cars heads toward the hoisting shaft. Note the signal lights on the right side. The white coating on the roof and ribs is rock dust, or powdered limestone that prevents coal dust from becoming airborne.

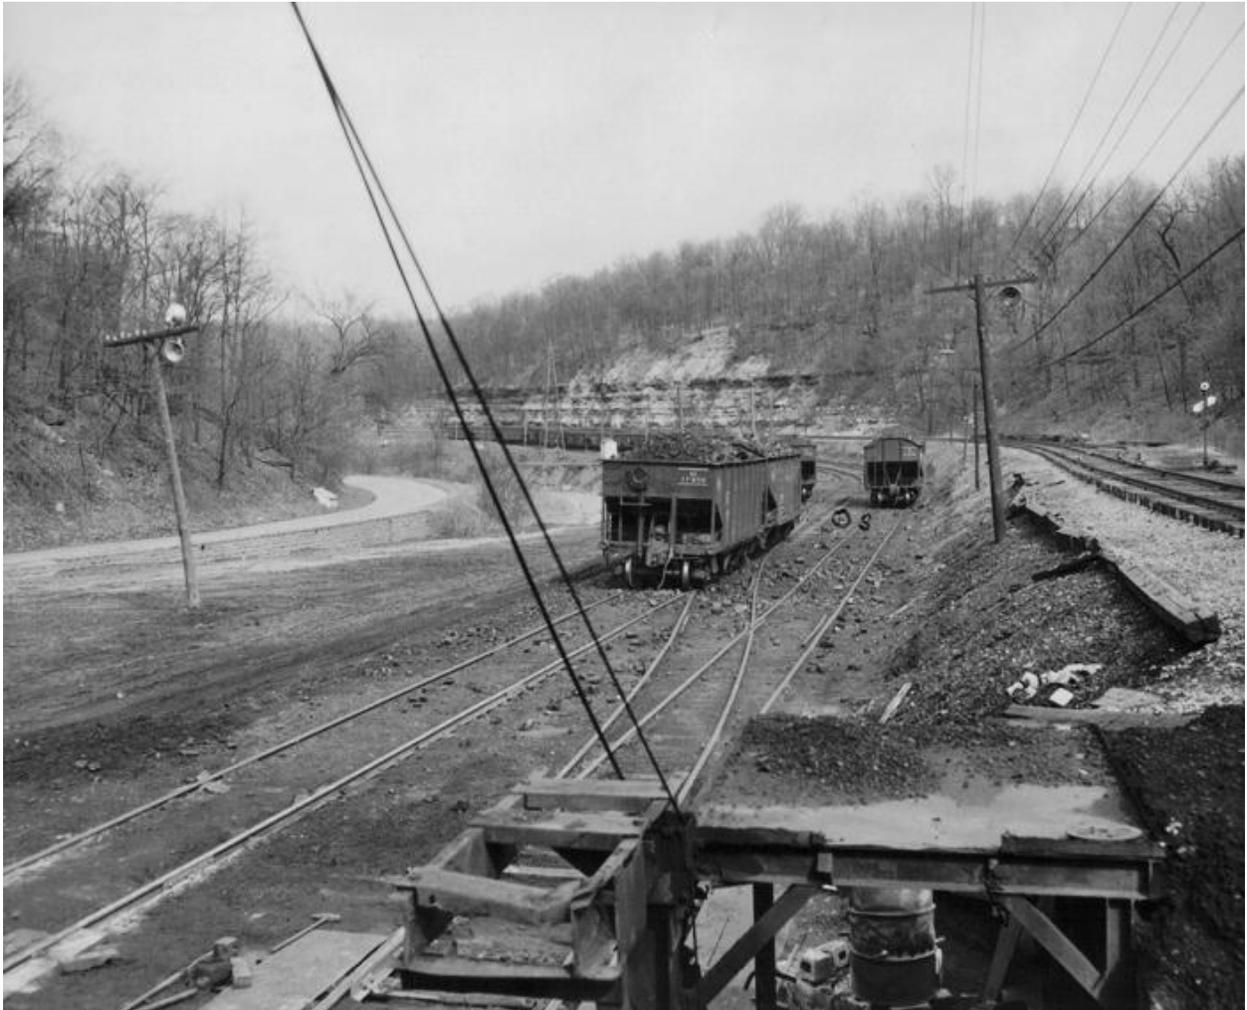
This is a 1957 view of the loaded yard at Montour No. 4 looking timetable west with the Montour main track and the switch leading to the Hills Interchange track on the right. Valleybrook Road is on the left. This is from a Montour Railroad accident report. Note that there are only two tracks coming out of the tipple.

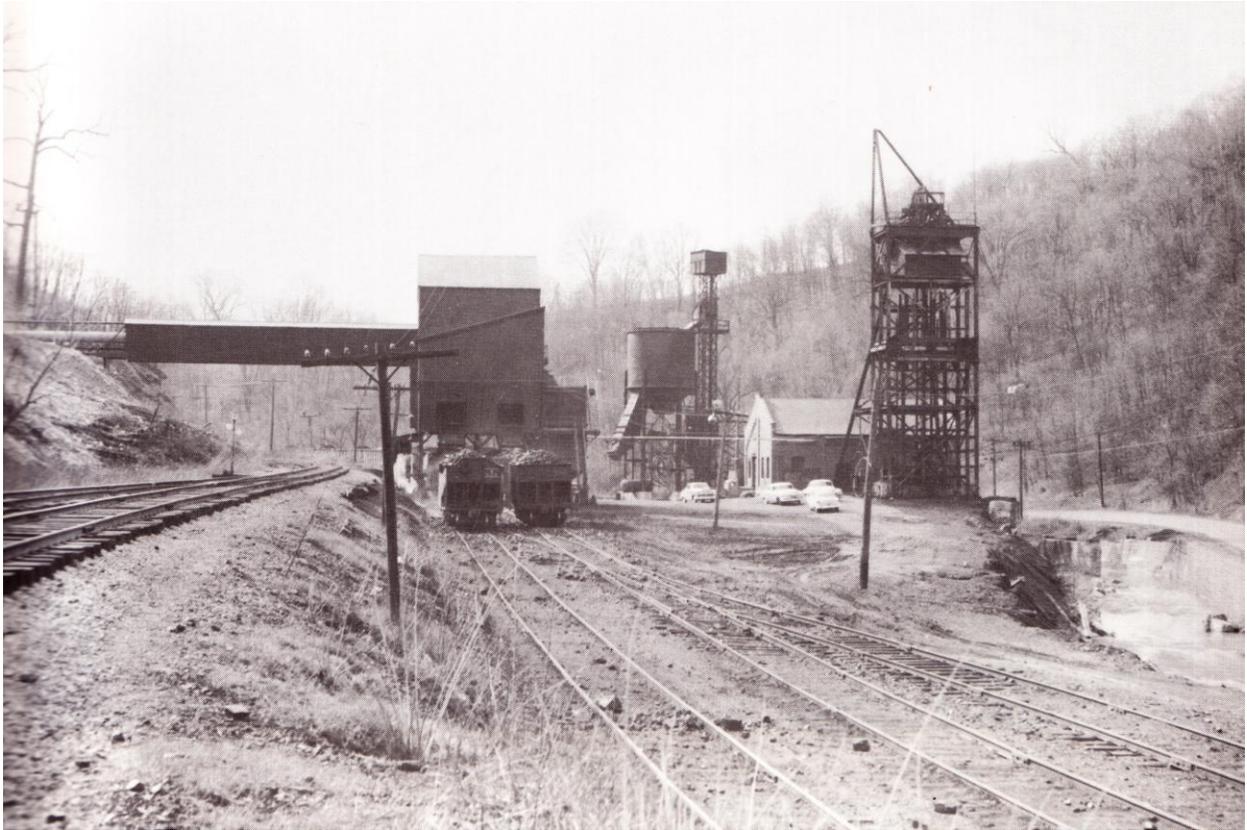
This photo was taken looking timetable east and shows the conveyor going into the newer and smaller tipple. Because all coal from the mine was washed at Champion, a tipple for sizing and cleaning the coal was no longer needed.

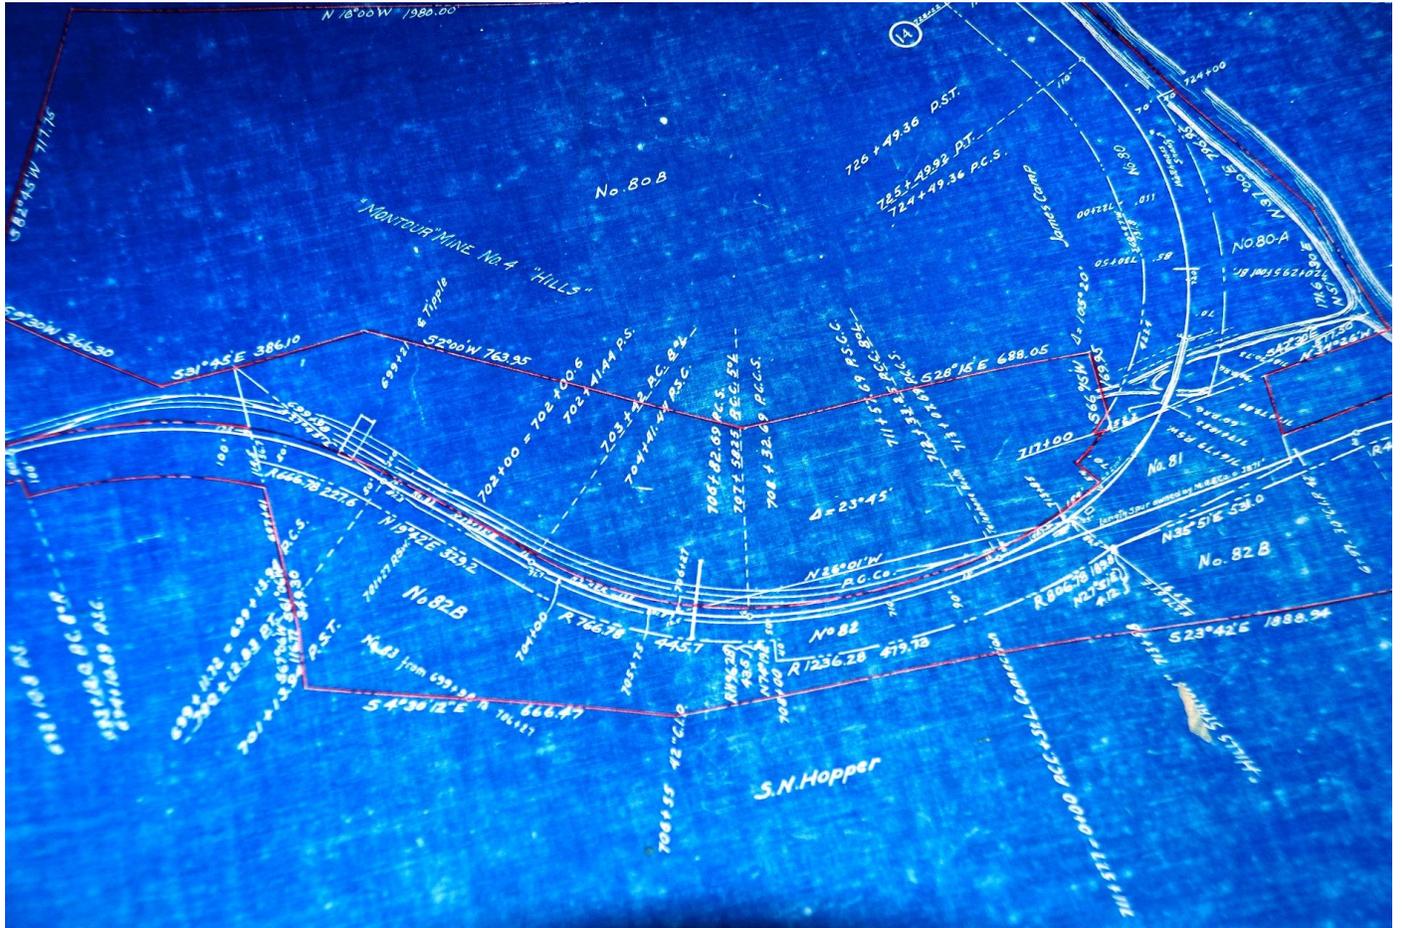
This is an early blueprint of the Montour tracks at the Hills hoisting tippie. A note above the Hills Interchange track says the length of spur owned by the Montour Railroad was 3,871 feet.

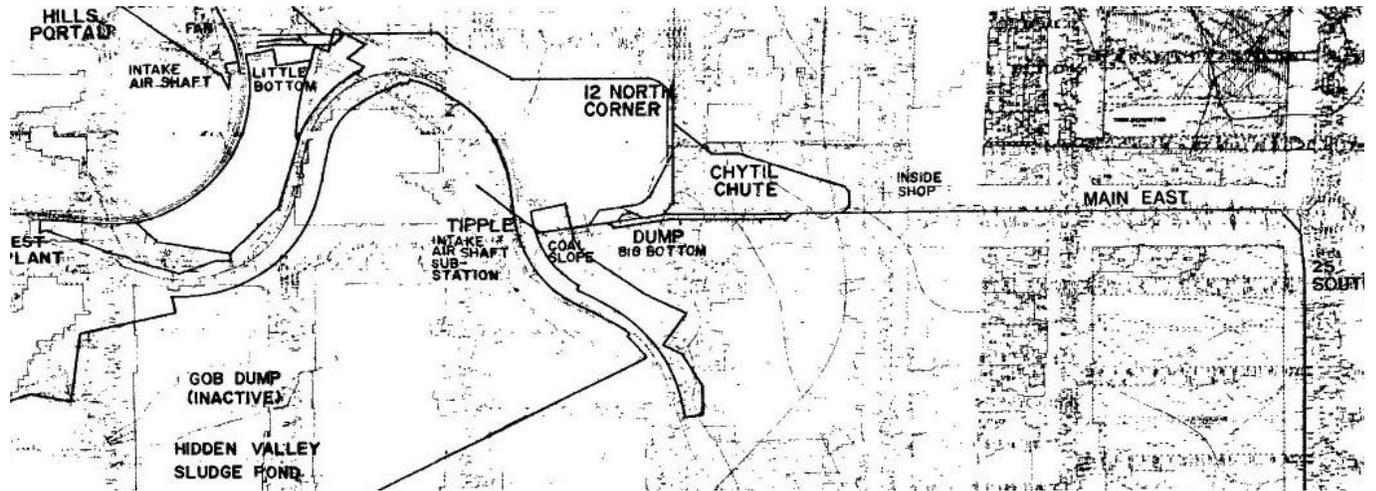
This underground map shows how some of the mine's features were named. This map was made late in the mine's lifetime because it shows the waste dump is no longer active.

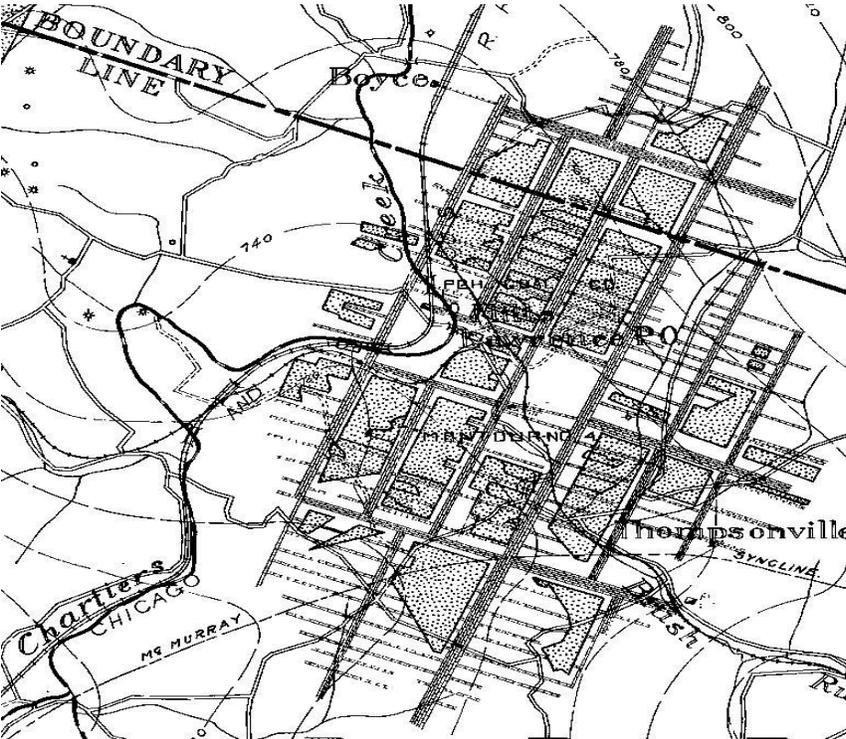
This is an underground map of Montour No. 4 from the 1930s. Note that it shows an entry into the mine up at Boyce. This may have been an escape route.

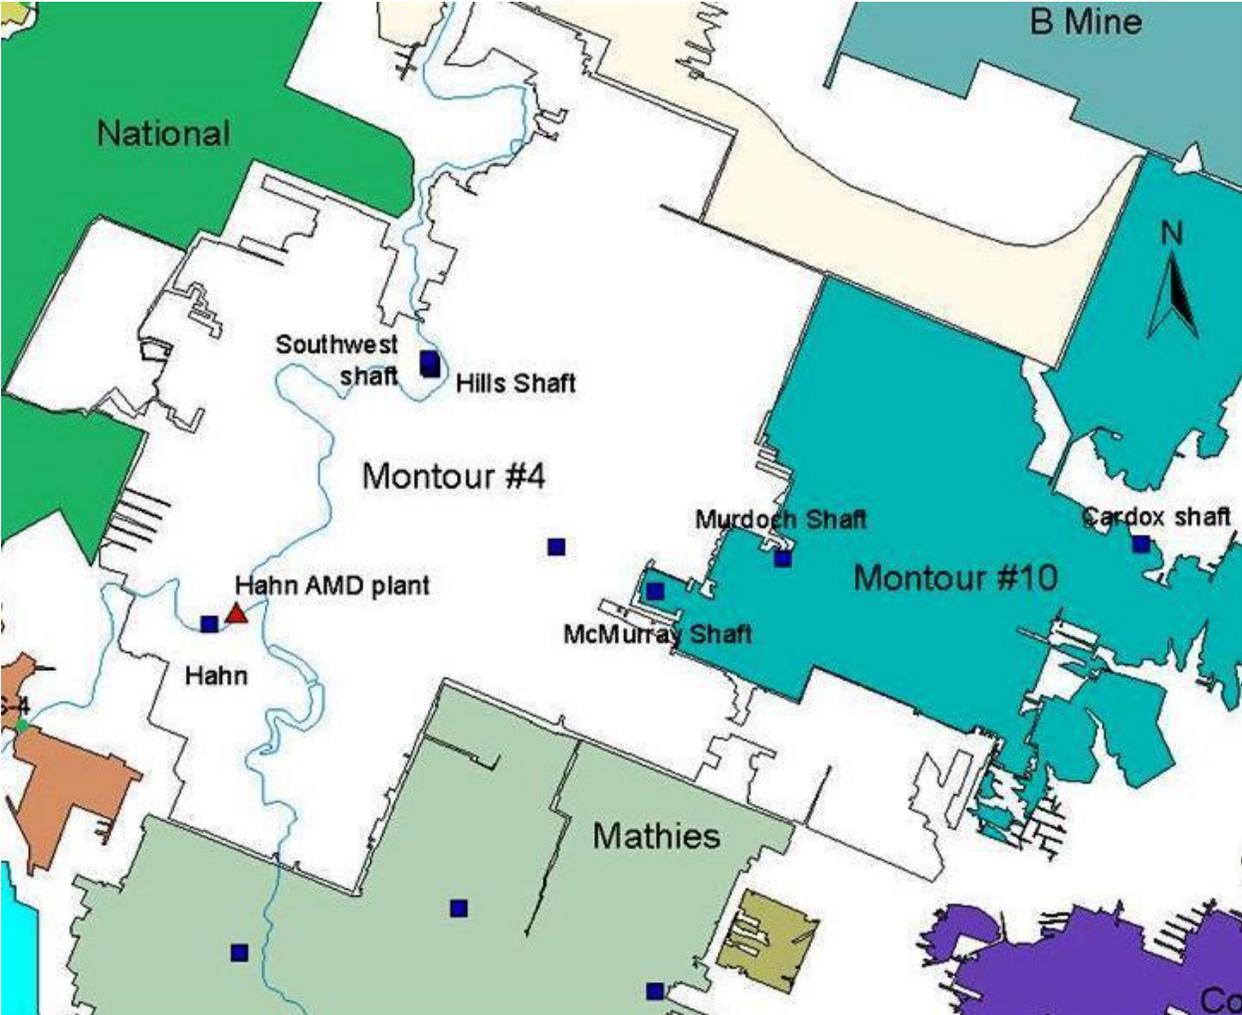
This map shows the relationship between Montour No. 4 and the adjoining mines. The barrier between No. 10 and No. 4 that failed and flooded the mine was located near the McMurray Shaft. There is some confusion between the McMurray and Murdoch shafts because the names are used interchangeably on some mine maps.

The 1980 flooding of No. 4 mine spelled the end of its tenure as a working mine. For some reason, a barrier between No. 4 and Montour No. 10 mine, which was closed in 1970, failed and water from No. 10 poured into No. 4, flowing downward toward Hahn Portal, the lowest point in the mine. Although the coal company spent two weeks trying to pump out the mine, they eventually gave up and shut it down. The closing of No. 4 mine allowed the Pittsburgh & Lake Erie Railroad, which took over the Montour Railroad in 1975, to file for abandonment of the main line between Gilmore Junction and Hills.

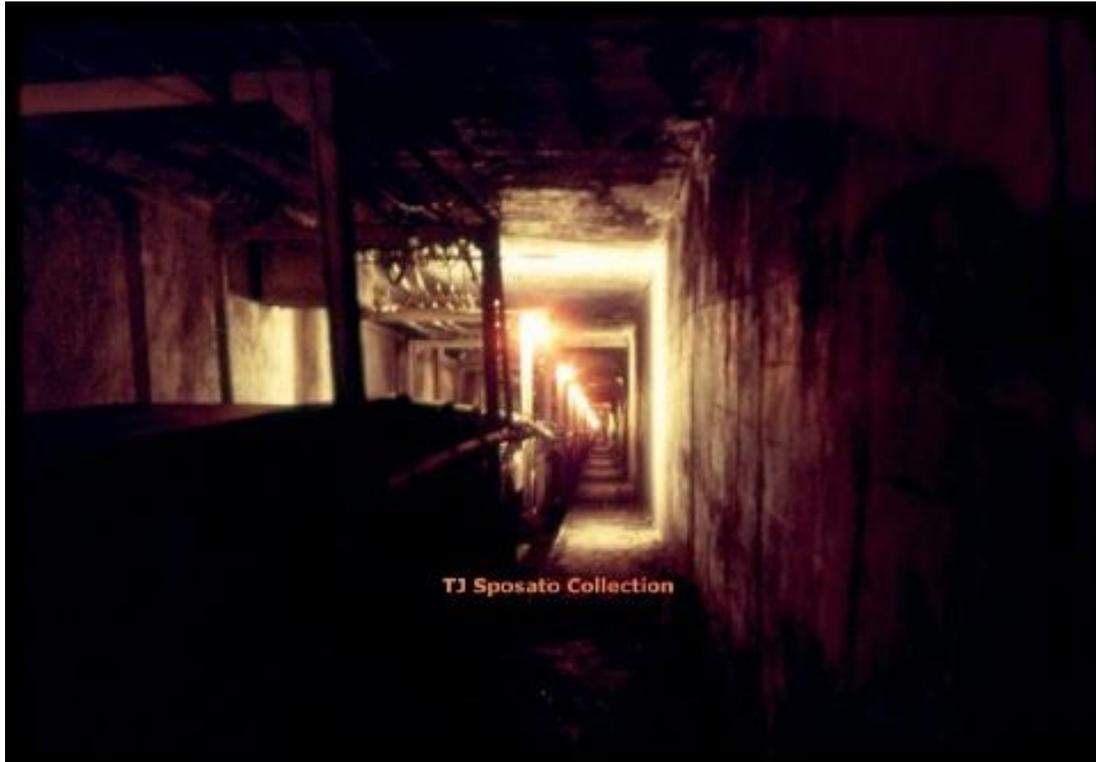
This is a photo of the inside of the conveyor slope after the mine was closed. Power and ventilation were still in service, but the mine was closed.

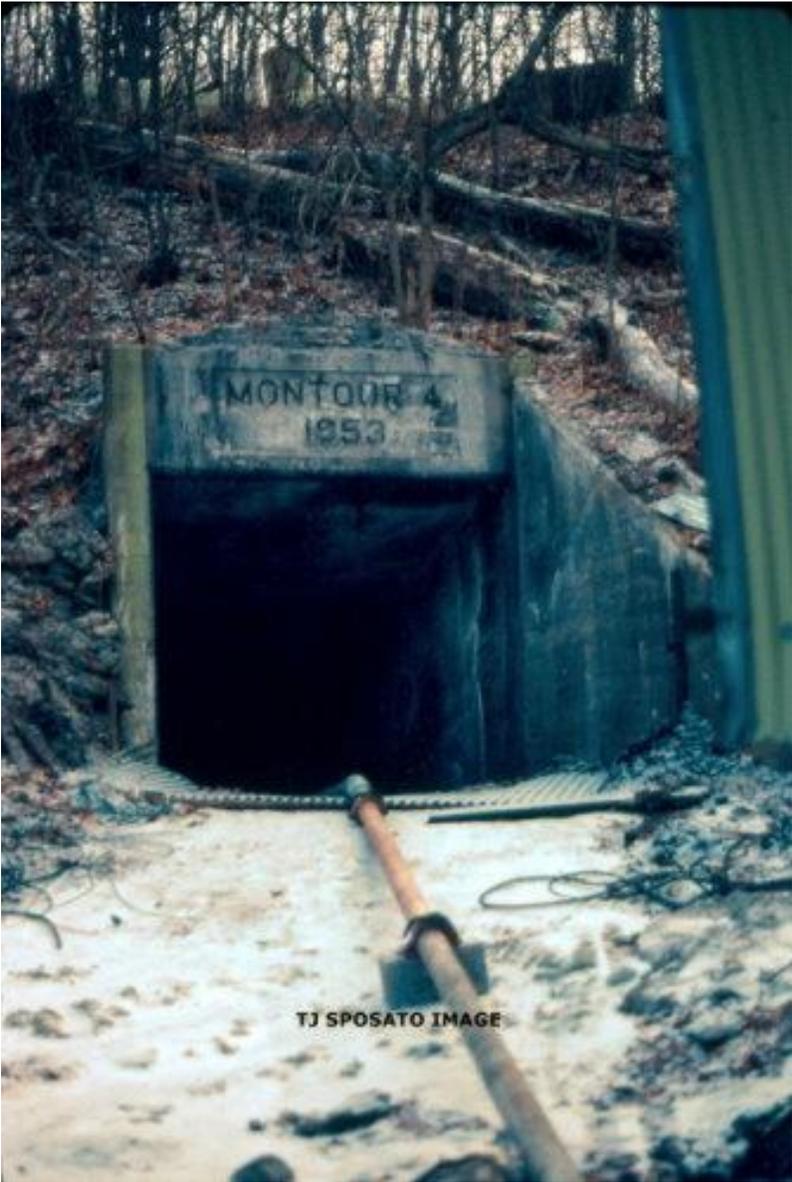
Concrete is being pumped into the conveyor slope entry to seal the mine in late 1980.
