MP 10.8 84'8" Through Plate Girder Concrete Deck

Mile 9.8 Trail MP 8.9 Over Rt. 30

No Builder's Plate – No dates in concrete

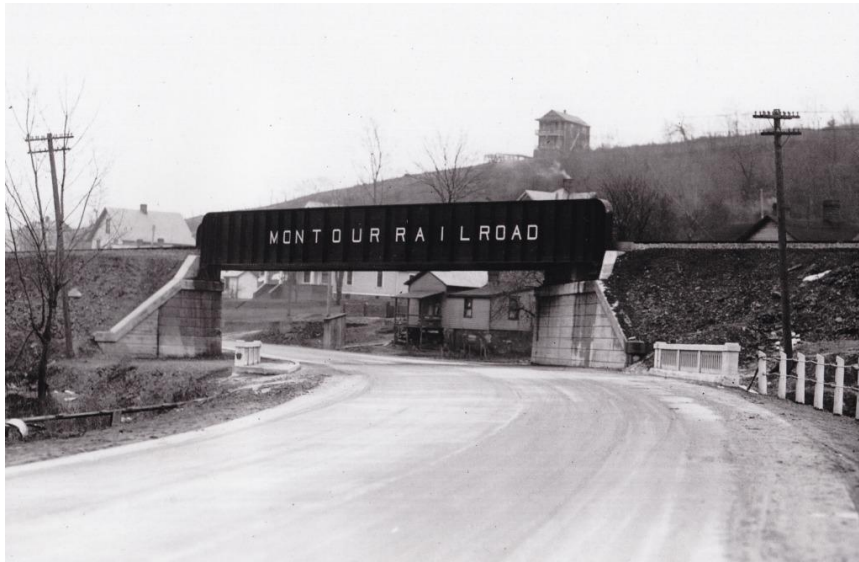
This bridge replaced a grade crossing at Rt 30 during 1928 realignment – this view in 1930 looking east on Rt. 30. Concrete guardrails in front of bridge are for Montour Run flowing under roadway bridge.

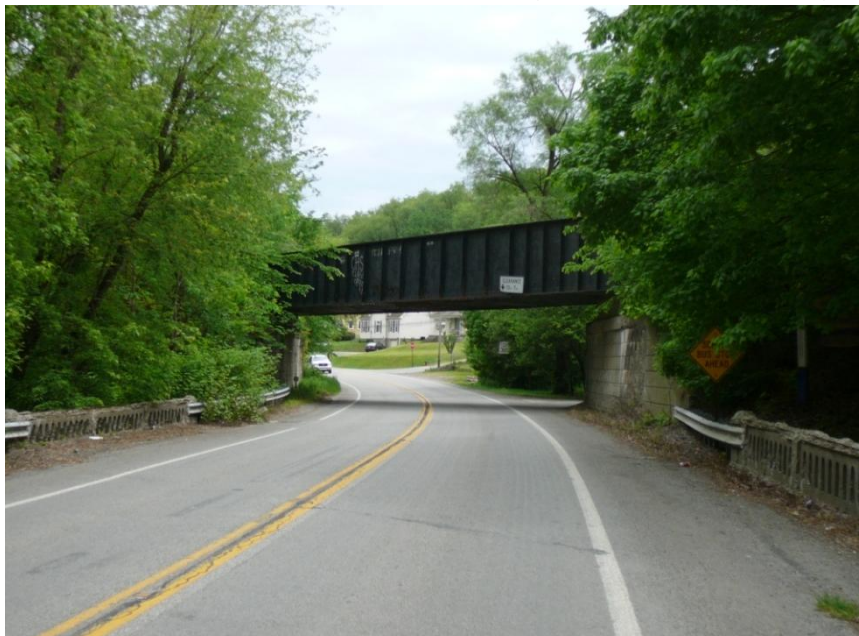
Similar view in 2010. One of five bridges built during realignment project.

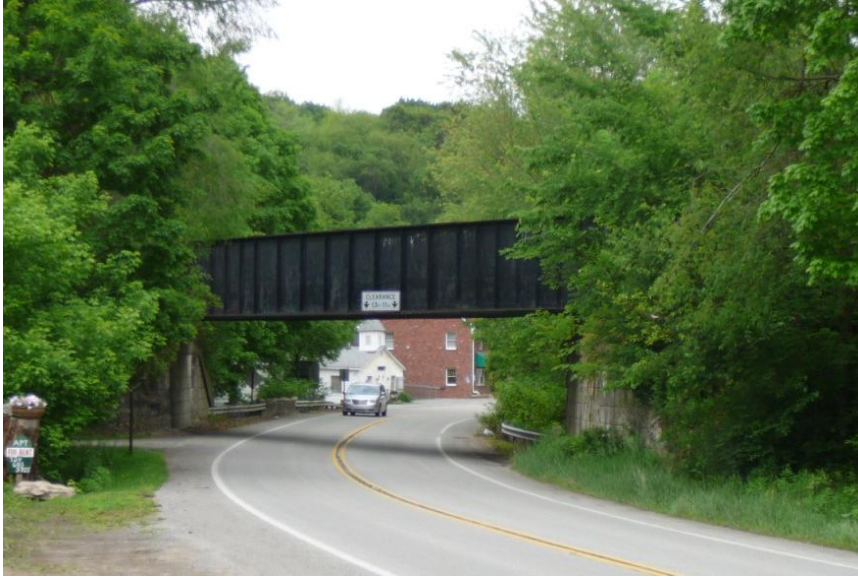
View looking east (RR westbound) – toward Findlay Activity Center. Through Plate Girder and skew construction are evident in this picture, as is concrete deck which supported ties & rails on ballast laid across deck.
