# Lotus Bridge

By Bryan Seip - Montour Railroad Historical Society

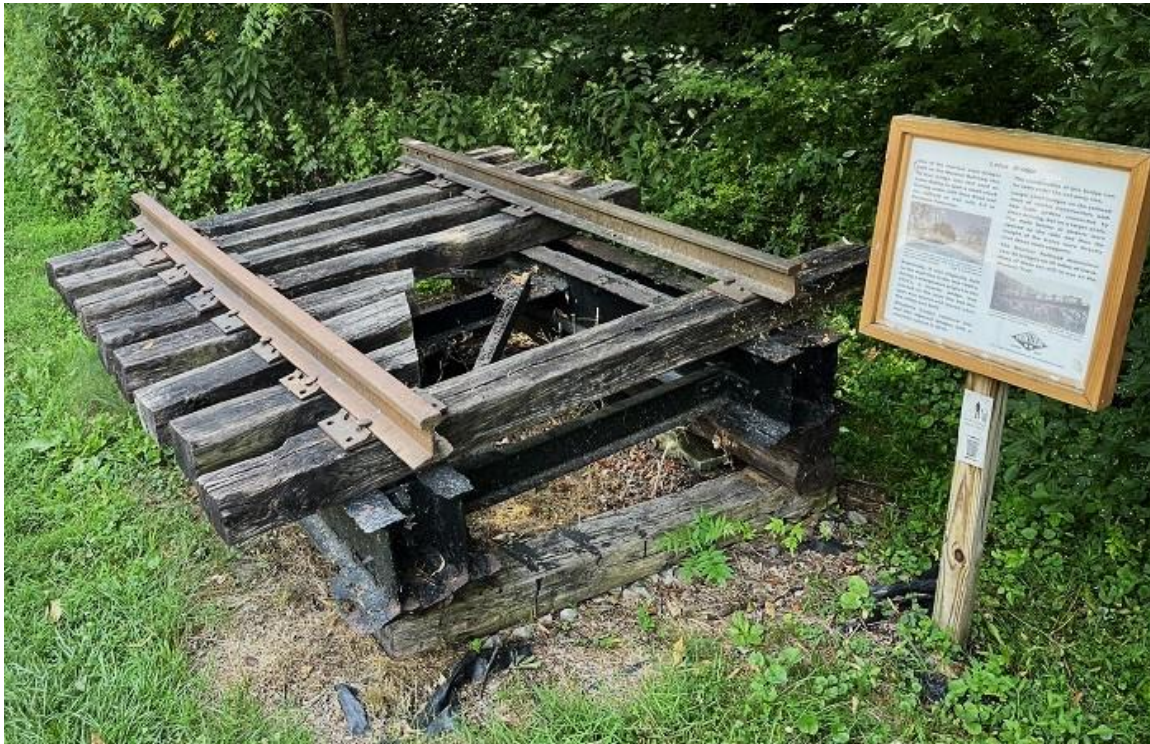
**Lotus Bridge display at Trail Mile 30. Bryan Seip photo**

During the 2010 culvert project, one of the bridge spans was recovered by the Montour Trail Council and the Montour Railroad Historical Society completed a display of it along

the trail. It features a cut-away section of ties to show the construction of the bridge. Two parallel I-beams on either side are connected by cross bracing to hold the main beams in place. Ties were laid across the beams and the rails were then laid on top of the ties, running directly above the main support beams. "L" or "J" shaped bolts were drilled through the ties and hooked under the top flange of the I-beams to hold the ties in place. Bridge ties are typically a bit larger than normal ties and spaced closer together to carry the weight of the trains on the bridge.

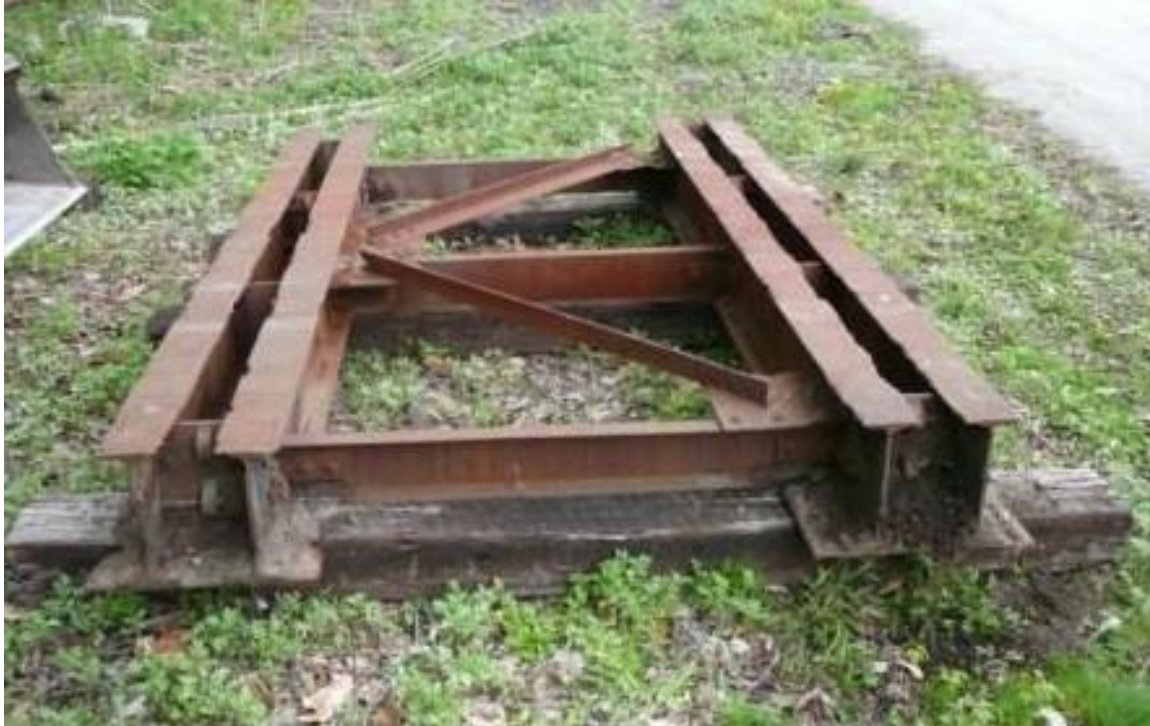
**Lotus bridge relocated to Mile 30. The main I-beams and cross bracing are evident in this view without deck ties and rails. Bryan Seip photo**

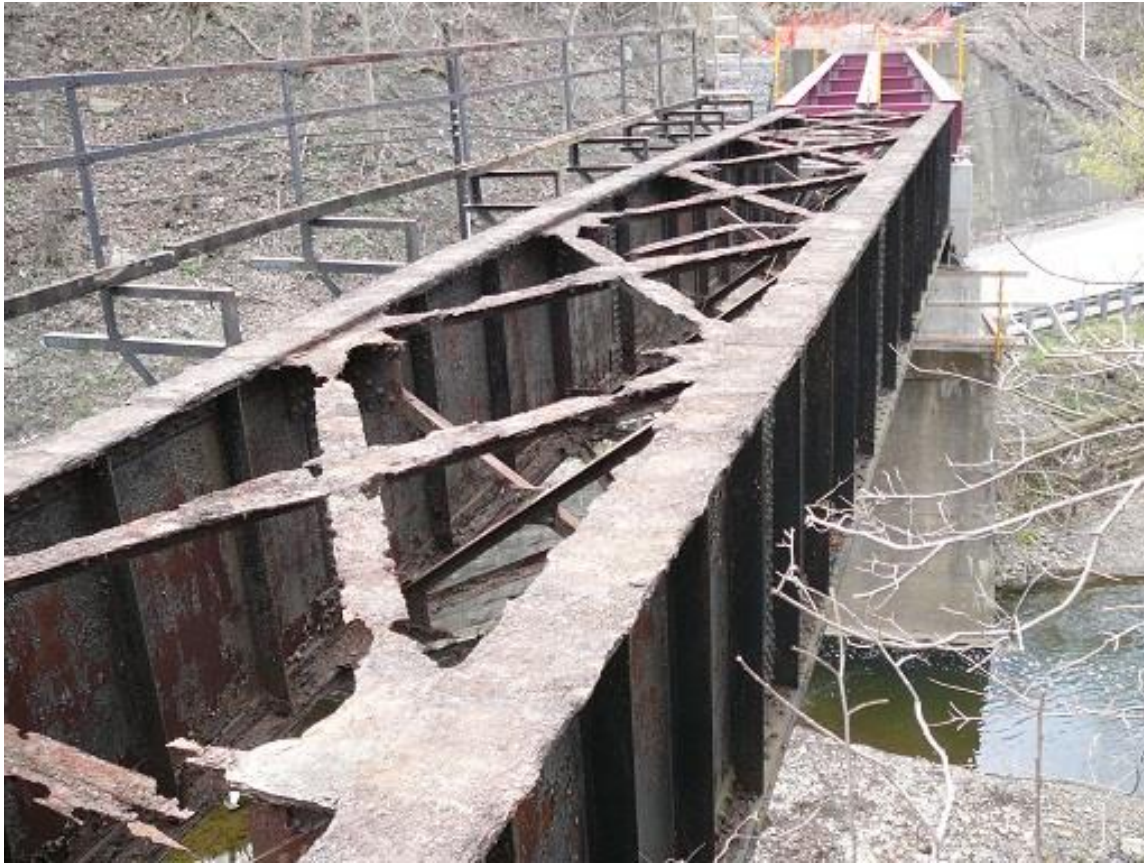
**A much larger bridge stripped of its deck shows the same basic construction as the Lotus Bridge. Large beams to carry the load with cross bracing to hold them in place.  
Bryan Seip photo**

This is the same basic construction design as the much larger steel girder bridges on the Montour, such as the McDonald and Library Viaducts and many of the deck plate girder bridges along the trail. The main support beams were situated directly beneath the rails with cross bracing to keep them in position, but on a much larger scale. A deck of wood timbers was laid on top of the main beams or girders and then the rails topped off the structure. Many of the bridges also had a safety walkway on one or both sides of the railway. These walkways also served a purpose by catching chunks of coal that would fall off loaded hopper cars and prevent them from falling onto traffic using the roadways below the bridges.
